Cherry Creek Stream Mitigation

Date of Installation: 2016

Location: Cherry Creek at the Westmoreland County Community College (145 Pavilion Ln, Youngwood, PA 15697)

Client: Westmoreland Conservation District & Pennsylvania Department of Transportation (PennDOT)

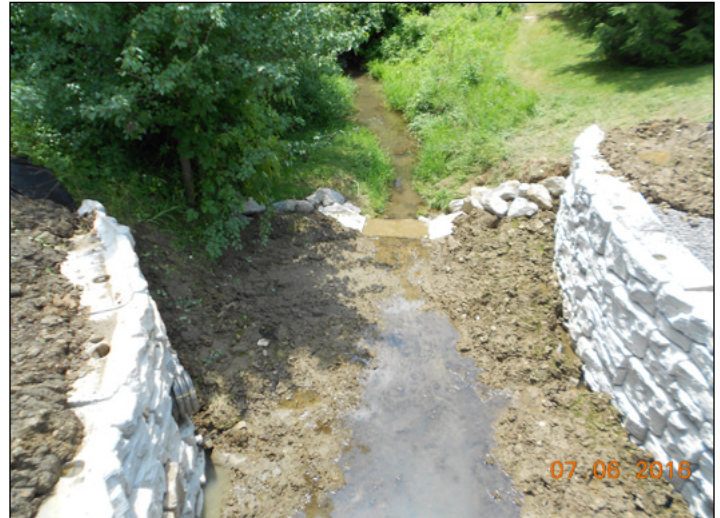
Newly installed Redi Rock walls and rock cross vane

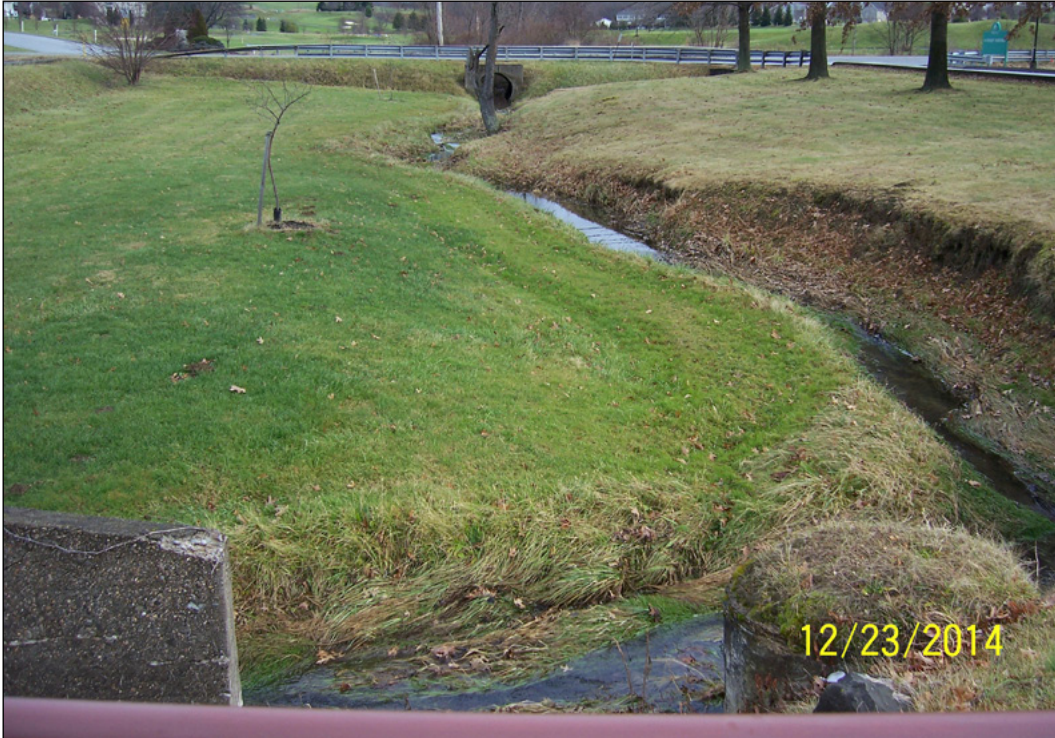
Furthest upstream portion of Cherry Creek before construction; note the mowed banks all the way up to the edge and erosion on the right-hand bank

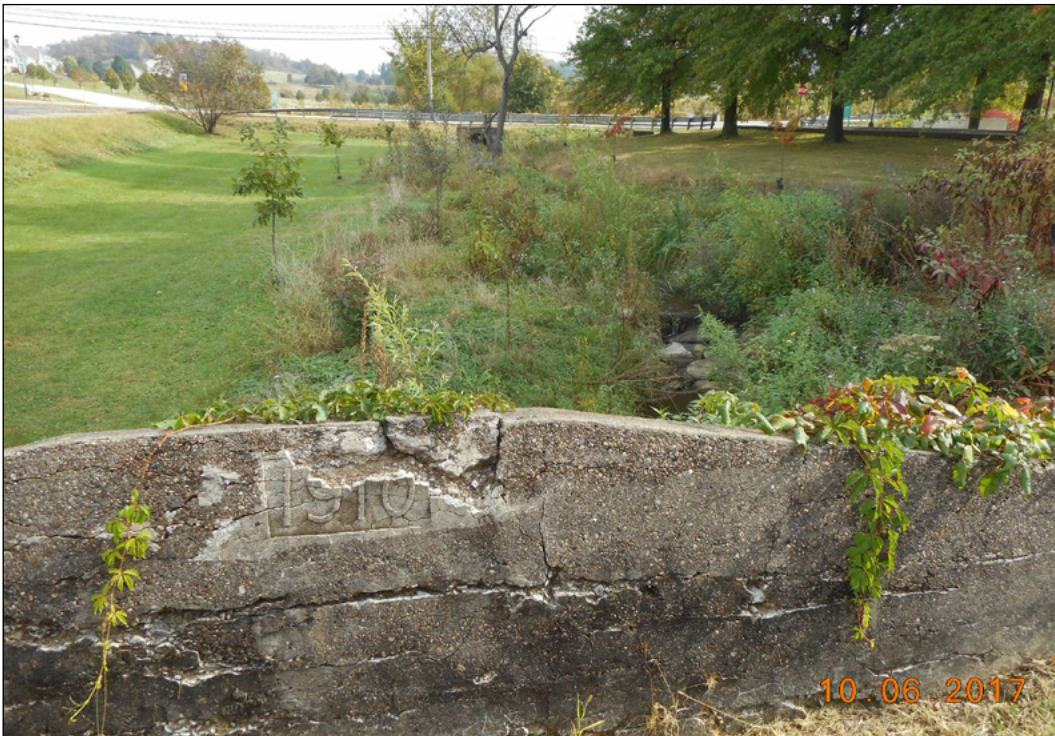
The furthest upstream section a year after construction

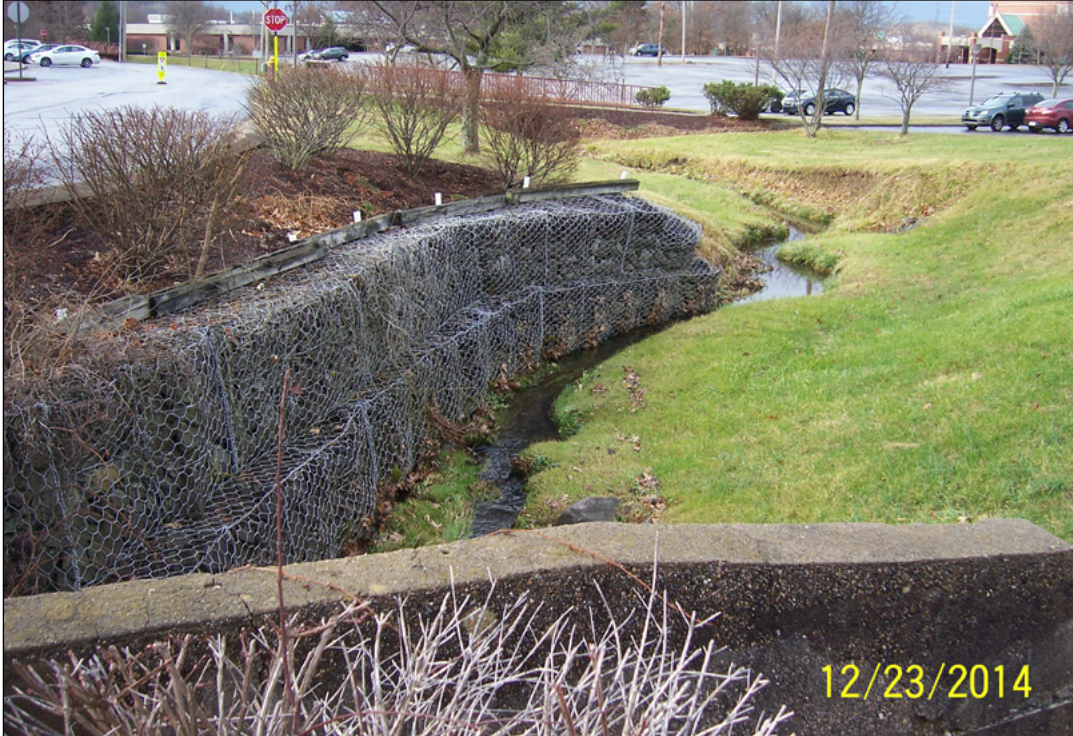
Moving downstream, the next section of Cherry Creek before construction; the gabion baskets were falling in on the end and again, the bank was being mowed to the edge

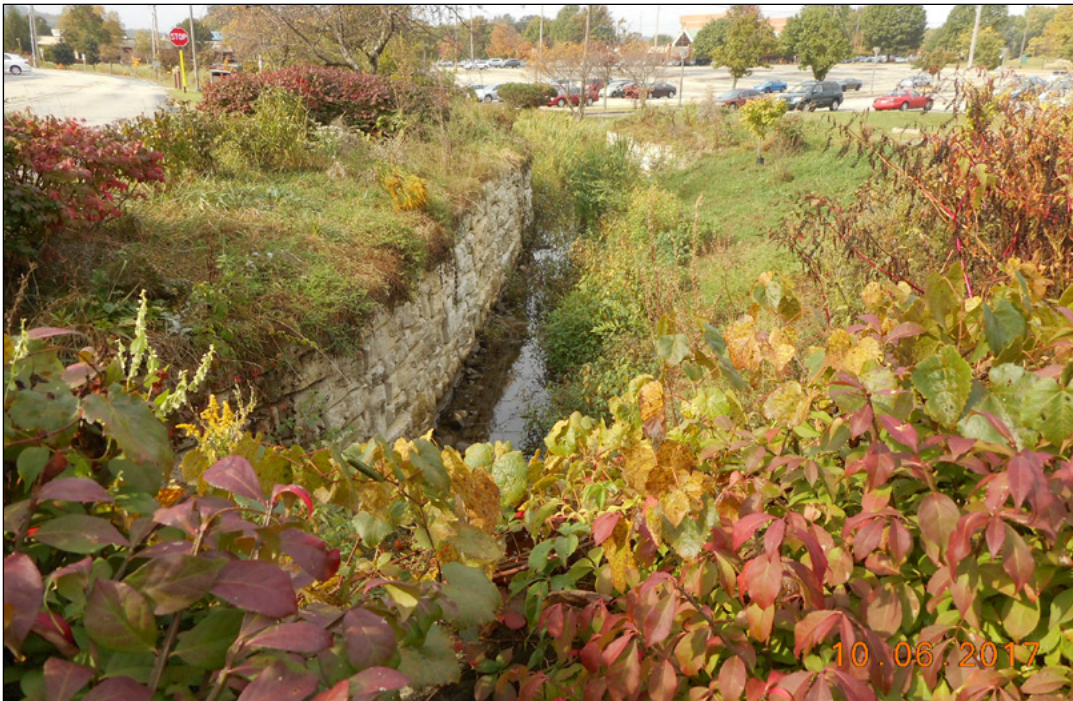
The same section a year after construction with Redi Rock installed in place of the gabion baskets

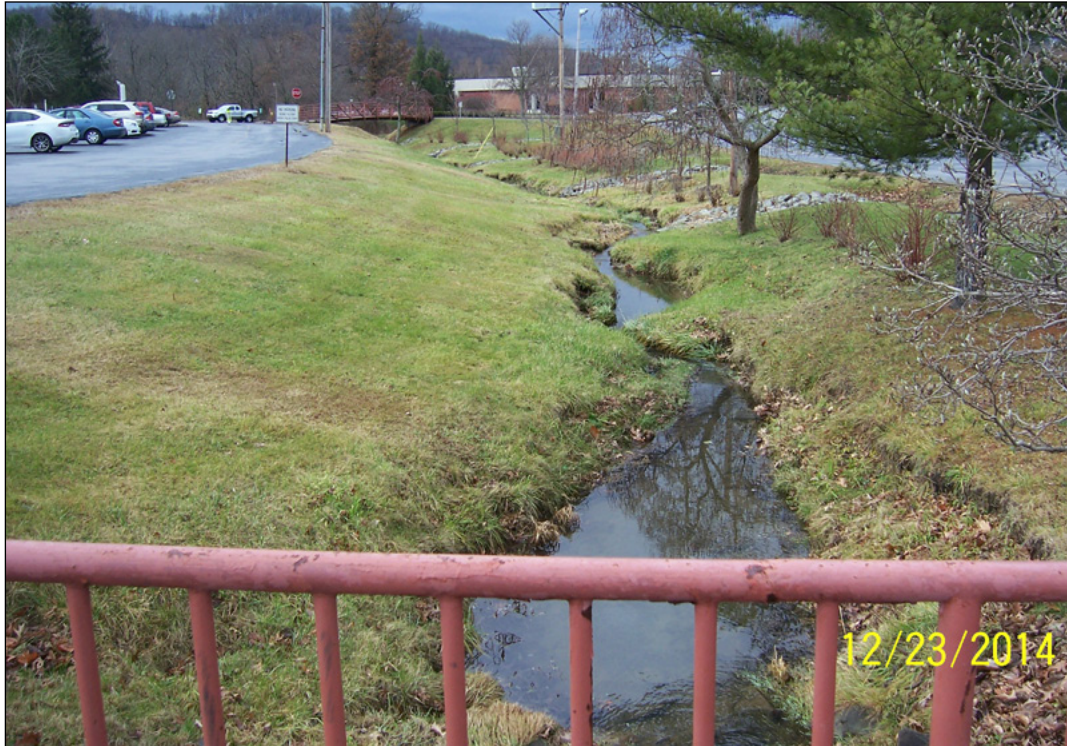
The next section downstream before construction

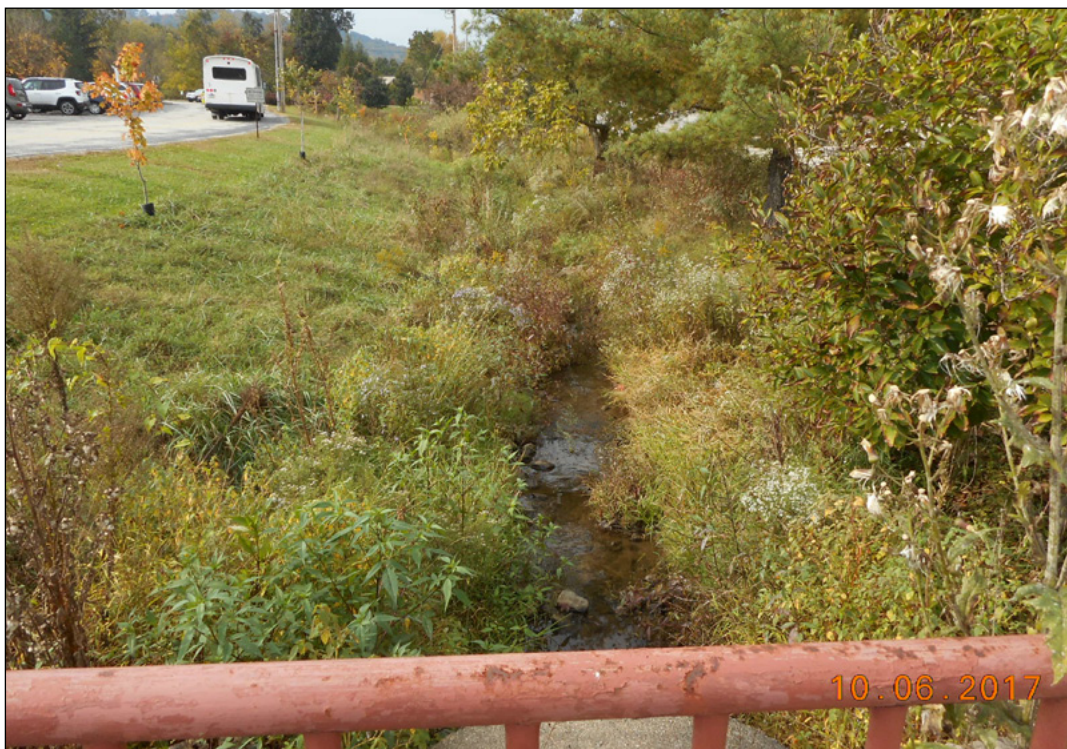
The same section one year after construction

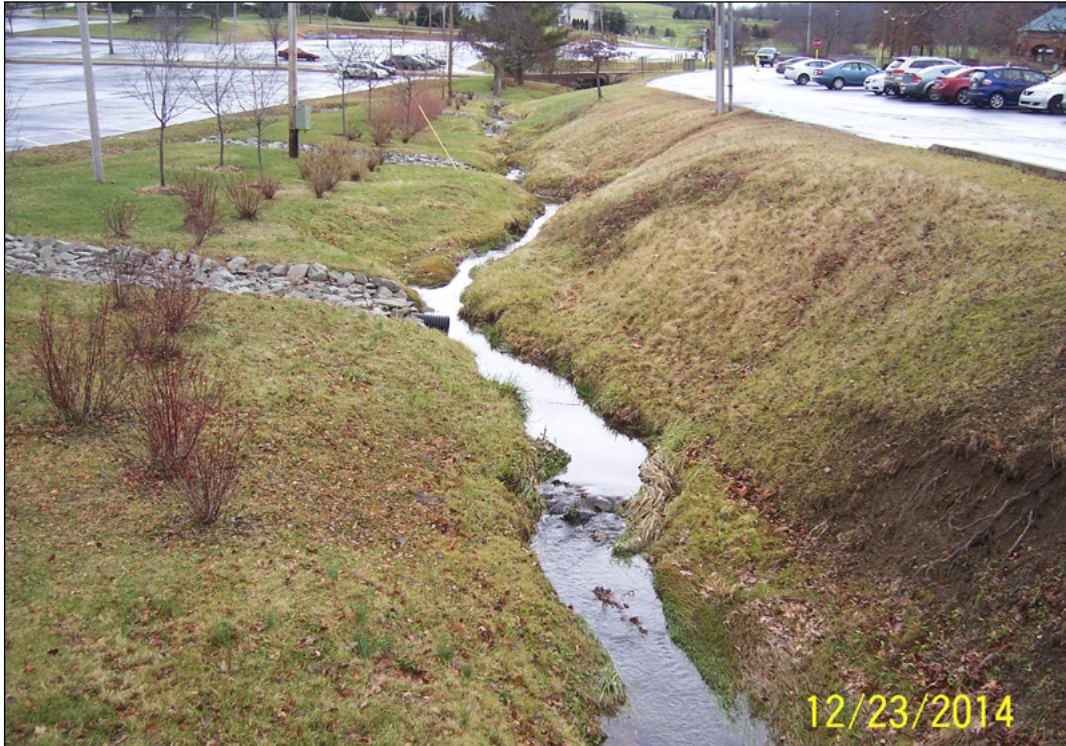
The furthest downstream section of Cherry Creek before construction

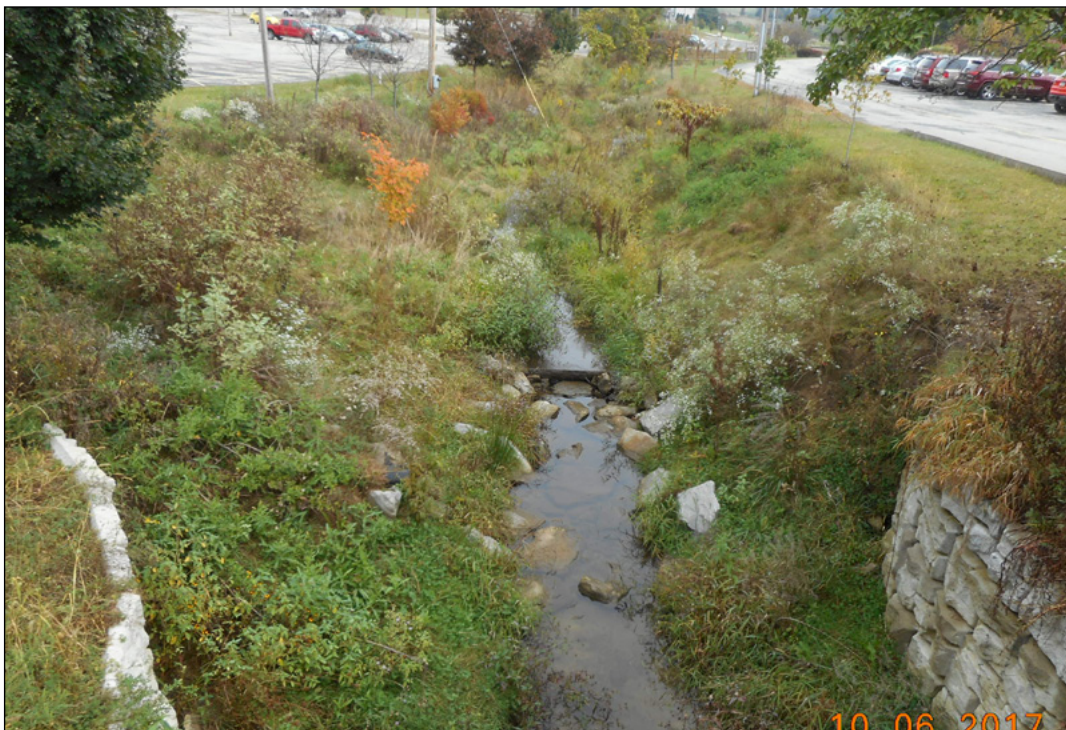
The same section a year after construction; Redi Rock was installed to stabilize the banks underneath the pedestrian bridge

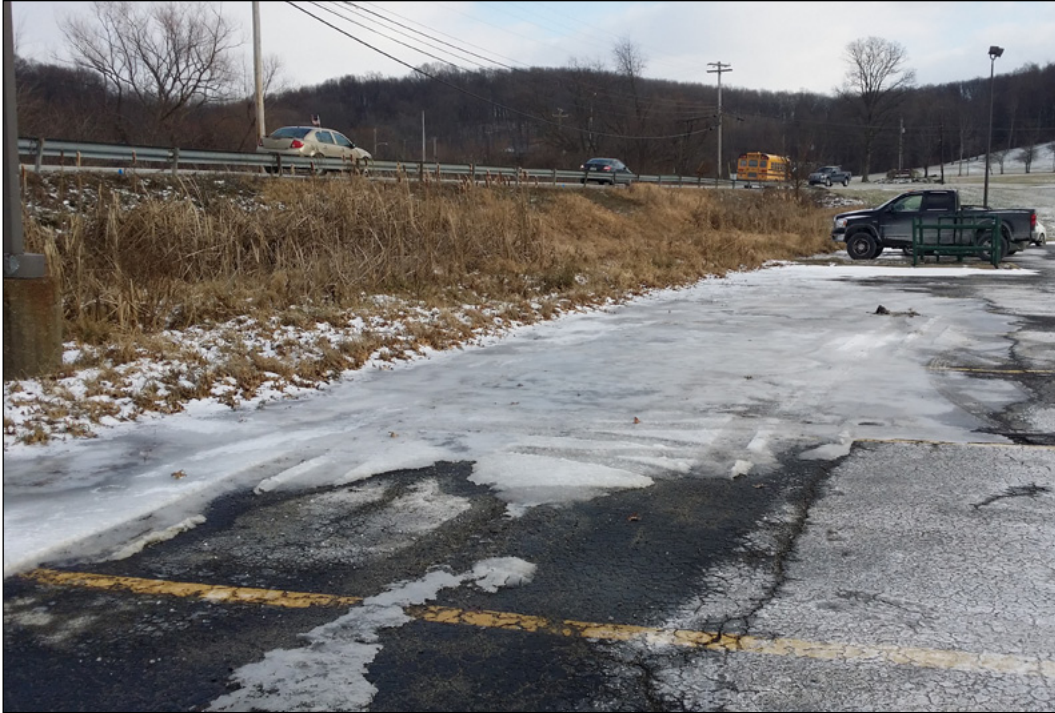
The parking lot area next to Armbrust road where the stream channel needed re-aligned; note the ice frozen over the parking spaces caused by the poor drainage

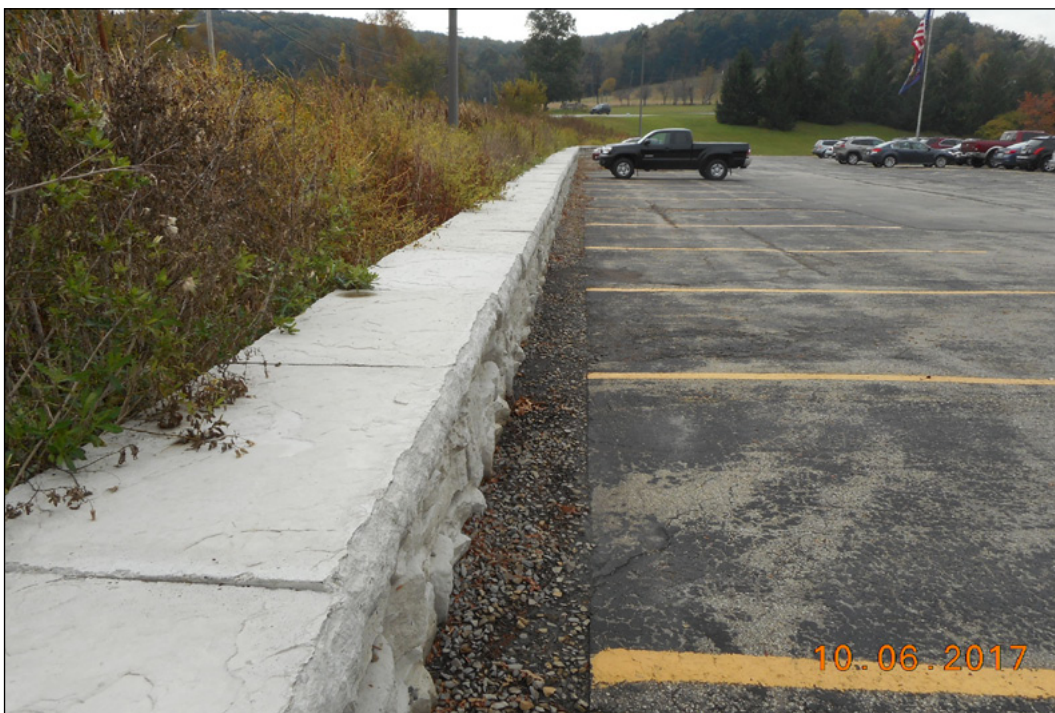
The same area after a Redi Rock wall was installed with underdrain, and the channel to the left was re-aligned
