Watershed Restoration

Style-Rite Kitchens Streambank Stabilization

Location: City of Lower Burrell, PA

Client: Style-Rite Kitchens

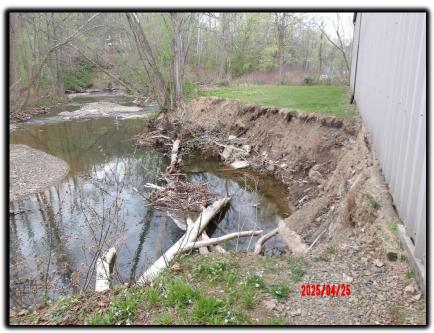
Severe streambank erosion threatening the back of the Style-Rite Kitchens building.

In April 2024, significant rainfall caused Pucketa Creek to cut a new path and make a sharp bend directing the stream to the back of the Style-Rite Kitchens building. The streambank along this area was very unstable due to unconsolidated fill material. The yard/ streambank of the business next to Pucketa Creek after a large rainfall event eroded within 18-inches of the building decreasing water quality downstream. The Westmoreland Conservation District provided technical assistance and project management for this project. Funds were acquired from an NRCS - Emergency Watershed Protection Grant and a DEP- Office of Water Programs Grant to implement this streambank stabilization technique along the eroding section.

R-8 sized rip-rap was placed along the section of eroding streambank to create a shallower slope and prevent the water from wearing away the bank further. Smaller R-5 and R-3 size stone and gravel bar material was used to fill in the gaps of the larger rip-rap and restore the lawn area. The site was seeded and mulched.

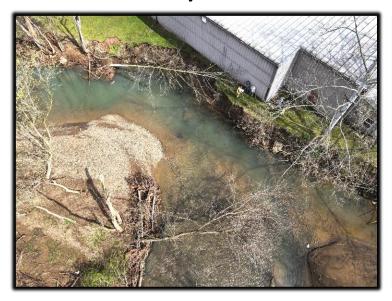
Before: Streambank erosion threatening the building.

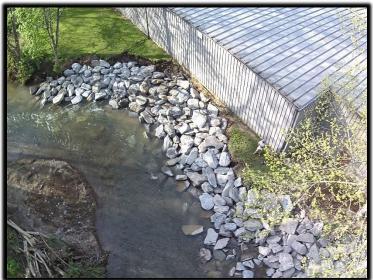
During: Large R-8 size rip-rap installed to restore eroding streambank.

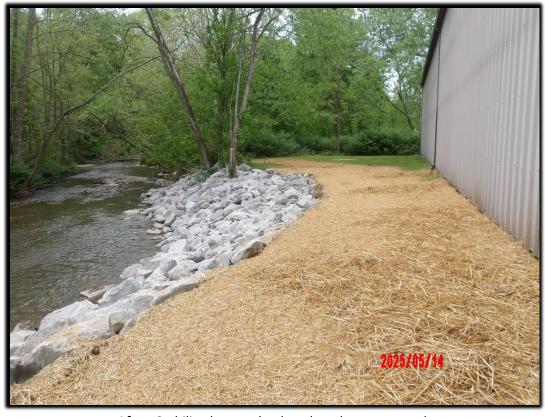
After: Stabilized streambank and yard area restored.
