Beaver Run Unimproved Roads Best Management Practices

Date of Installation: 2014-2016

Location: Beaver Run Reservoir and Coal Hollow Road

Client: Westmoreland Conservation District, Bell Township, Municipal Authority of Westmoreland County (MAWC)

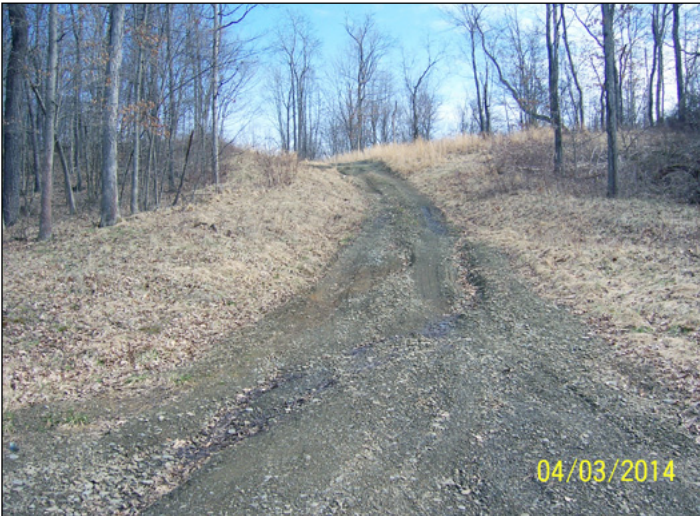
A section of road around Beaver Run Reservoir before construction

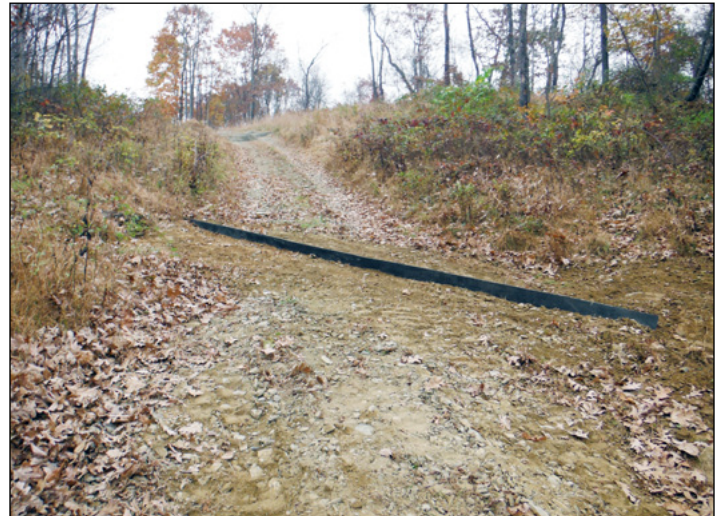
The same section of road with conveyor belt diversions installed

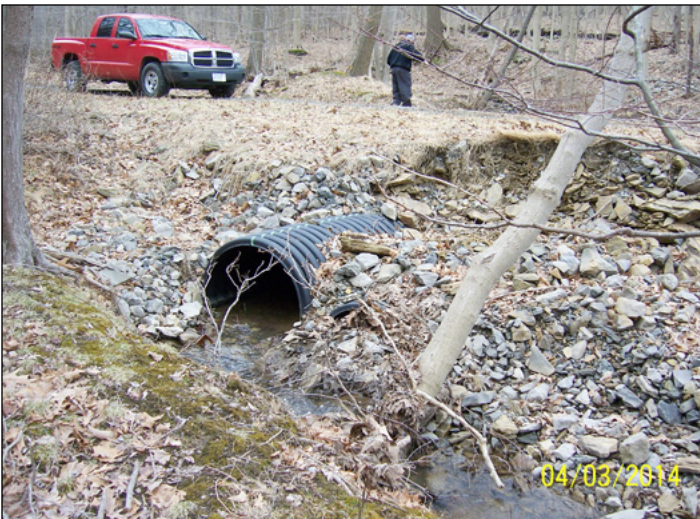
Another section of road around Beaver Run Reservoir; the crosspipe was installed incorrectly and needed to be realigned to remove the 90 degree bends at the inlet and outlet of the pipe

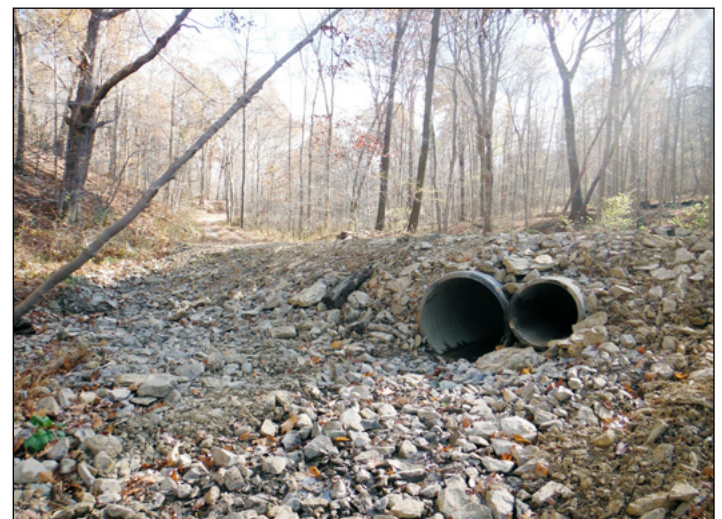
The same crosspipe after being realigned

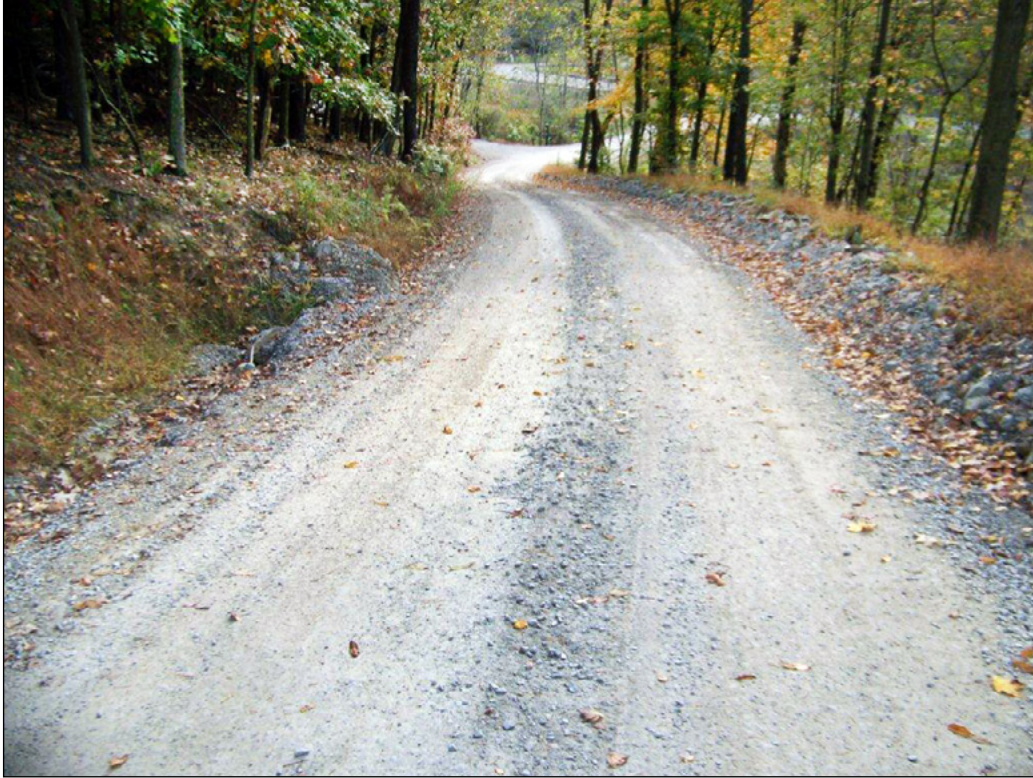
A section of road around Beaver Run Reservoir before construction; note the berms on the side of the road that held water in the roadway

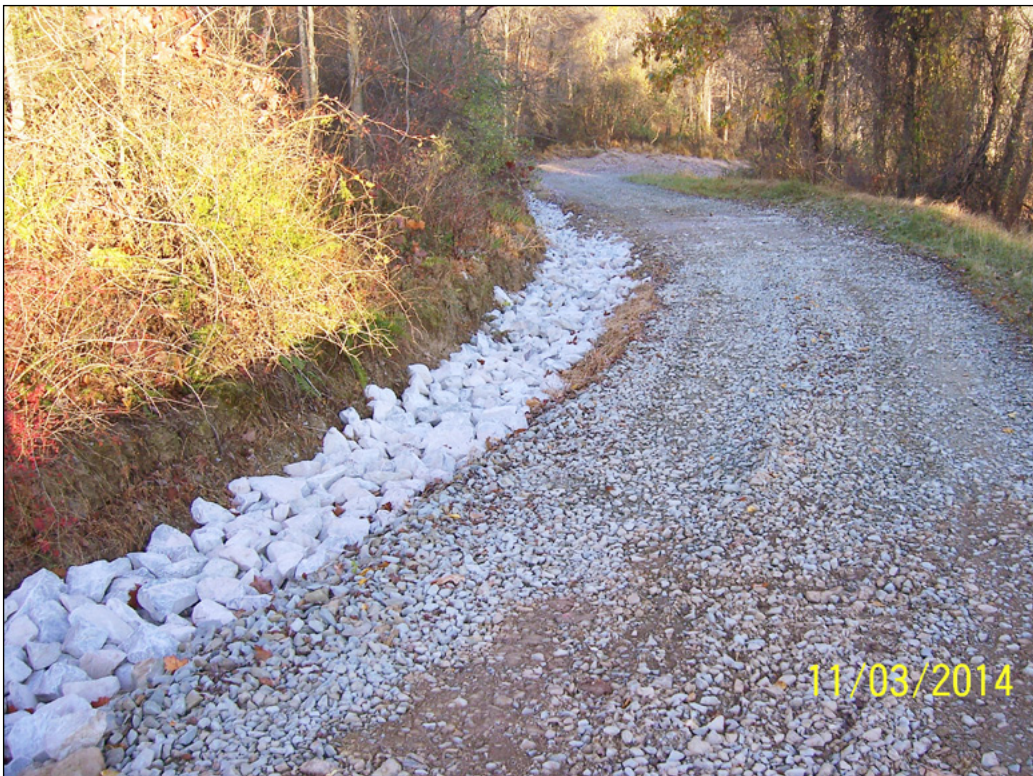
A similar section of road after underdrain was installed and the berms were removed

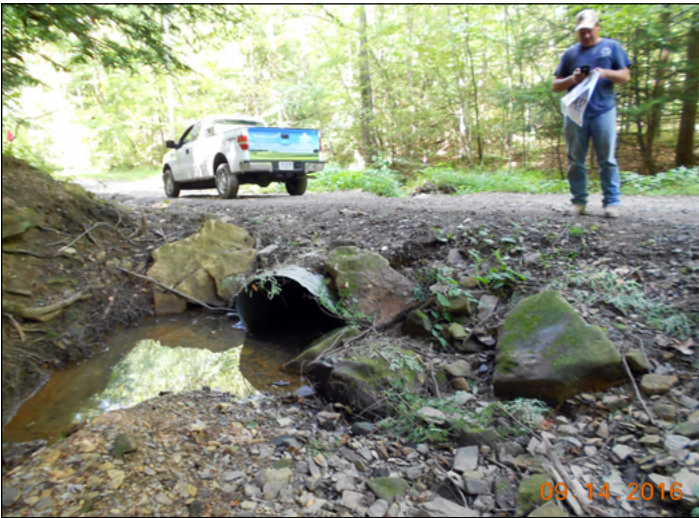
Coal Hollow Road before construction; note the lack of headwall and overflow pipe

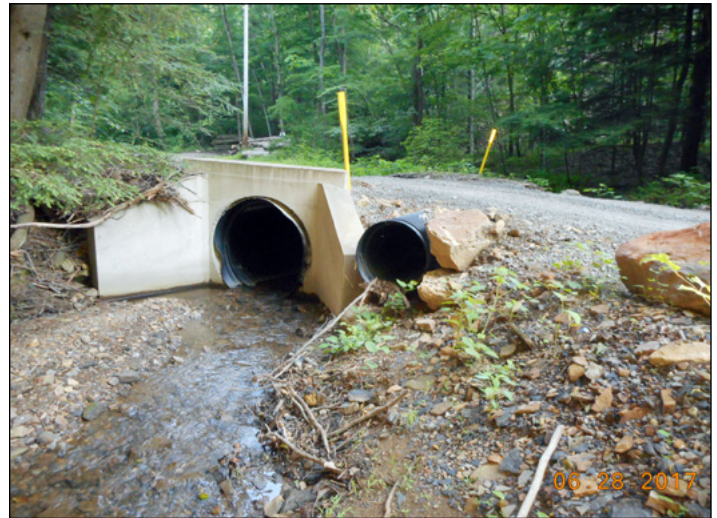
The same section a year after construction; a headwall and overflow pipe were installed along with a new crosspipe

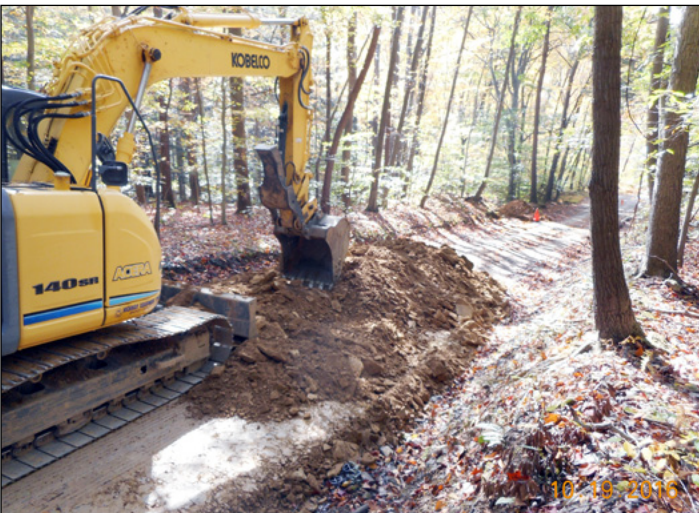
The road profile was filled with shale; [Click here for more detailed information on road profiles](#)

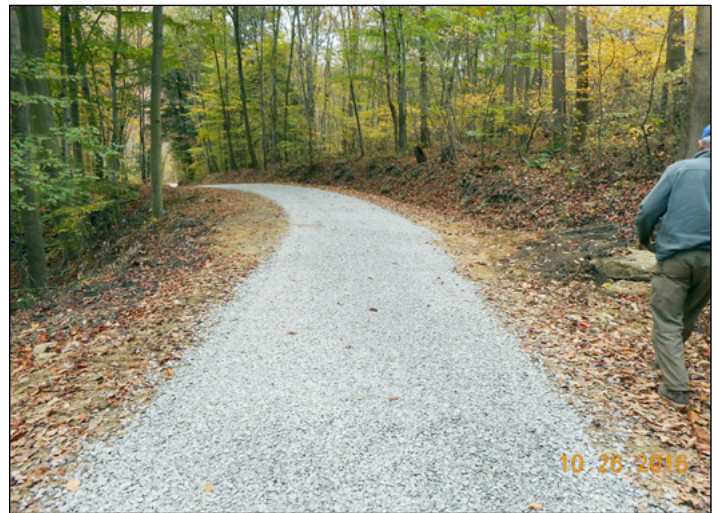
The road after construction was completed; note how the road is no longer entrenched
