## Mill Creek Streambank Stabilization

**Date of Installation:** 2006-2008

**Location:** Ligonier Township

**Client:** Loyalhanna Watershed Association

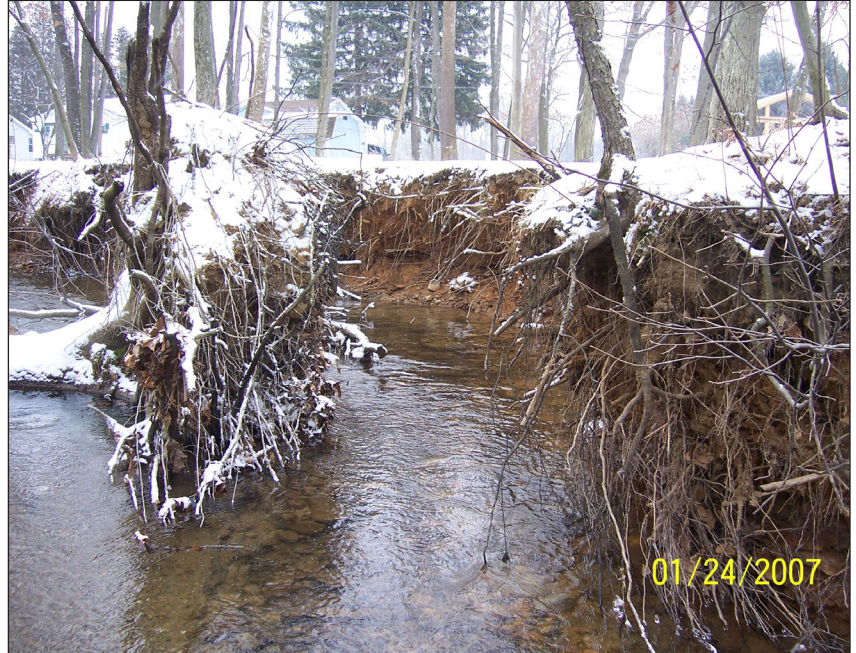
*Serious erosion along the bank of Mill Creek at Hannas Run*

The streambank along portions of Mill Creek in Ligonier Township had been severely eroding from the force of water coming down the creek. The landowners' backyards were being worn away, and restoration was needed to prevent any further erosion and improve water quality.

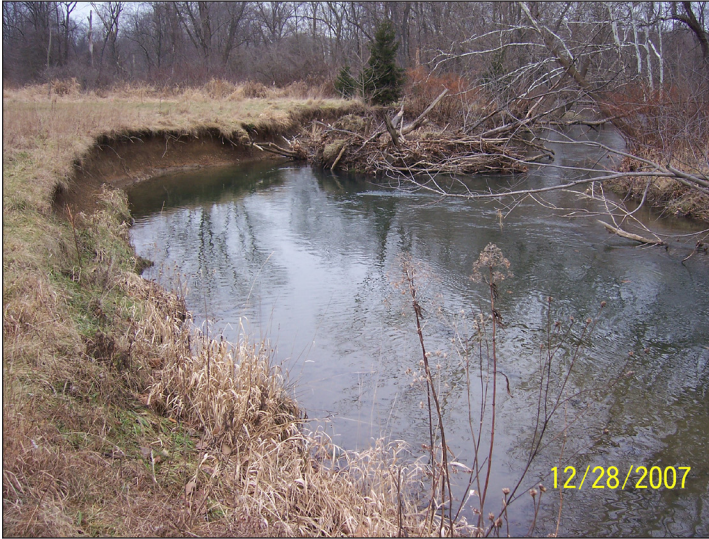
*Denison Investment property before any streambank stabilization was done*

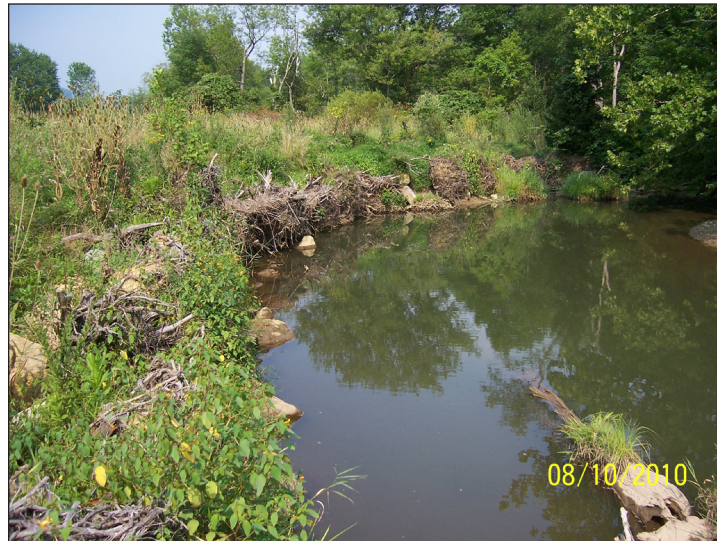
*The bank section at Denison over a year later since the installation of the rootwads and rip-rap*

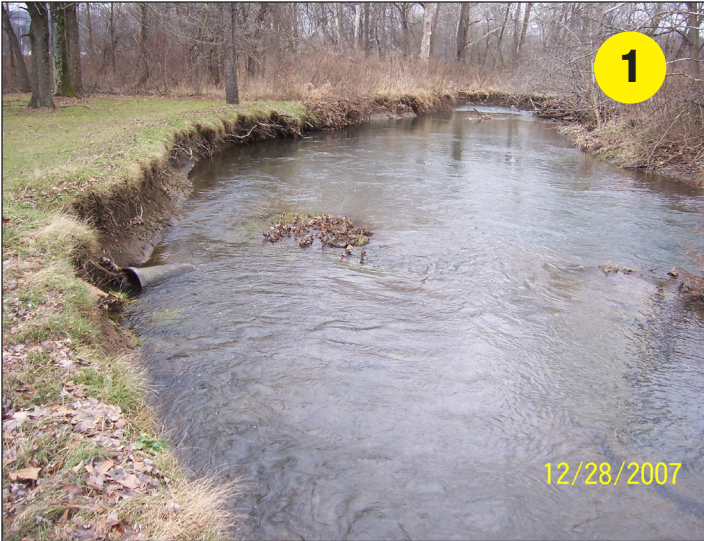
*Another streambank along Mill Creek at the Denison property before any stabilization was done*

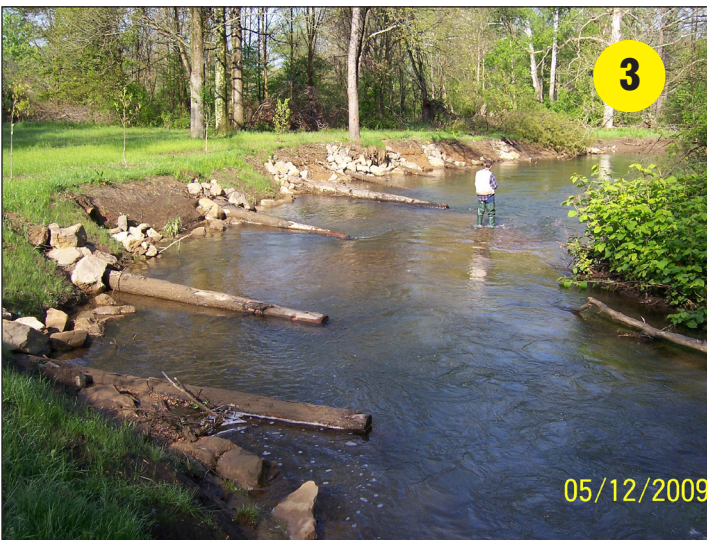
*The same streambank almost one year after construction*

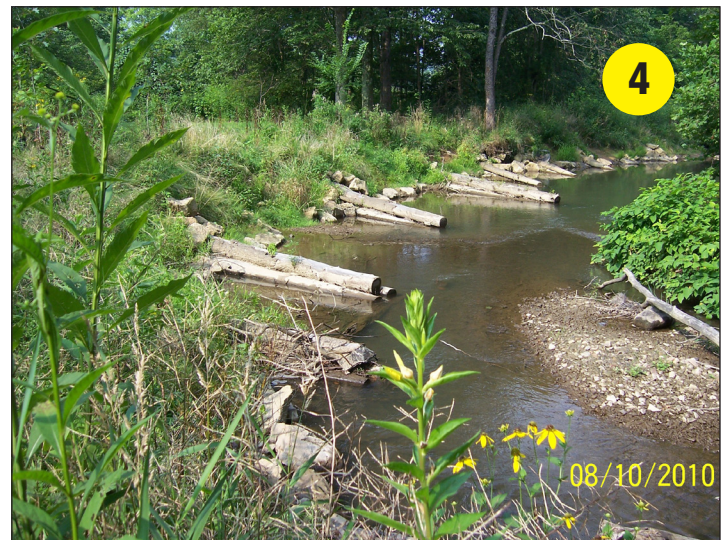
*The same streambank two years after construction*

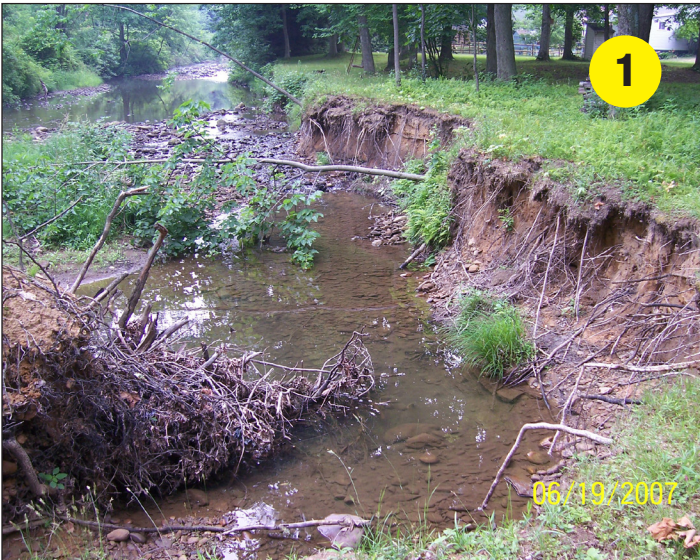
*A section of streambank at Hannas Run before any stabilization was done*

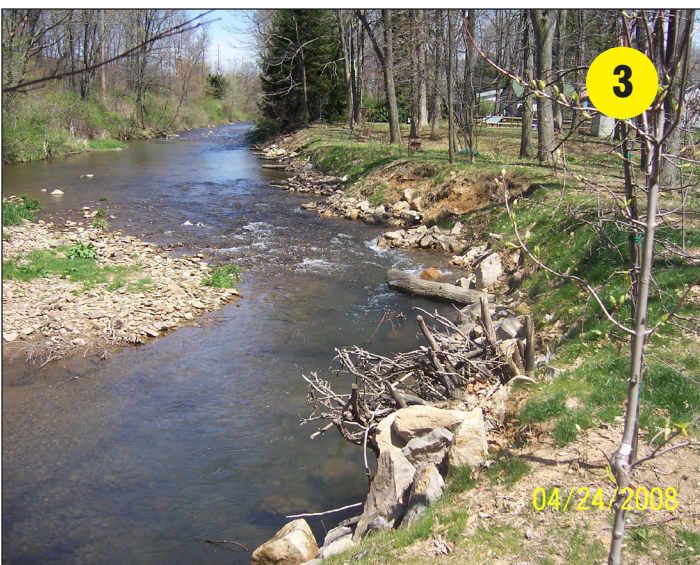
*The same streambank after about eight months of growth*

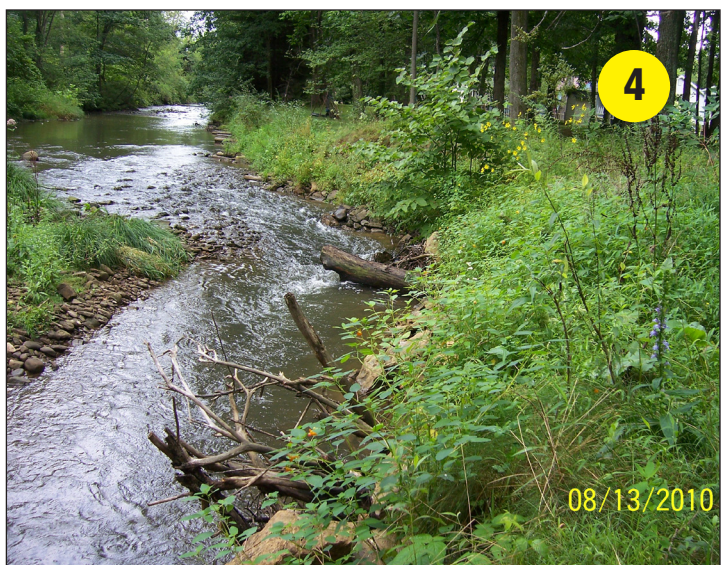
*The same streambank at Hannas Run two years after construction*
