## **Sugar Run Road Stream Crossing Improvement Project**

**Date of Installation:** September 2025

**Location:** Sugar Run Road, St. Clair Township, Westmoreland County

**Client:** St. Clair Township

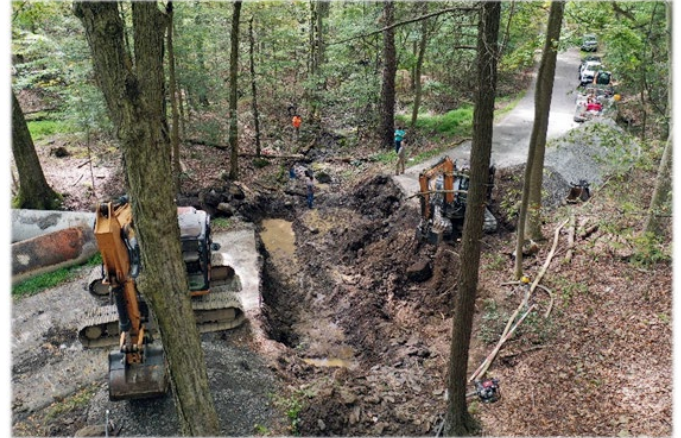
*Drone image of roadway being excavated for new structure.*

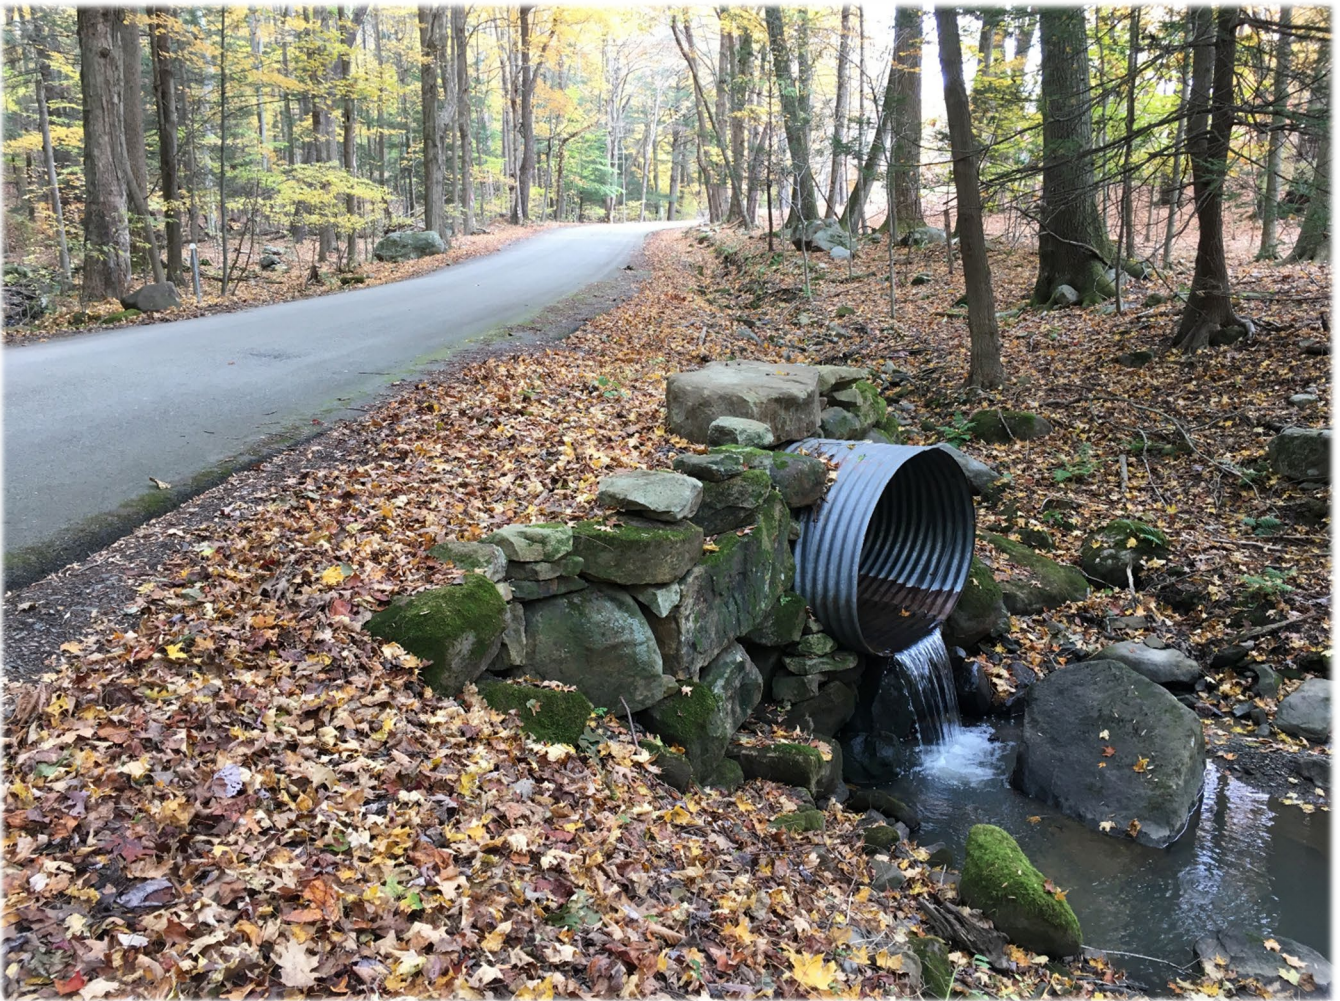
Previously there was an undersized corrugated metal squash pipe with a four foot waterfall at the outlet of the pipe. The waterfall at the outlet impeded aquatic passage up stream of the culvert. Poplar Run is a naturally reproducing trout stream, making fish passage upstream crucial. This squash pipe was replaced with a seventeen foot wide bottomless aluminum box culvert.

*(Before): waterfall at the outlet of pipe impeding aquatic organism passage.*

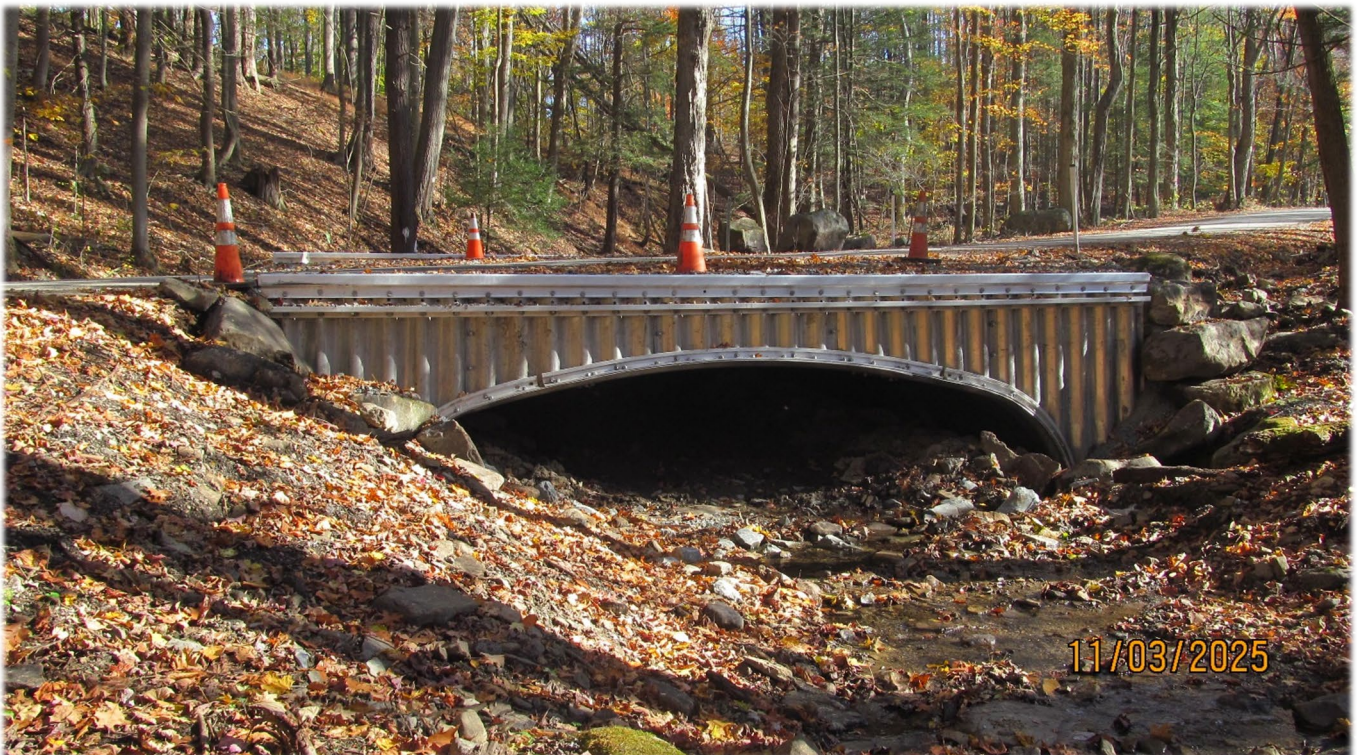
*(After): Stream reconnected allowing aquatic organism passage.*

The new structure reconnected the continuity of the stream, allowing aquatic organisms to move freely upstream and downstream. With the natural grade of the stream restored through the structure the erosion from the waterfall at the outlet of the previous pipe is eliminated, reducing the amount of sediment that is entering the stream.
