E&S In The Field

— Presented by: Ryan Peckheiser & —
Jared Meharey

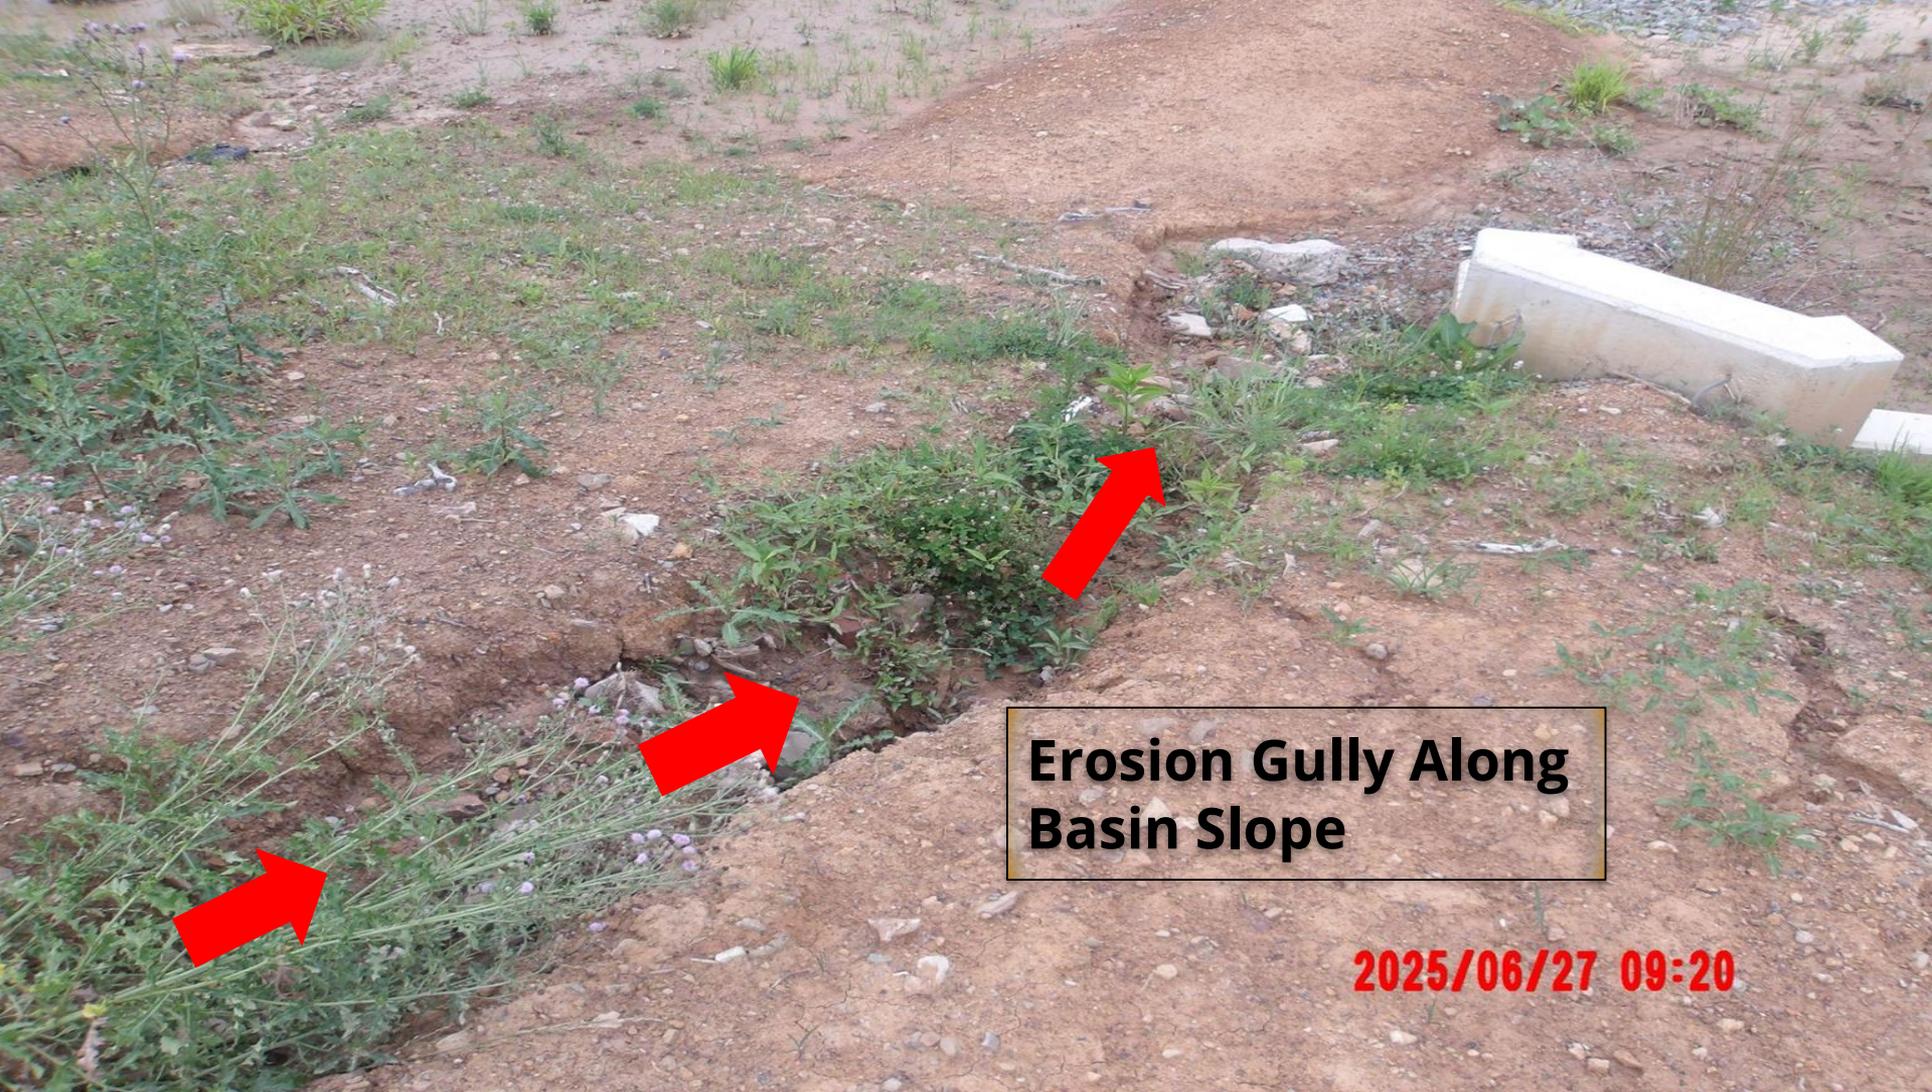
**Erosion Gully Along
Basin Slope**

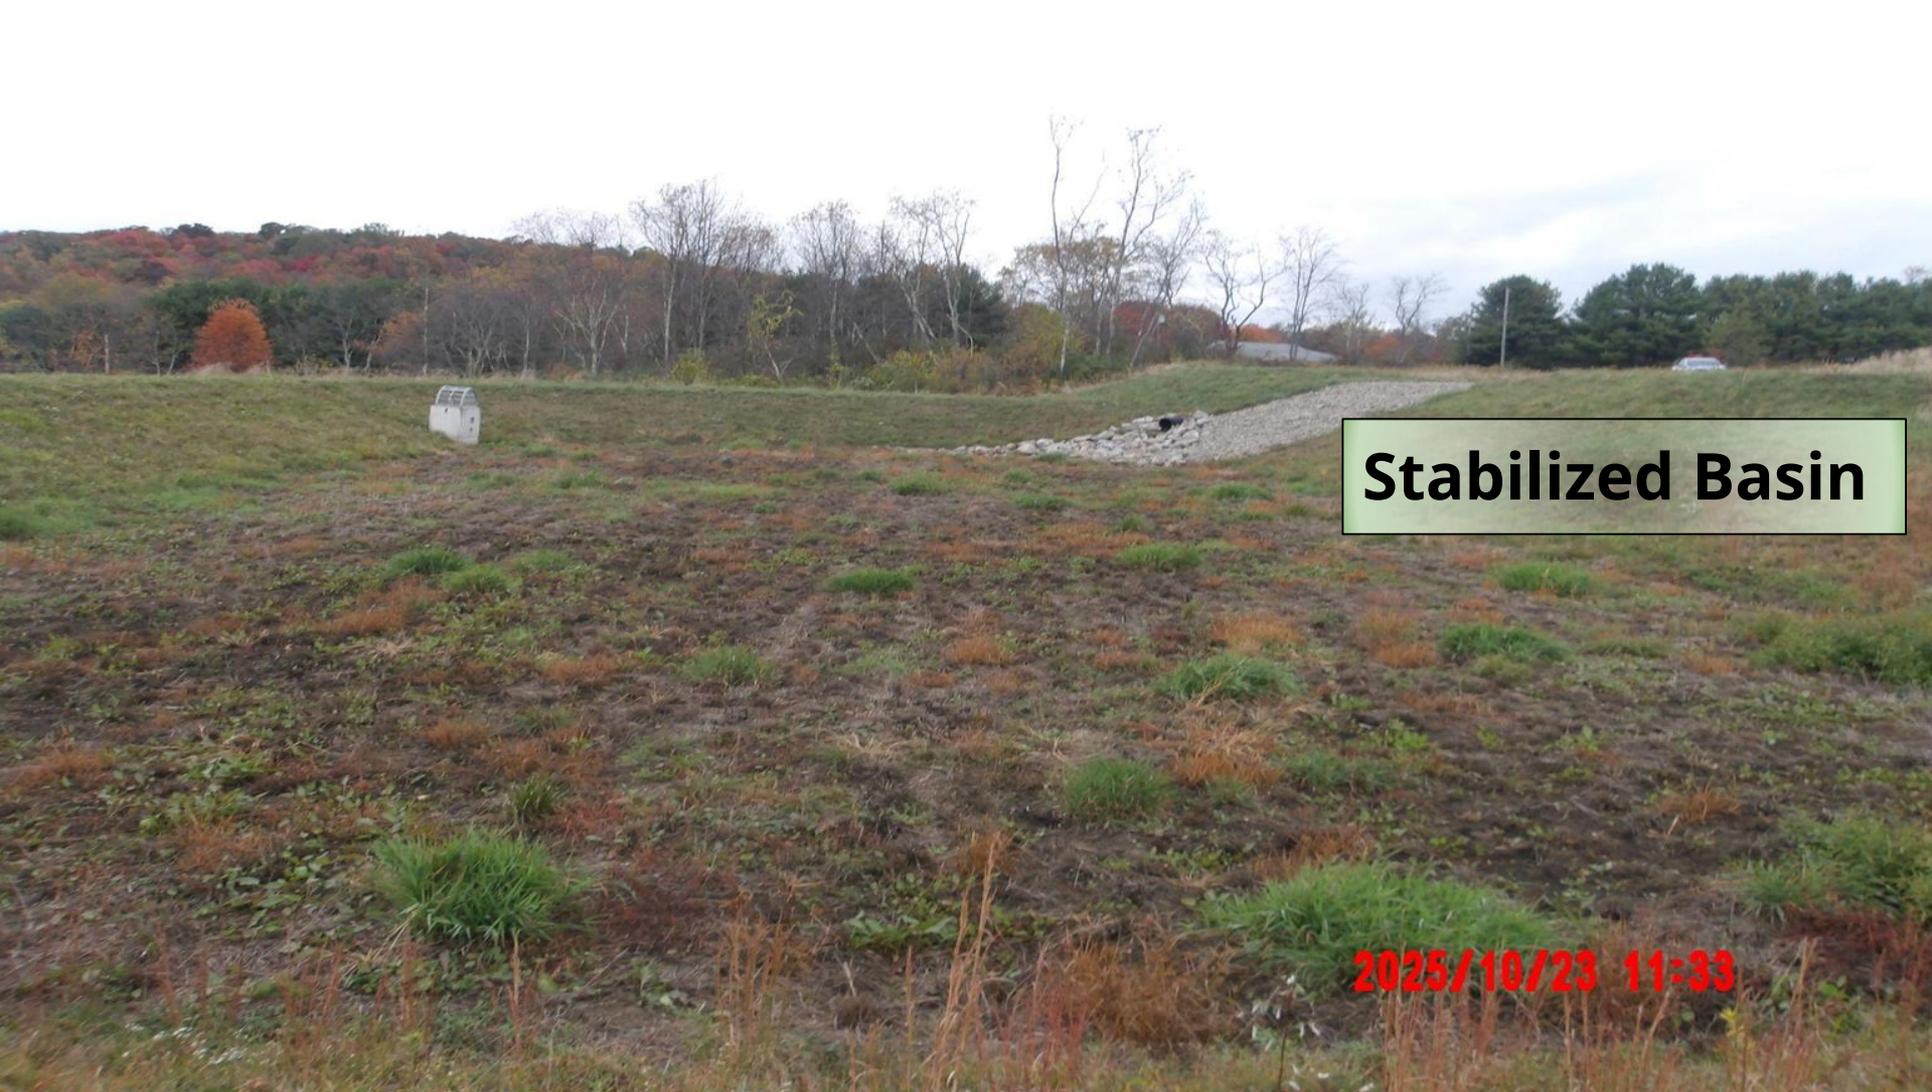
Stabilized Basin

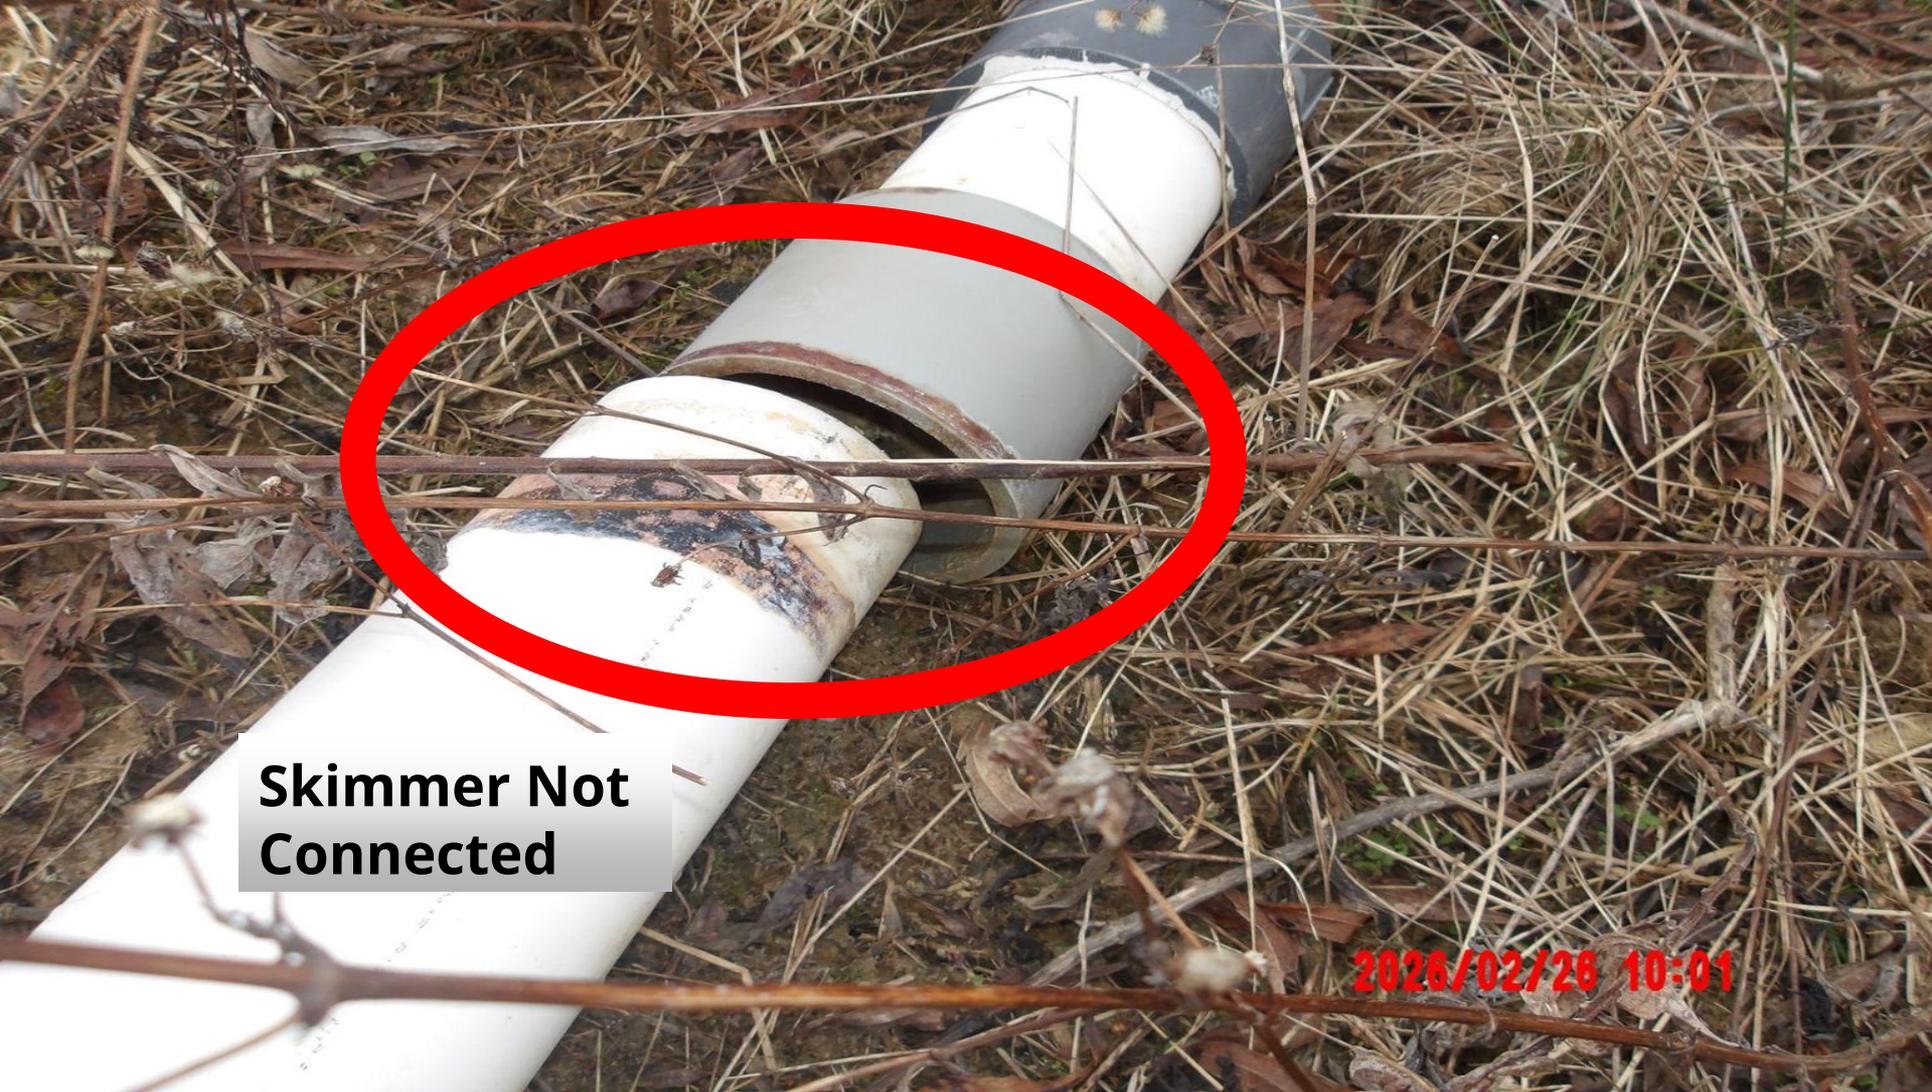
**Skimmer Not
Connected**

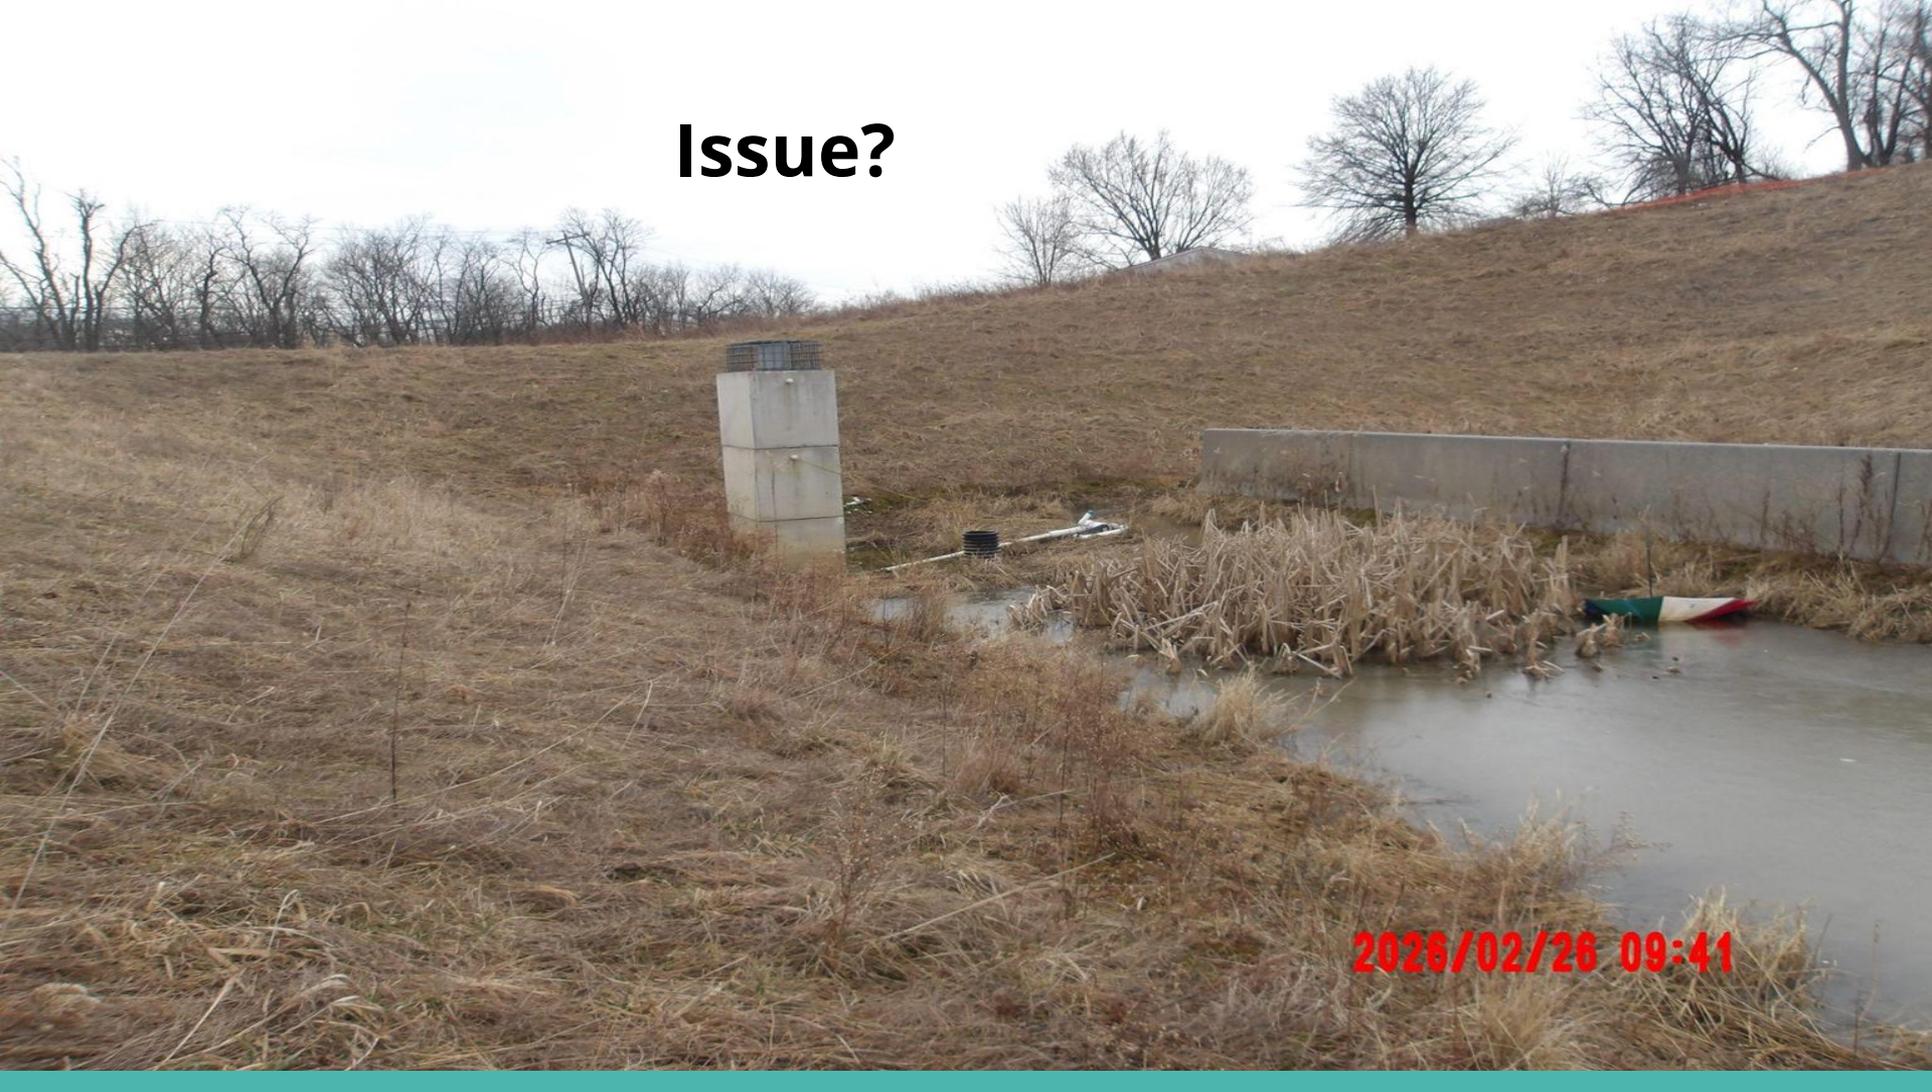
No Water Tight Seal

- Should be seeded immediately after final grade has been accomplished
 - Hydroseed/ Erosion control blanket slopes 3:1 or steeper
- Riser structures **must have a water tight seal**
 - Recommend Butyl-Mastic Sealant for water tight seals

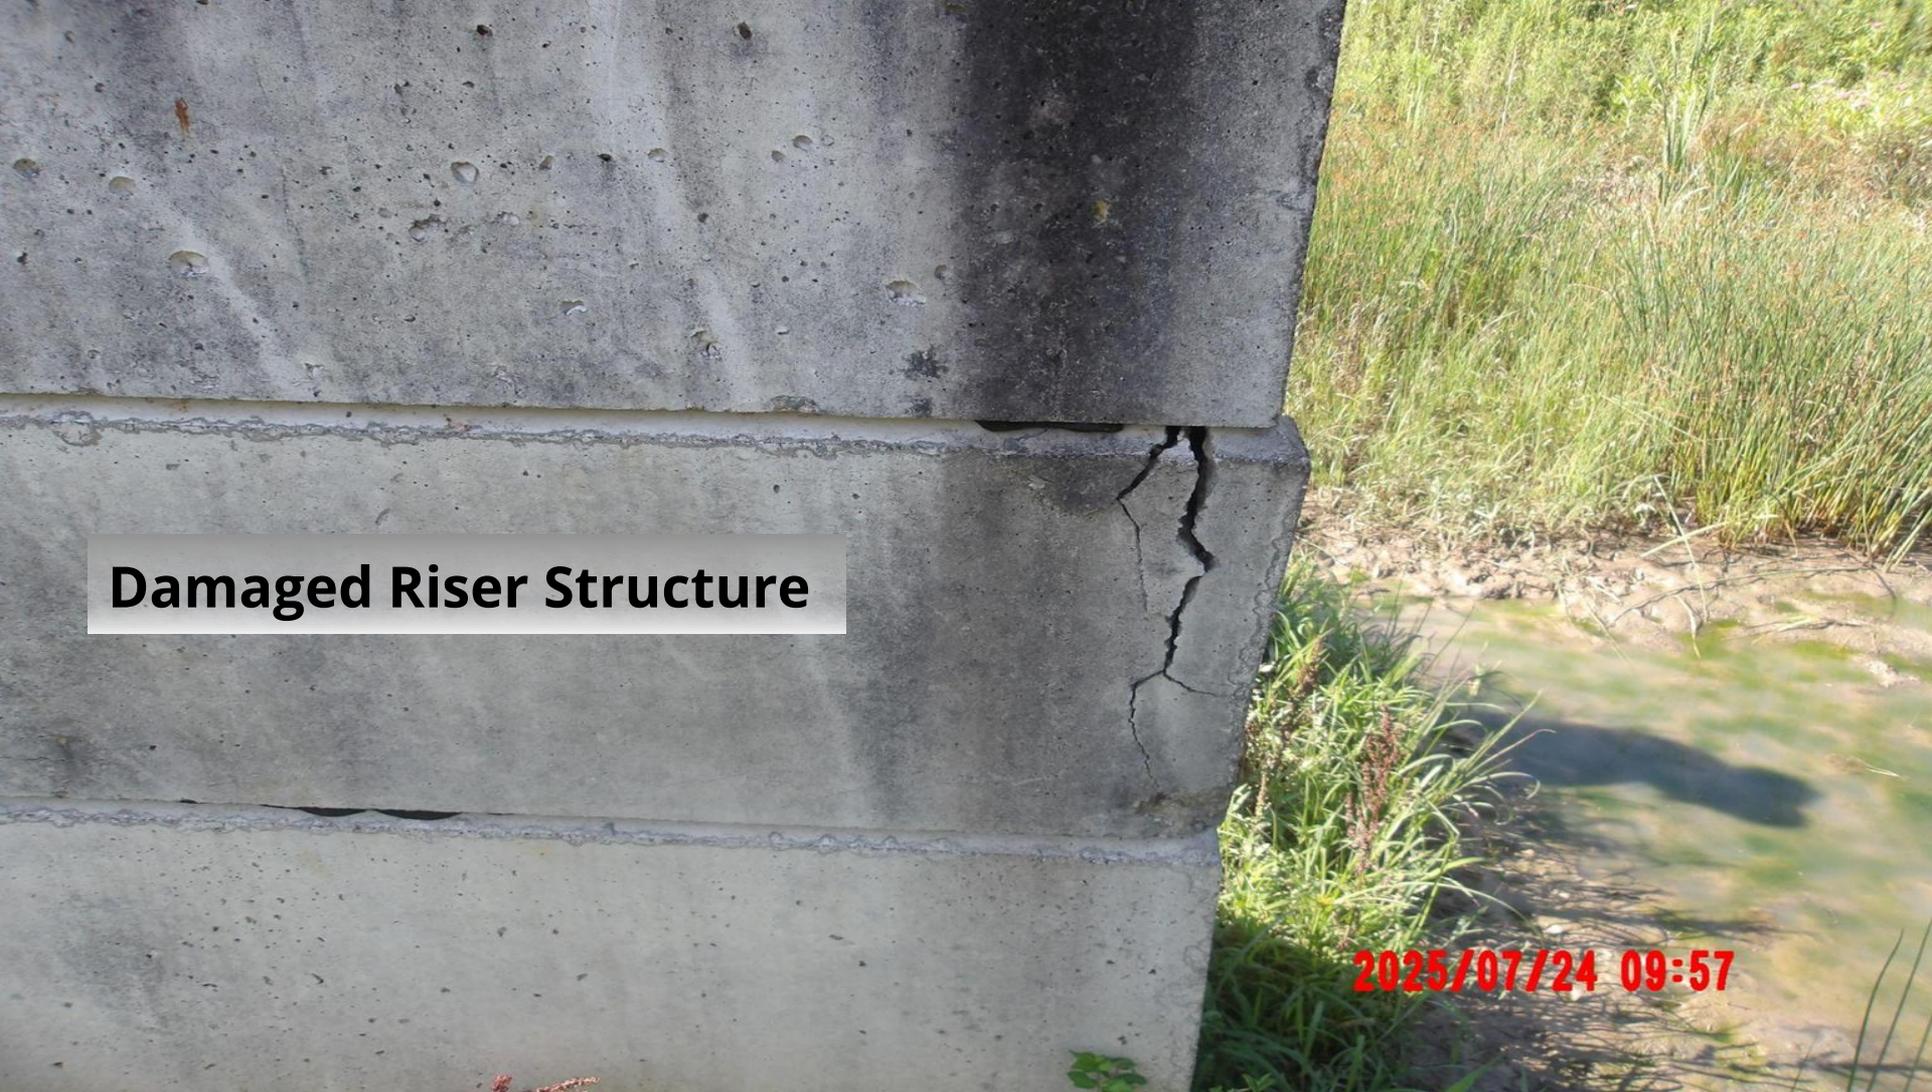
Damaged Riser Structure

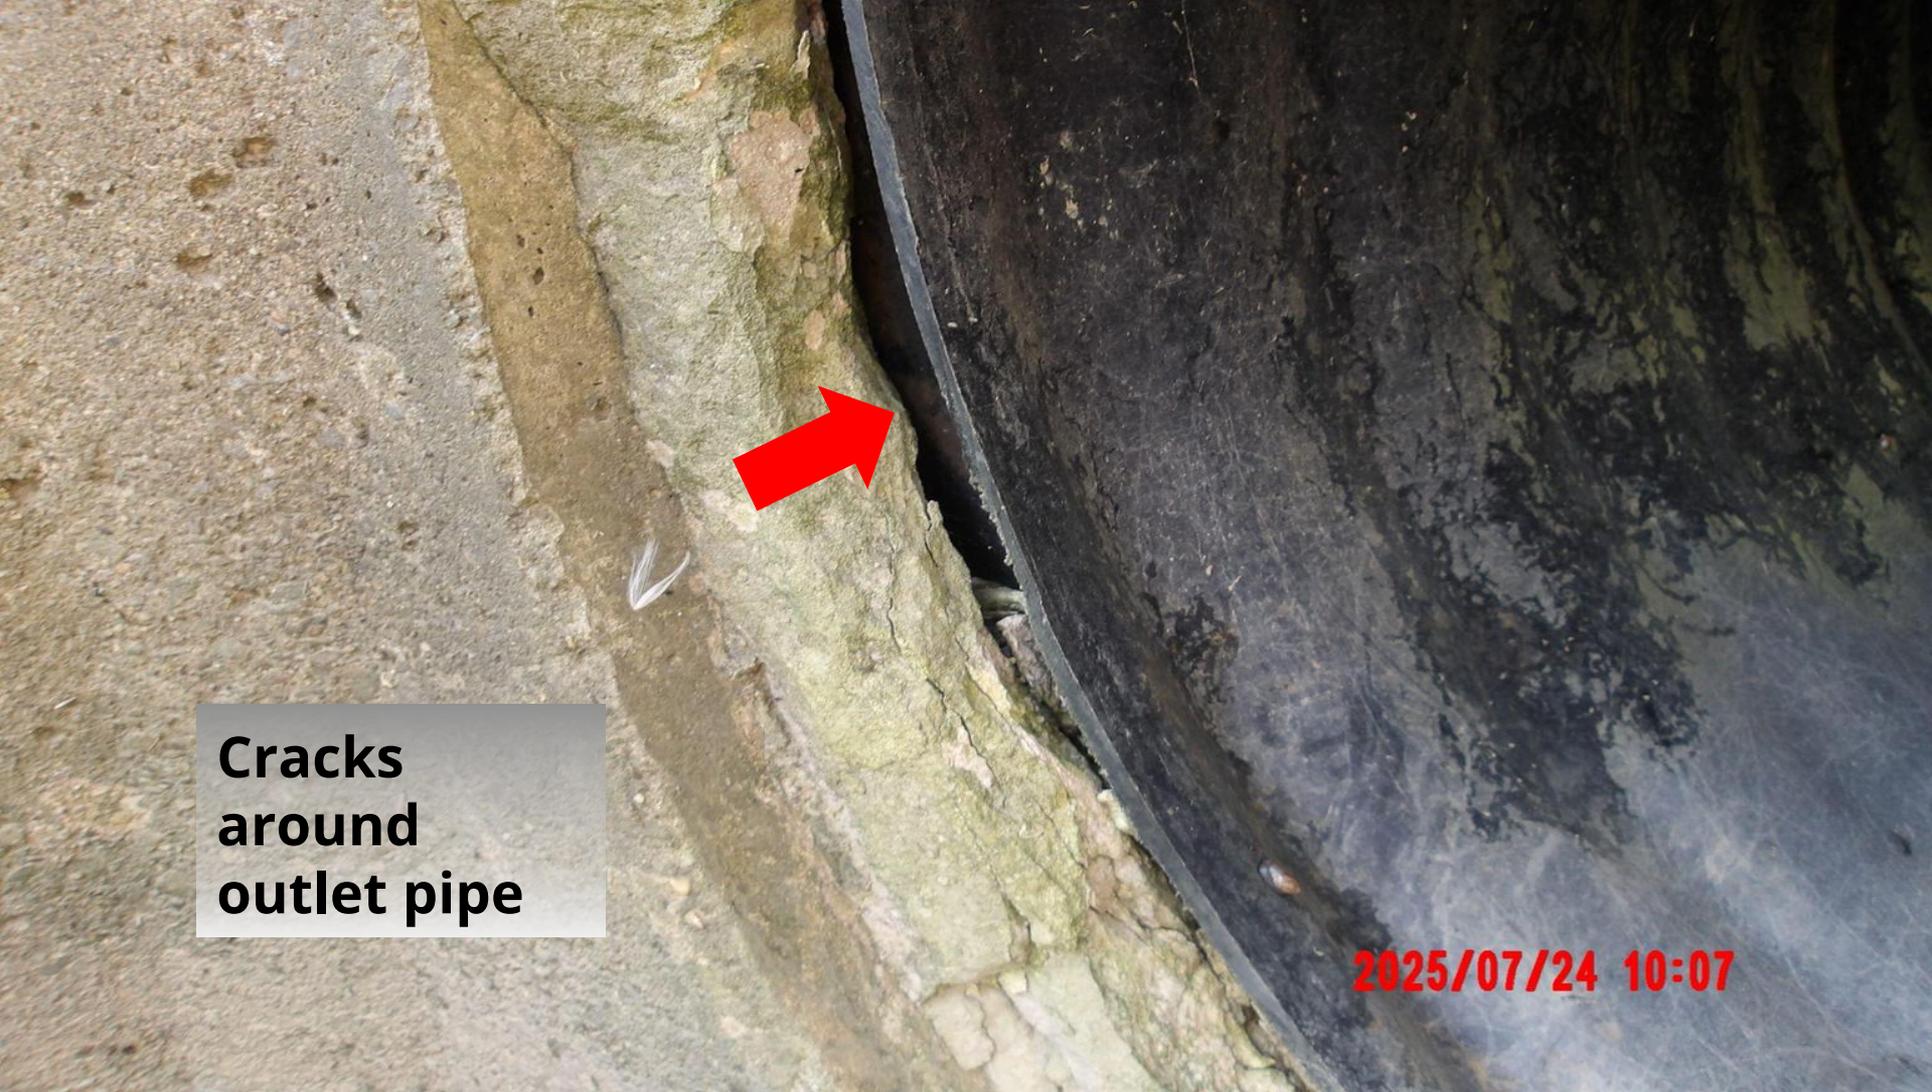
**Cracks
around
outlet pipe**

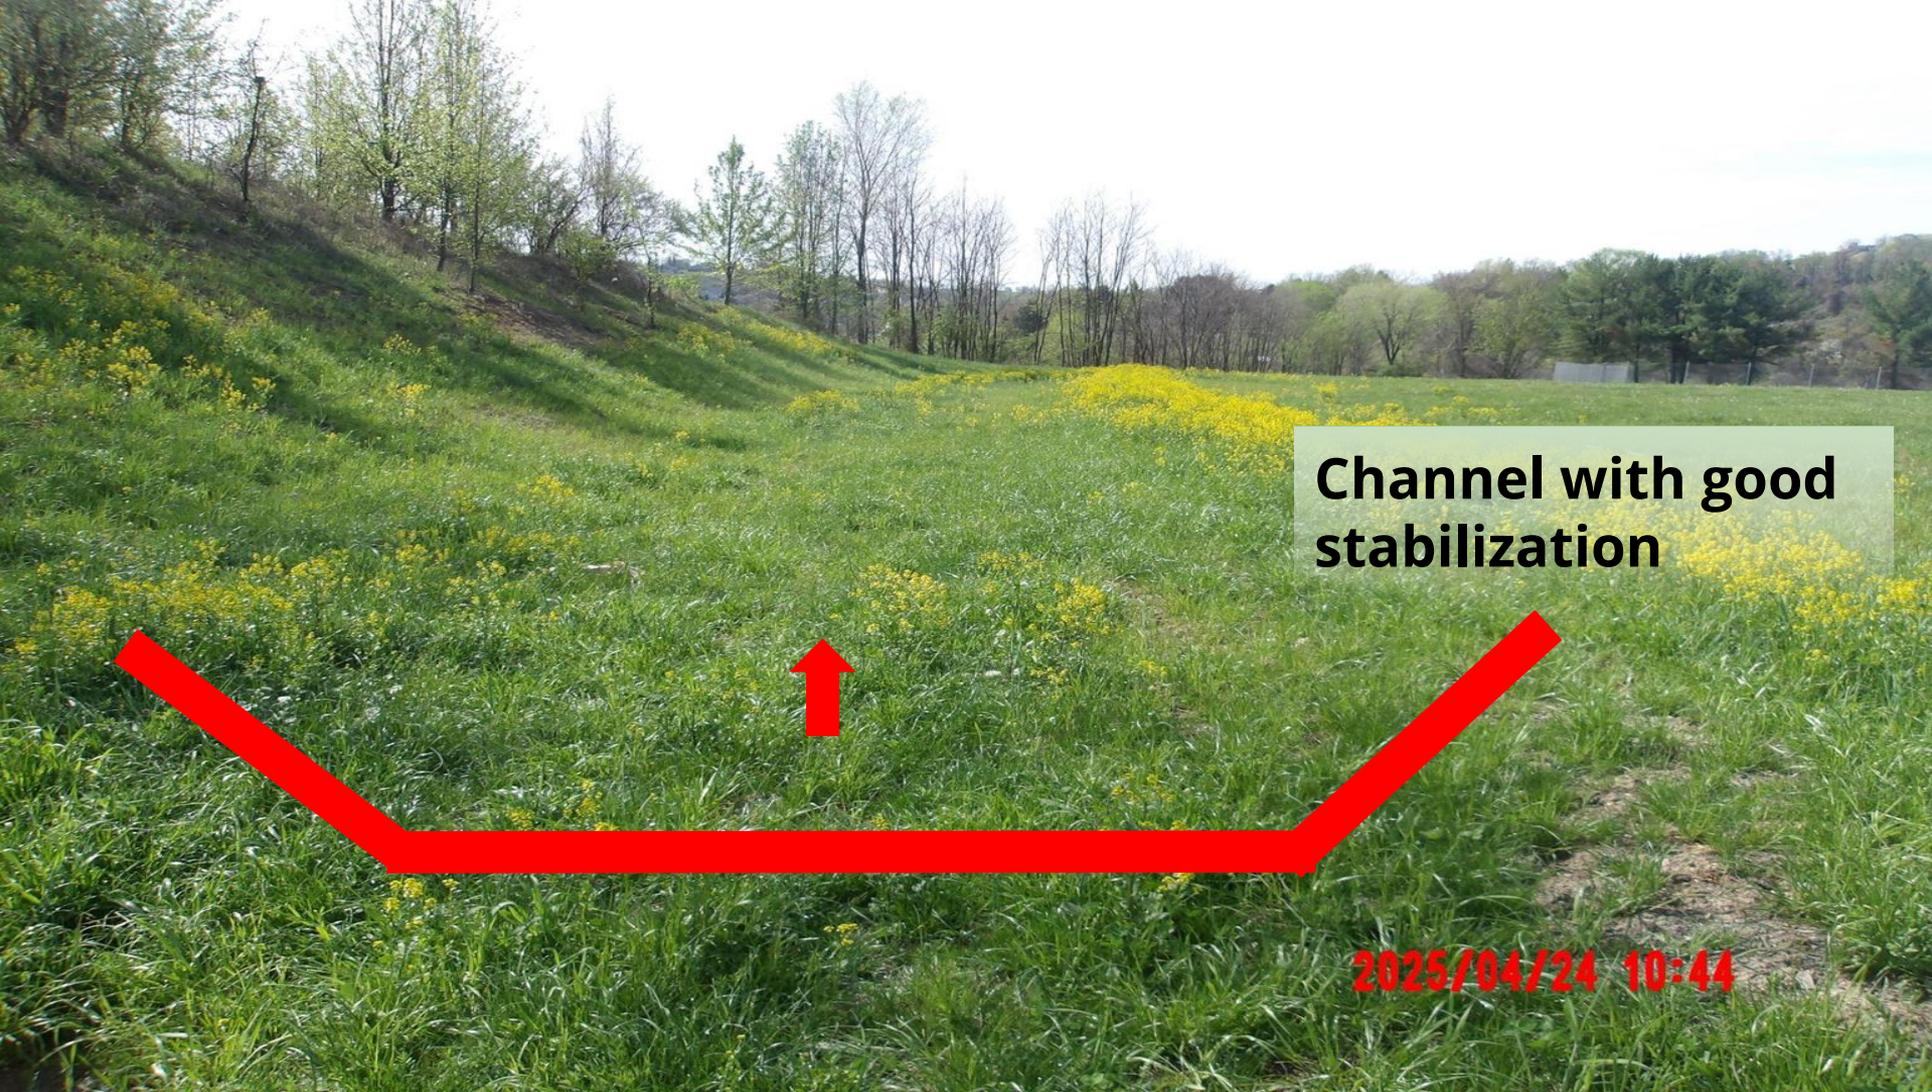
**Channel with good
stabilization**

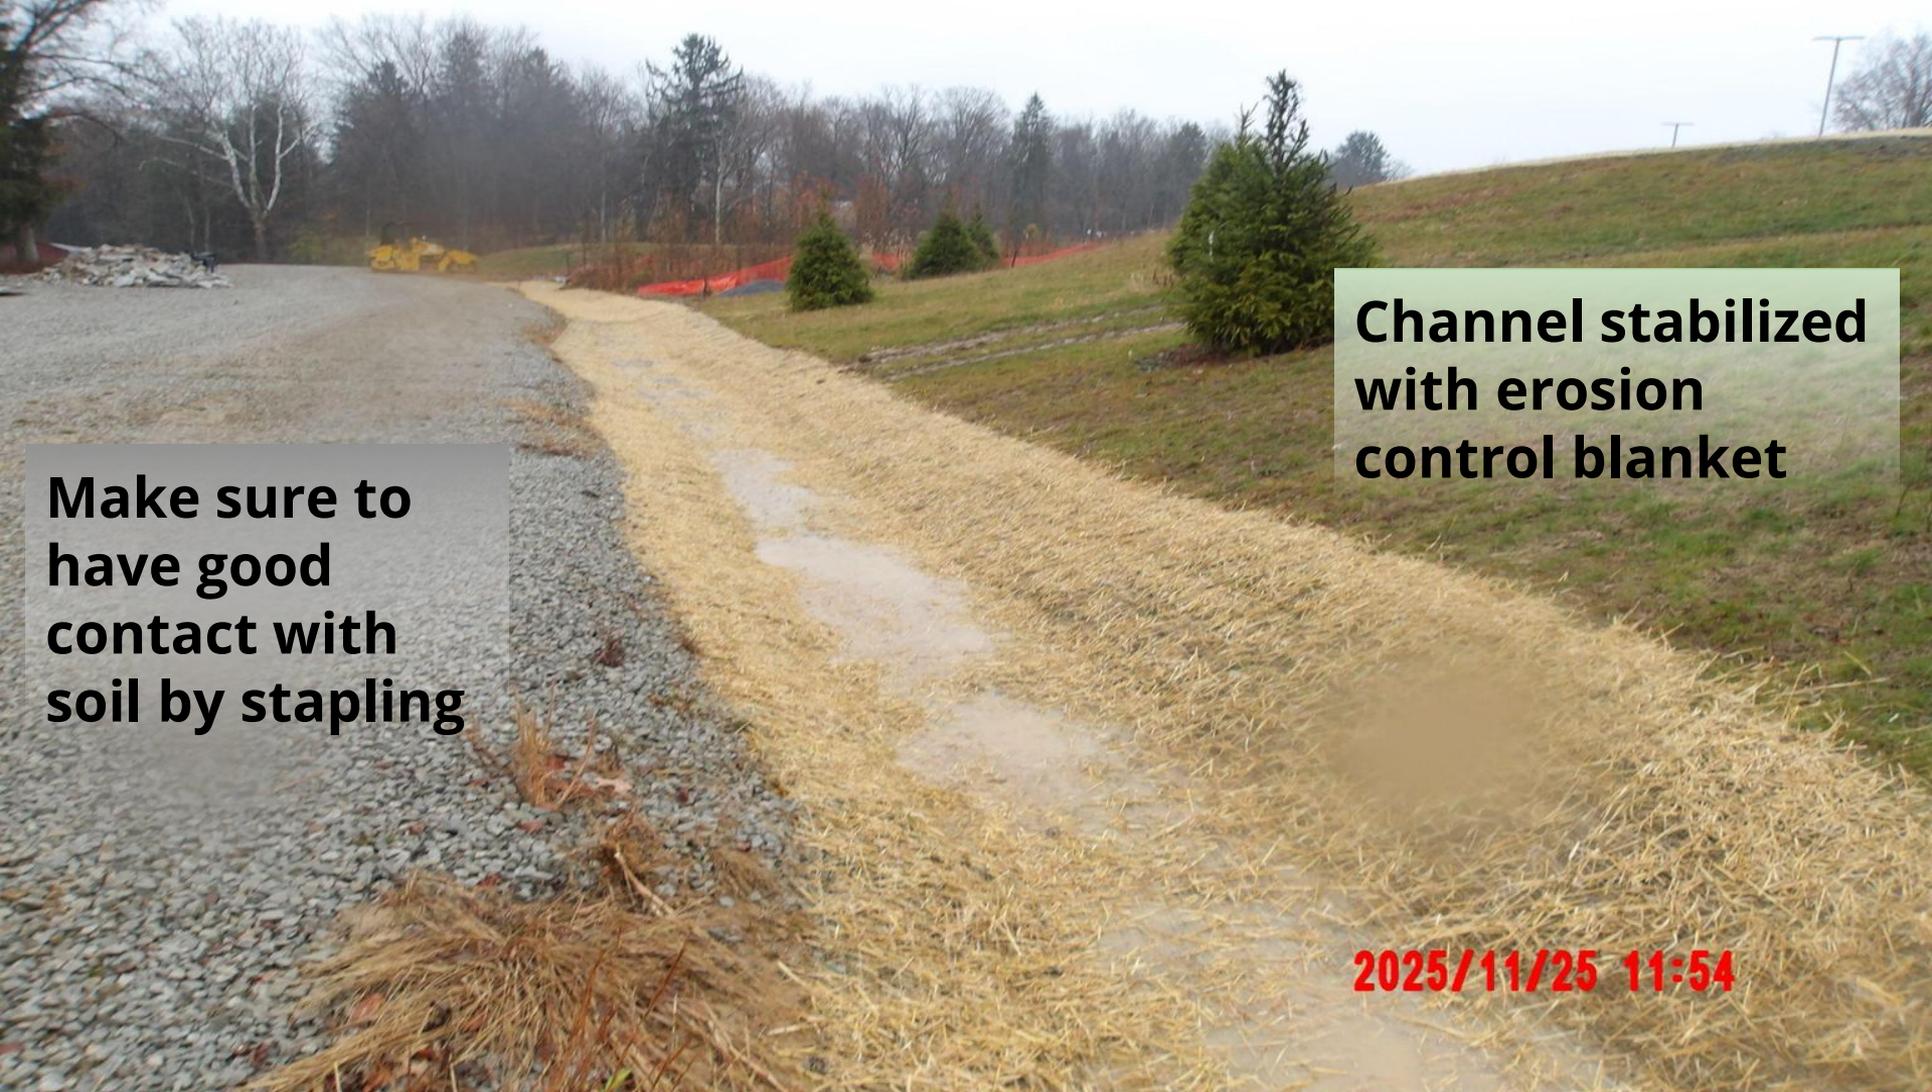
**Channel stabilized
with erosion
control blanket**

**Make sure to
have good
contact with
soil by stapling**

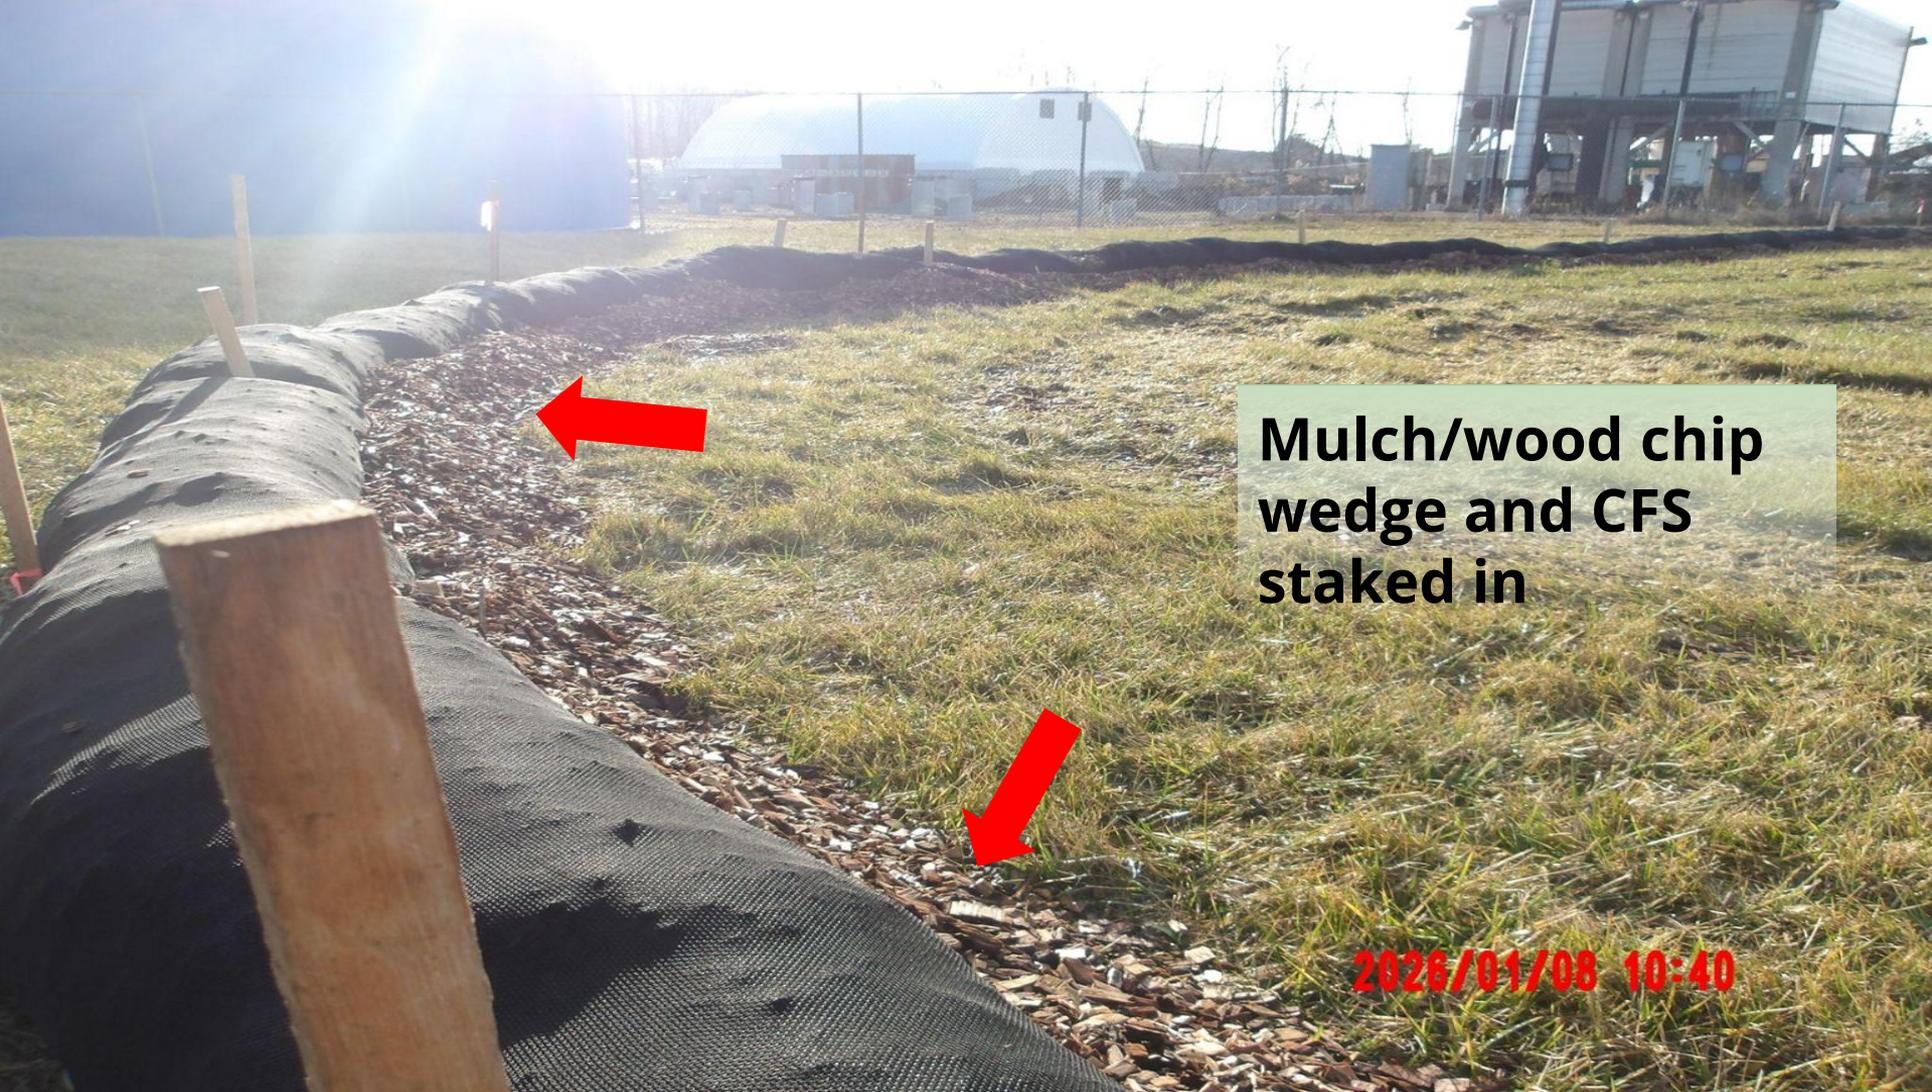
**Mulch/wood chip
wedge and CFS
staked in**

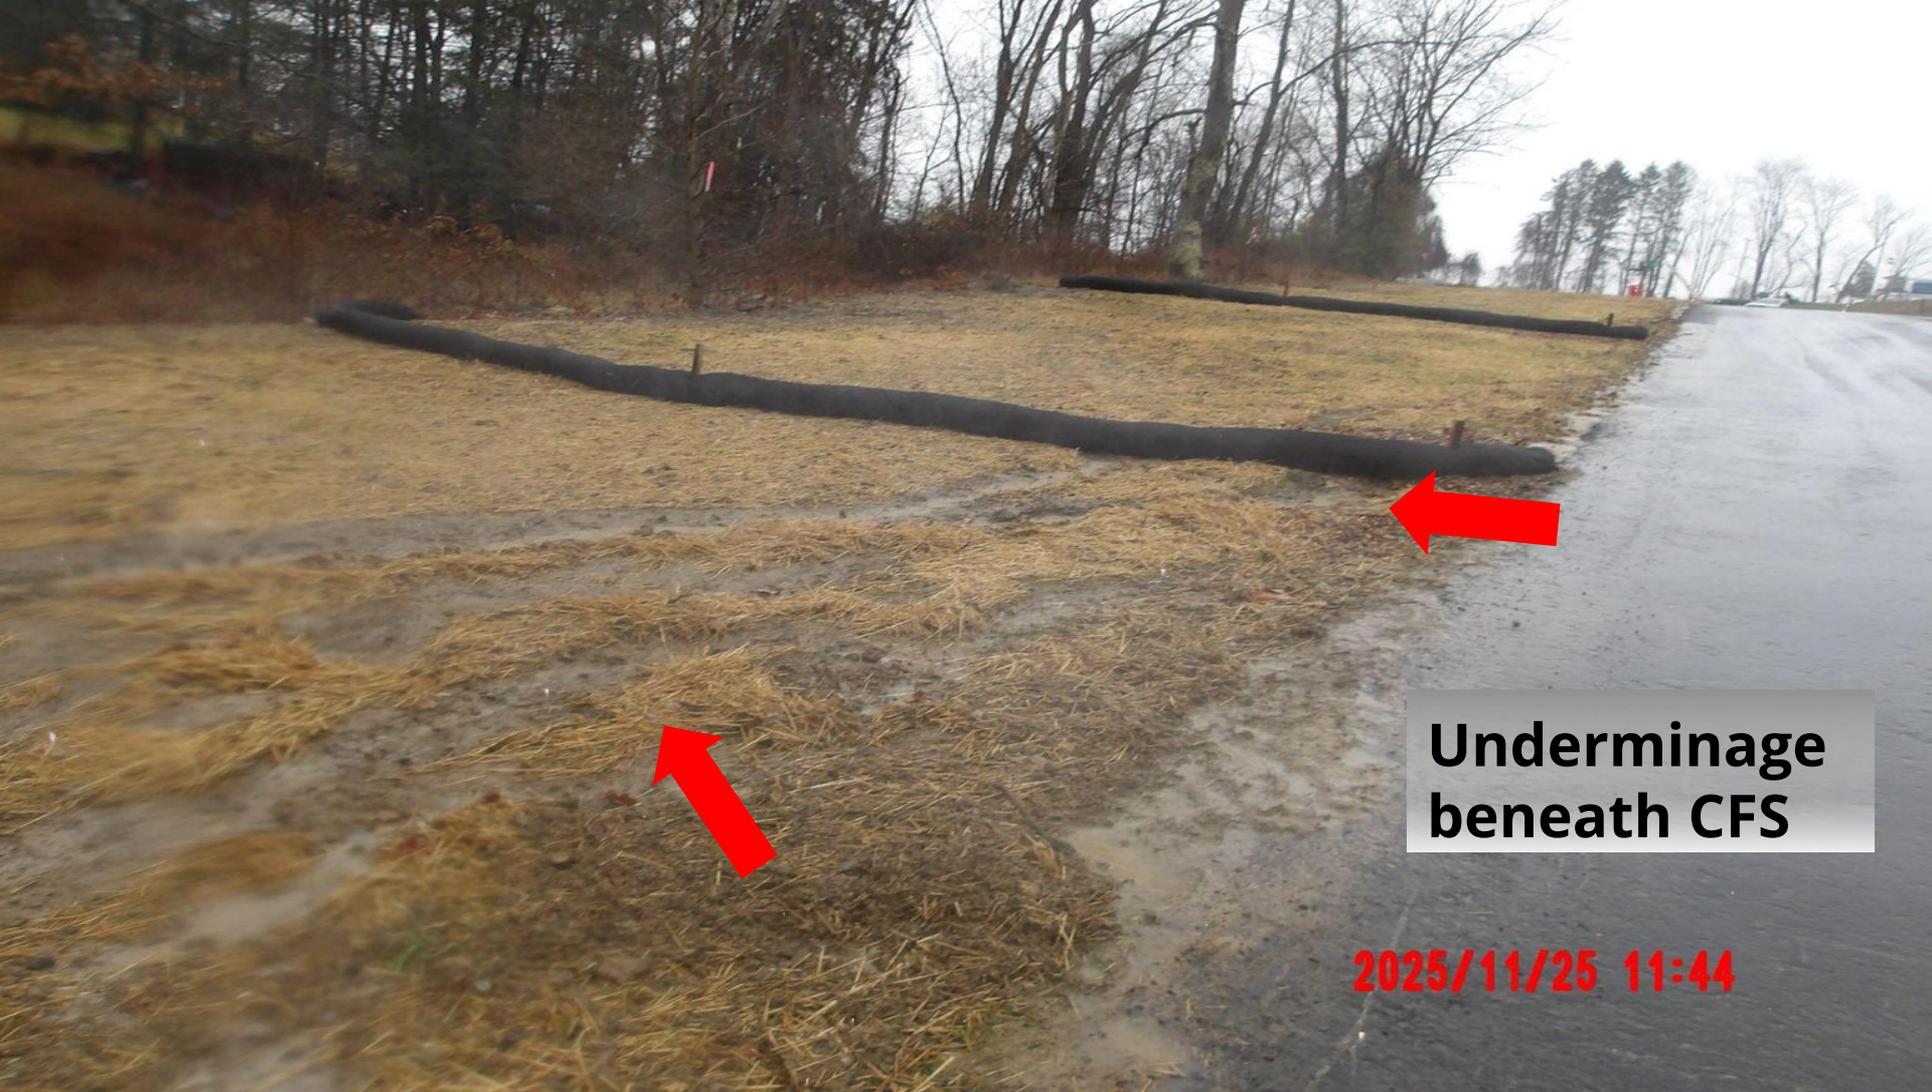
**Underminage
beneath CFS**

- Includes compost filter sock (CFS), silt fence, rock filters, and others alike
- BMPs like CFS and silt fence should be replaced within 24 hours after being damaged
- CFS should have a mulch/wood chip wedge to prevent sediment laden runoff from undermining
