E&S In The Field

— Presented by: Ryan Peckheiser & —
Jared Meharey

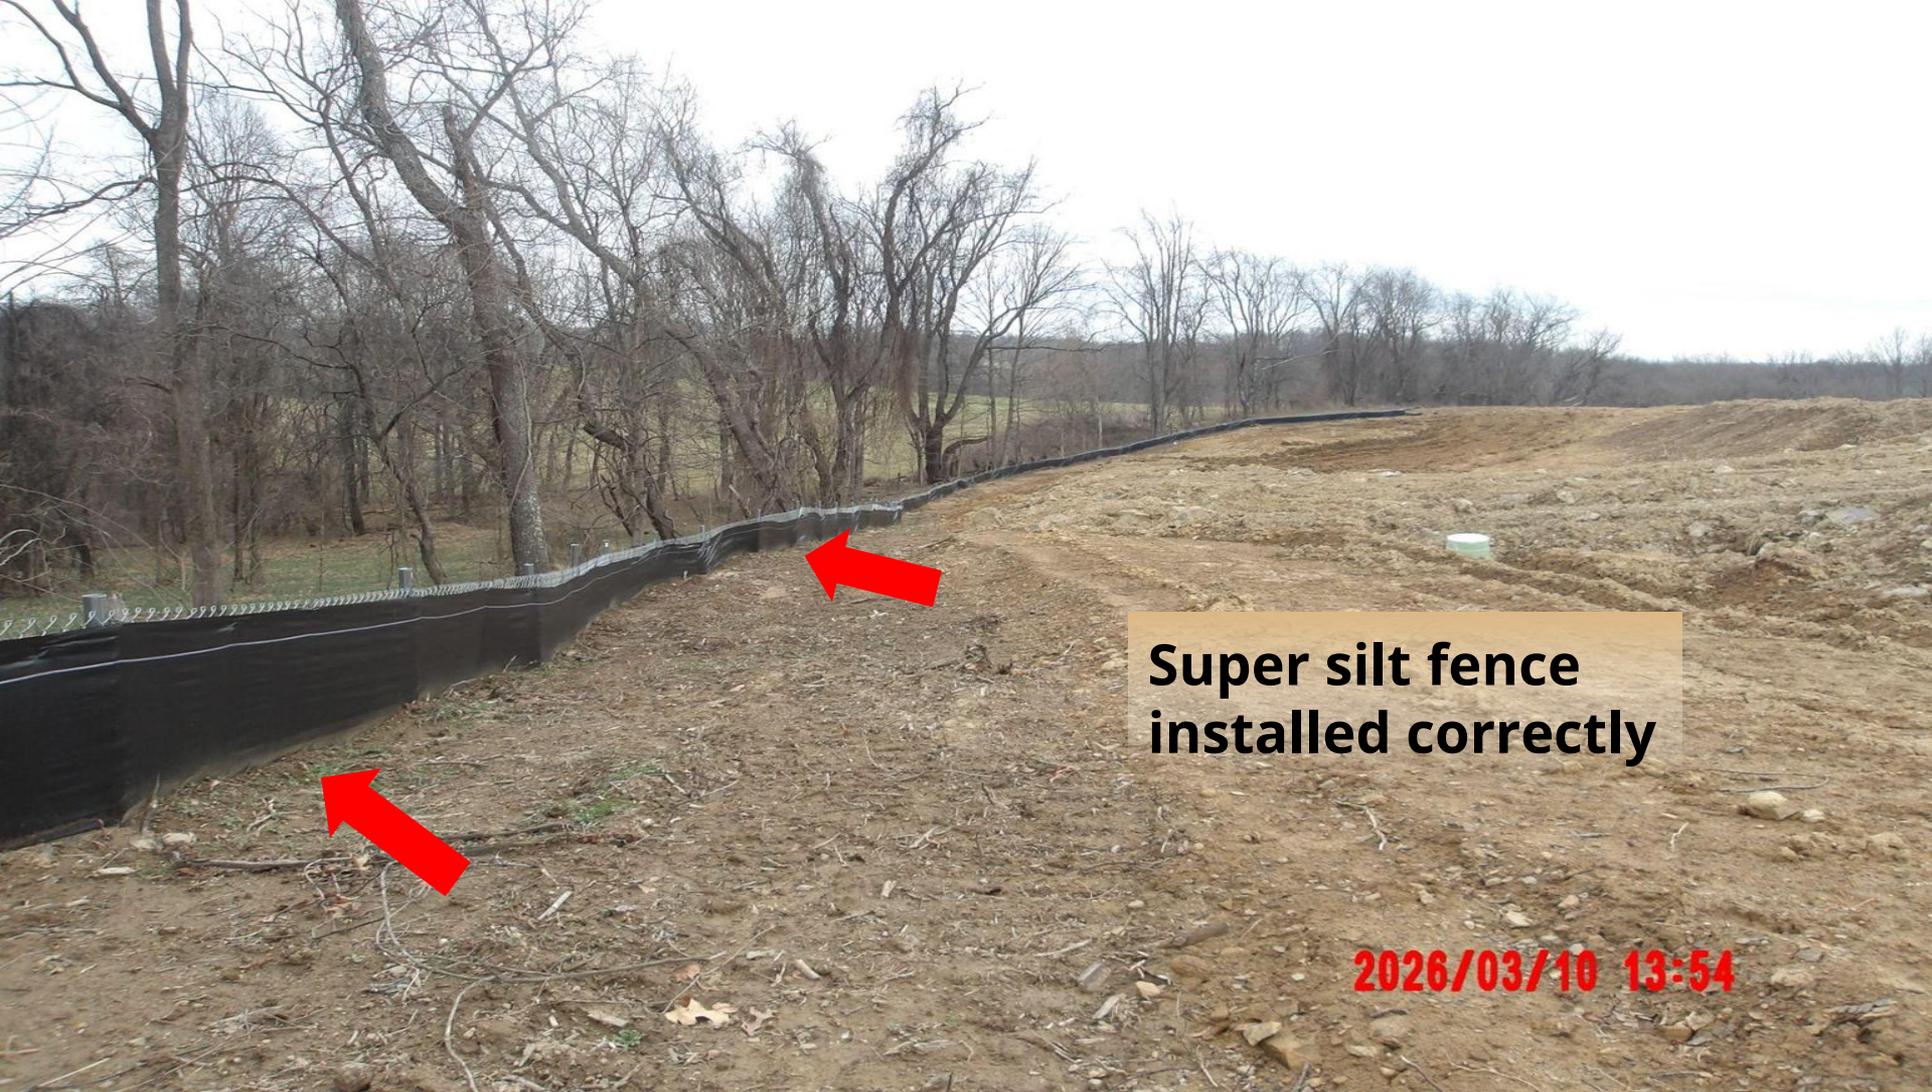
**Super silt fence
installed correctly**

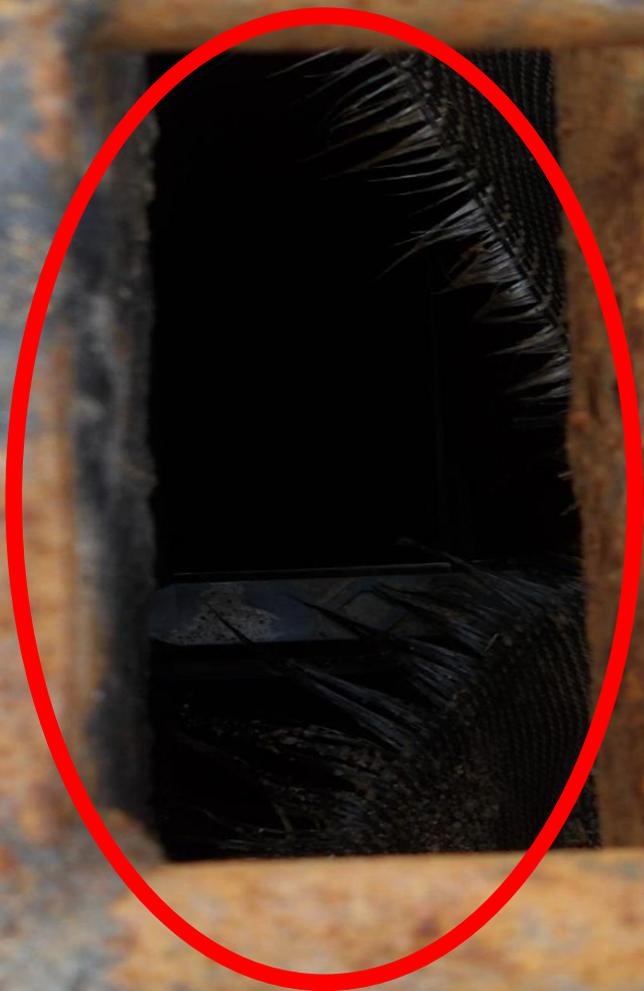
**Inlet Filter Bag
ripped open**

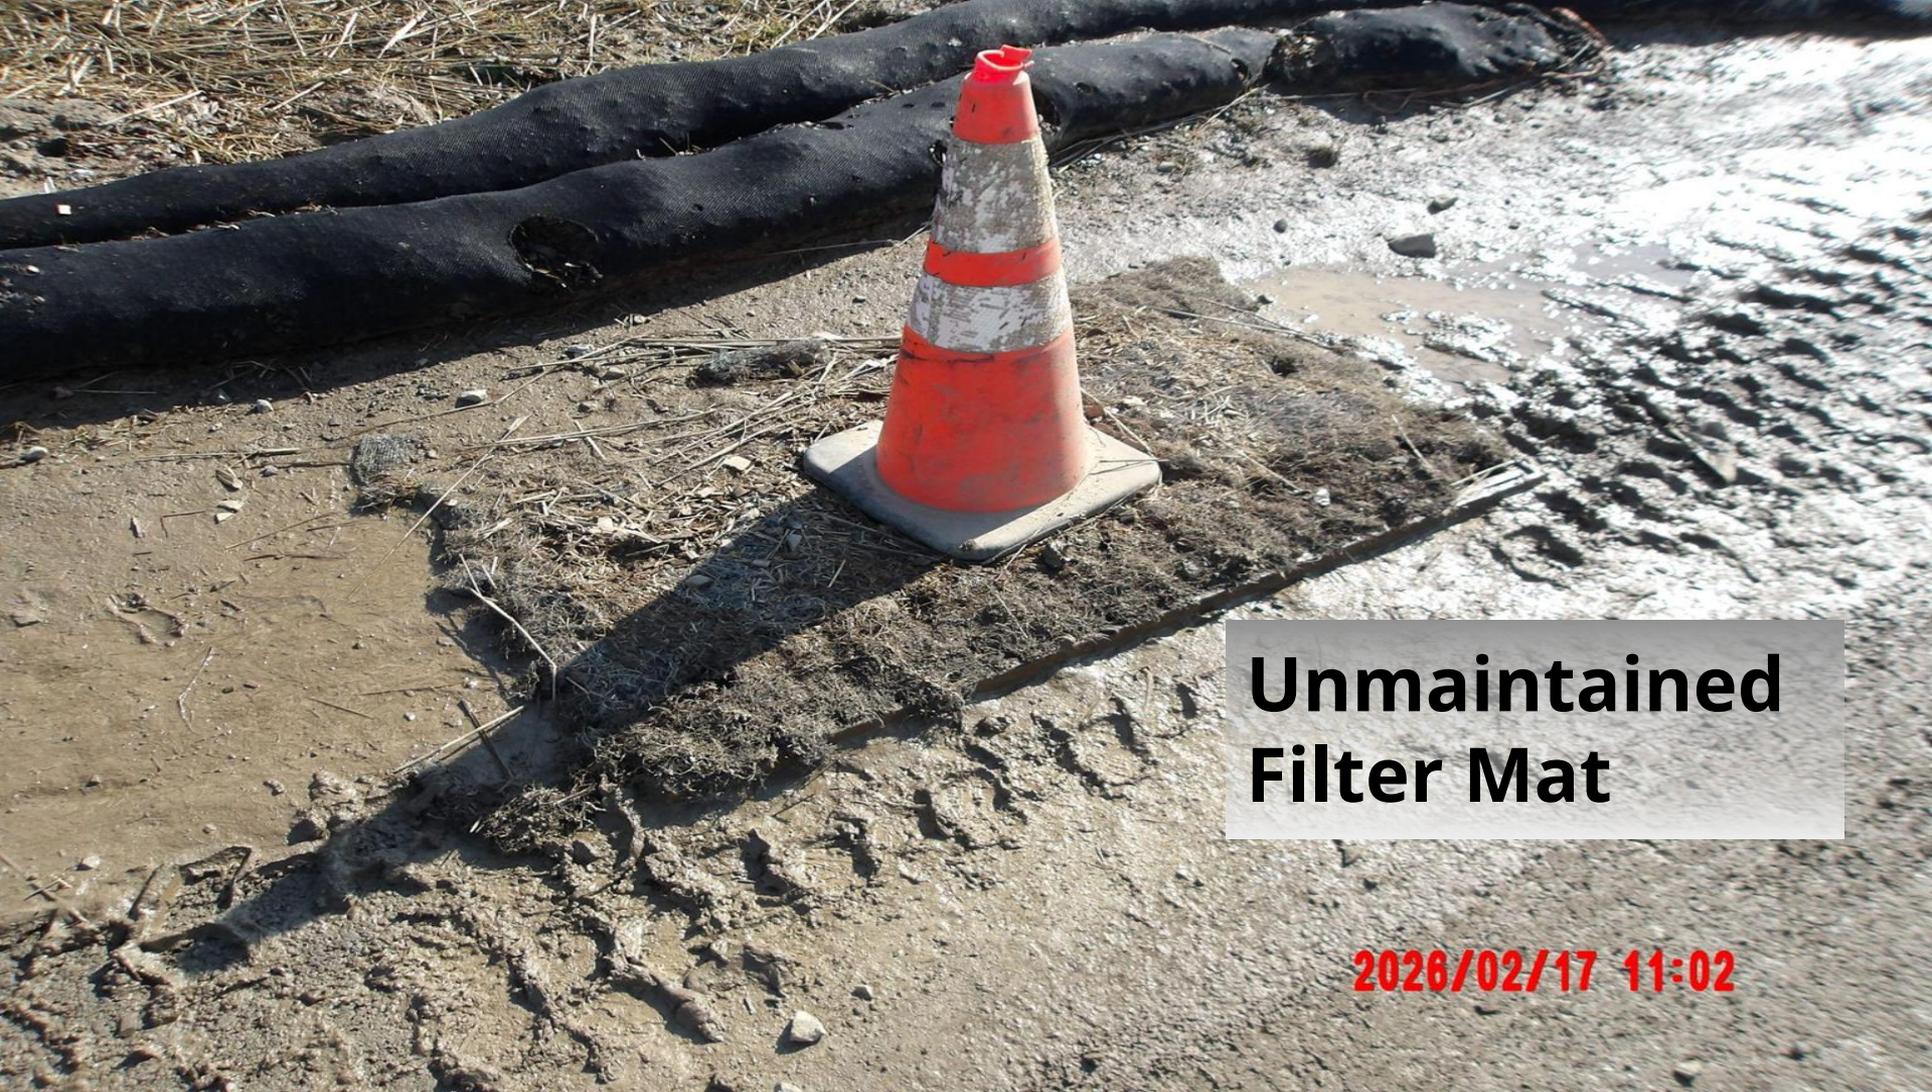
**Unmaintained
Filter Mat**

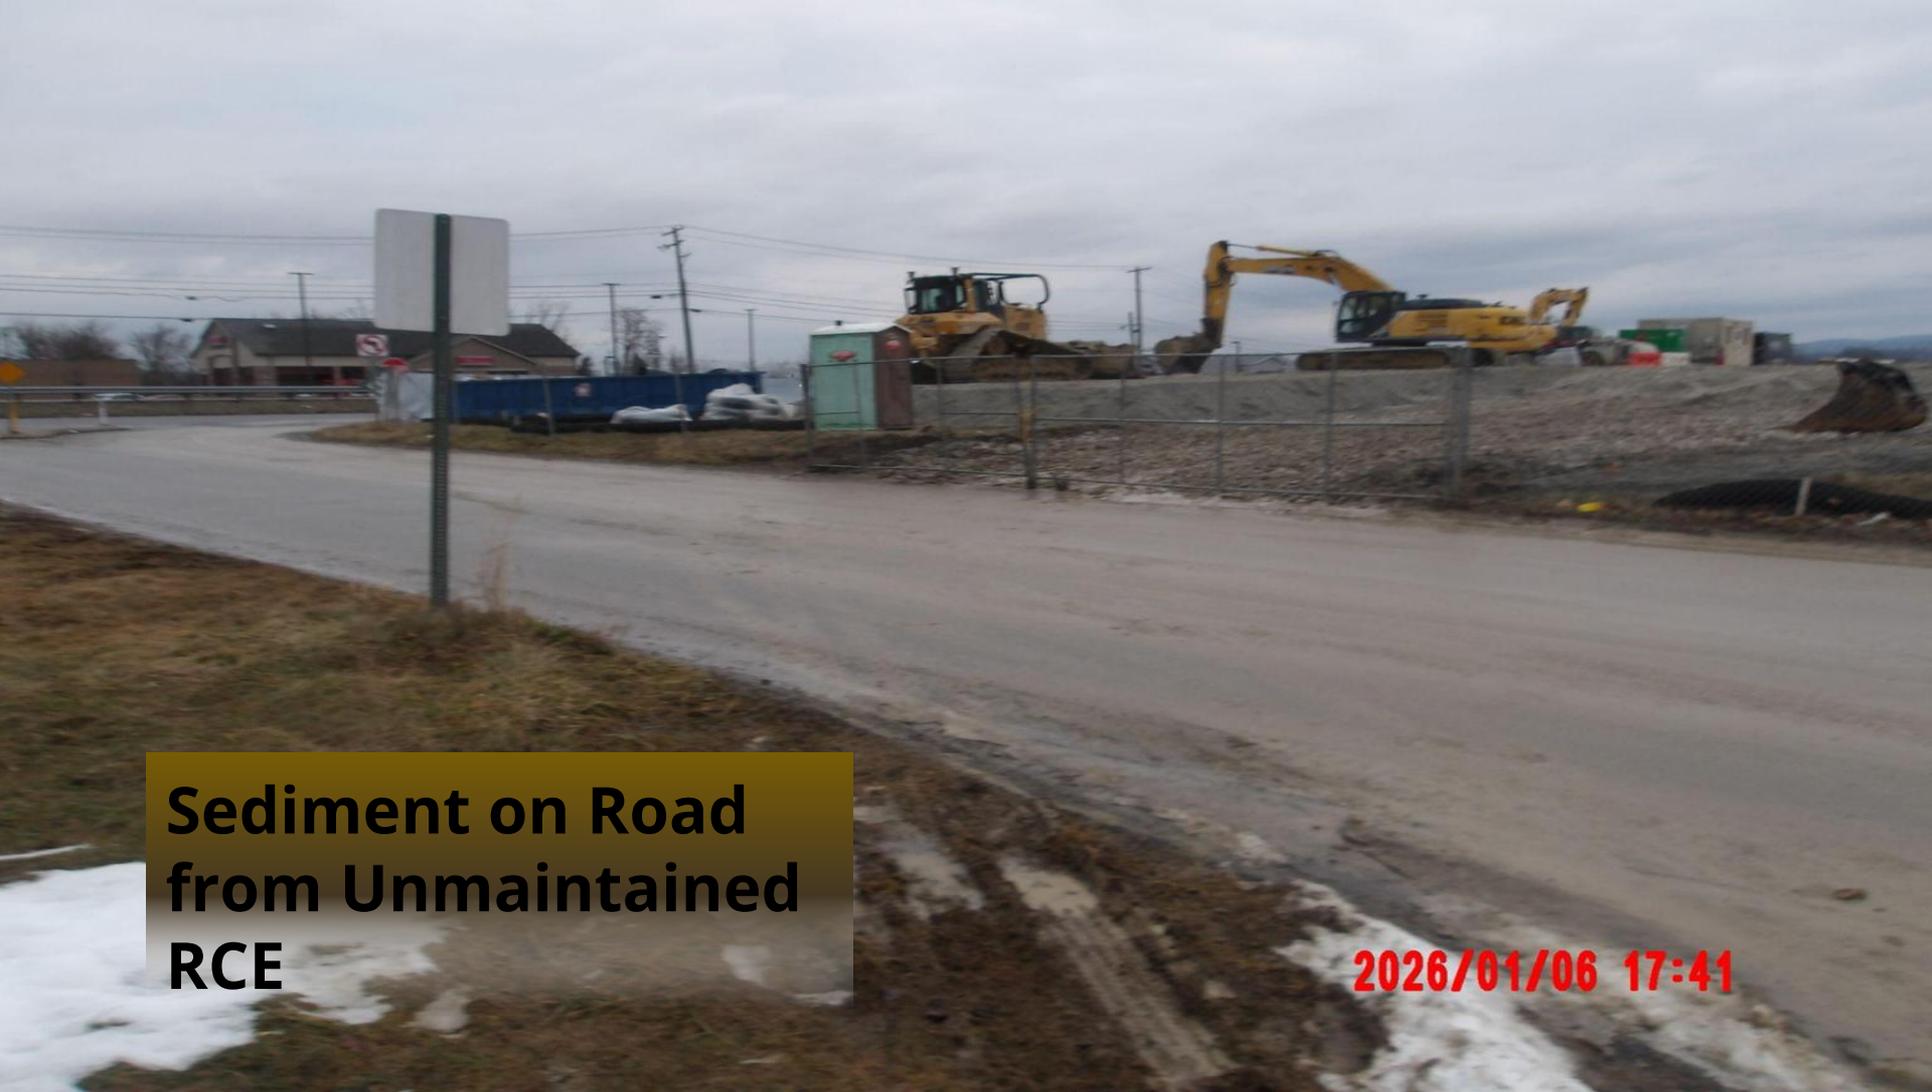
**Sediment on Road
from Unmaintained
RCE**

- Should be maintained and refreshed with **clean stone**
- Helps to keep main roads clean
- Geotextile fabric **needs** to be installed before rocks are in place

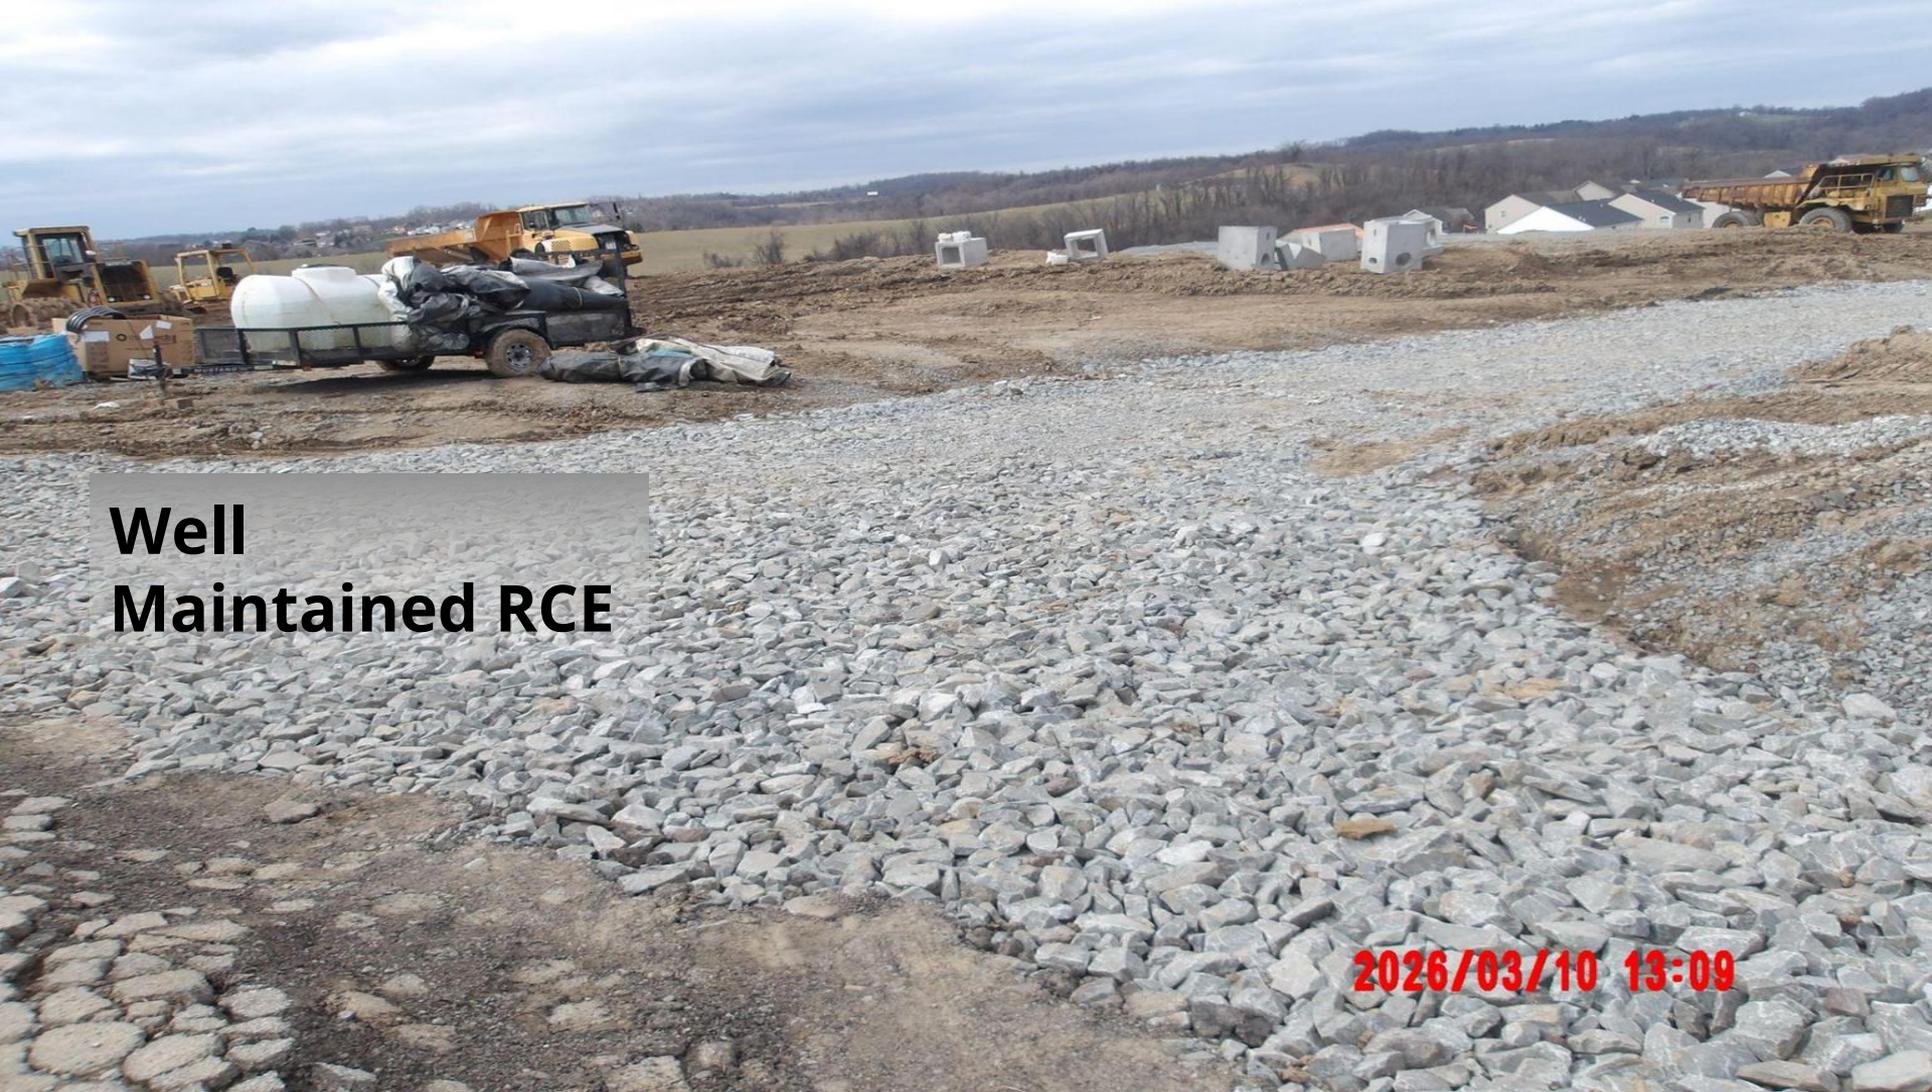
**Well
Maintained RCE**
