### Jacobs Creek Streambank Stabilization

**Design Features:** rip-rap, riparian buffers

**Date of Installation:** 2007

**Location:** 1733 Route 982, Mt. Pleasant, PA  
15666

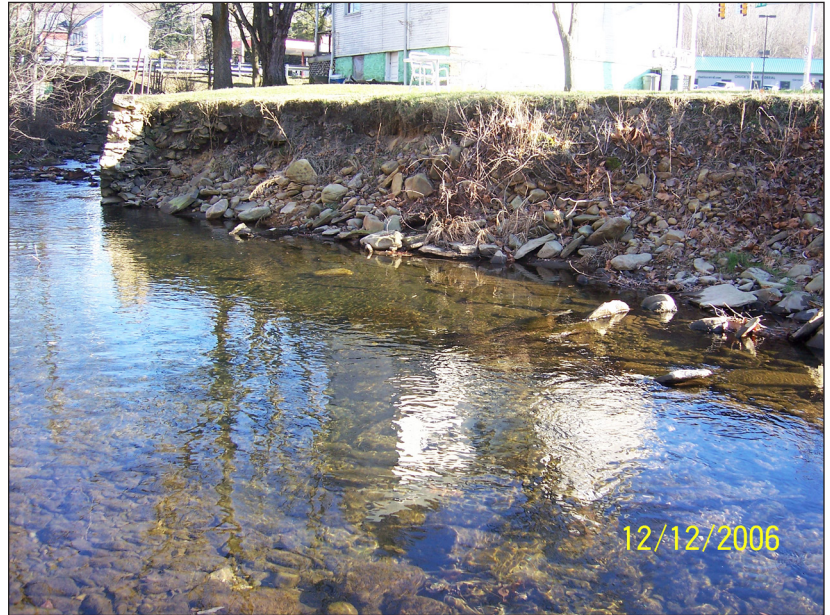
*Severe streambank erosion on a section of Jacobs Creek*

The sharp bend of the streambank along Jacobs Creek in Laurelville was severely eroding from the force of water hitting the exposed soil. The yard of the home next to the creek was being worn away, decreasing the water quality downstream. The Westmoreland Conservation District provided technical assistance and project management for this project. Funds were acquired from a Growing Greener grant to implement various streambank stabilization techniques along the eroding section. R-7 sized rip-rap was placed along the section of eroding streambank to create a shallower slope and prevent the water from wearing away the bank further. Smaller R-3 stone was used to fill in the gaps of the larger rip-rap, and the area was seeded and mulched. A riparian buffer of trees was also planted to help stabilize the area near the bank.

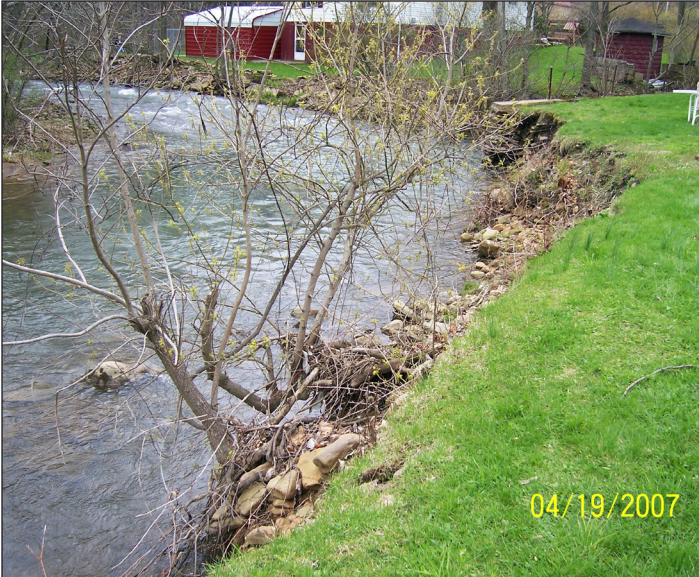
*Streambank erosion on a bank section of Jacobs Creek next to a landowner's house and property*

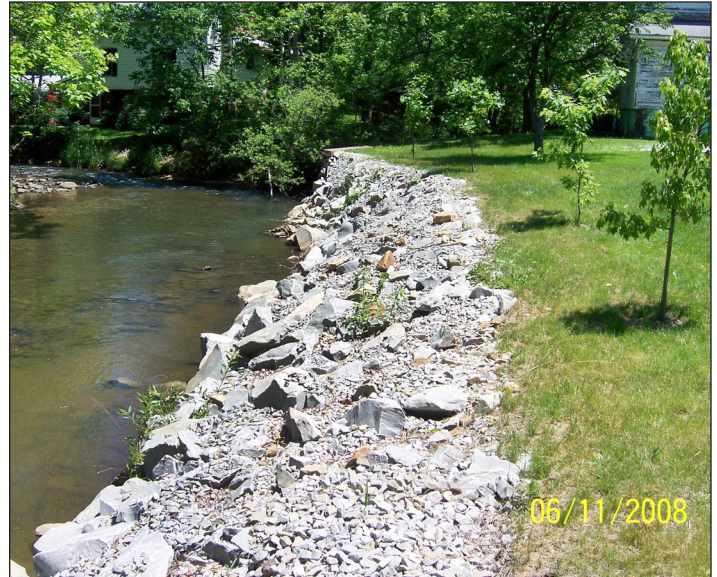
*Installed rip-rap and riparian buffer on the same section a year after construction*

Overall, this project stabilized around 500 feet of actively eroding streambank. The rip-rap stabilization and 200 feet of riparian buffer ultimately reduced sedimentation, improved the stream habitat, cooled the stream with vegetation cover, and protected the landowner's property.

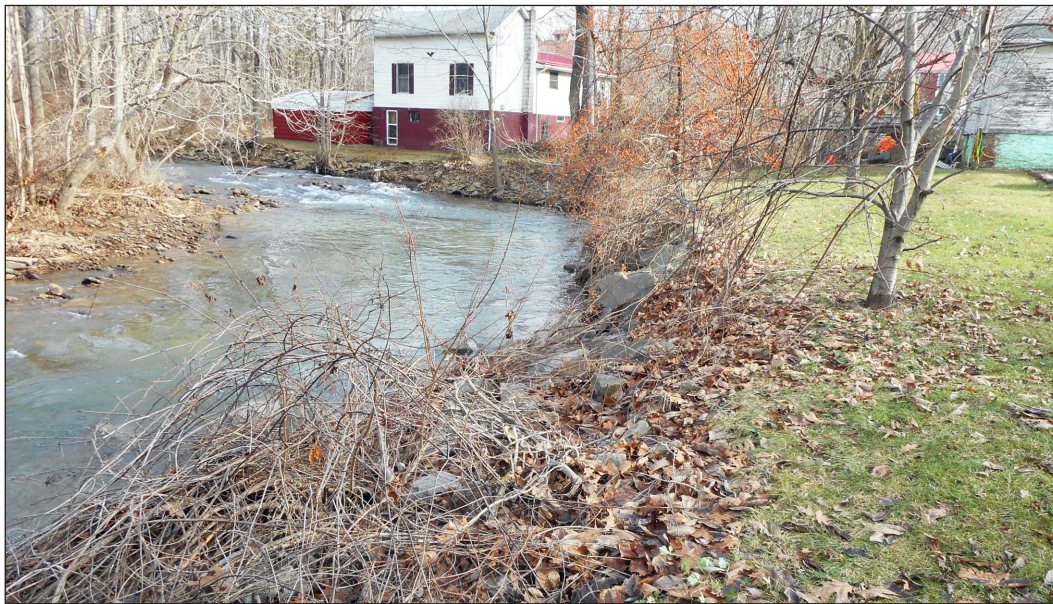
*Jacobs Creek streambank nine years after construction*
