Kinlock Basin

Design Features: 400,000-gallon detention pond

Date of Installation: 2011

Client: City of Lower Burrell

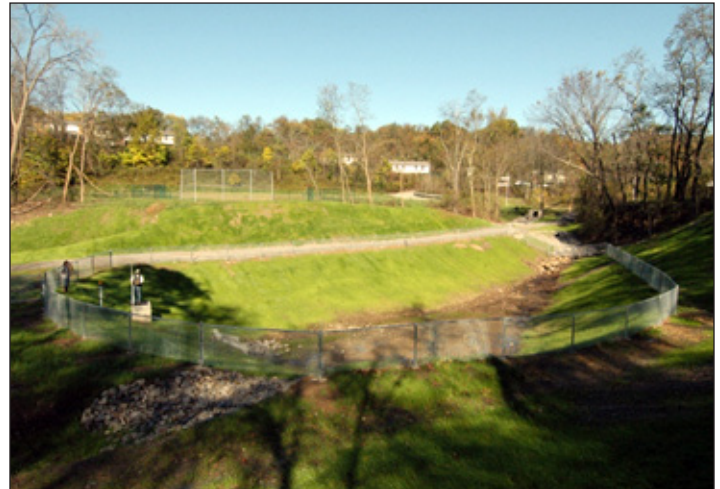
View of completed detention pond project

In 2011, the construction of a 400,000-gallon detention pond was built in New Kensington to relieve flooding in the Kinlock neighborhood of Lower Burrell. The 15-foot-deep basin captures and holds in excess of 400,000 gallons of stormwater and slowly releases the water into Pucketa Creek, reducing the damaging floods that have plagued the tiny community outside Lower Burrell for two generations.

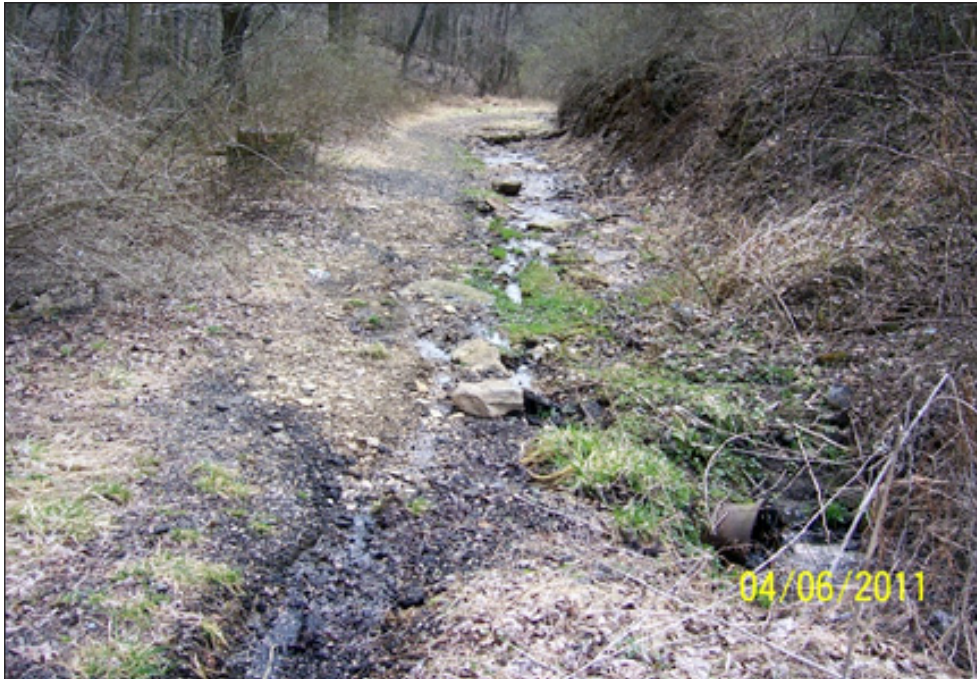
Site prior to construction of Detention Pond. Note: water flowing during low flow. Can you imagine what this would look like after a large rain event?

Prior to construction of the detention pond, uncontrolled runoff would enter a small tributary above the community of Kinlock. The runoff would travel down an extremely high gradient stream before entering Pucketa Creek. Due to the gradient of the stream, and high storm flows (lack of storm water control), the streams banks continued to erode causing excess siltation. The excess siltation and debris would clog and overtop the existing storm water facilities and the residents of Kinlock would become flooded.

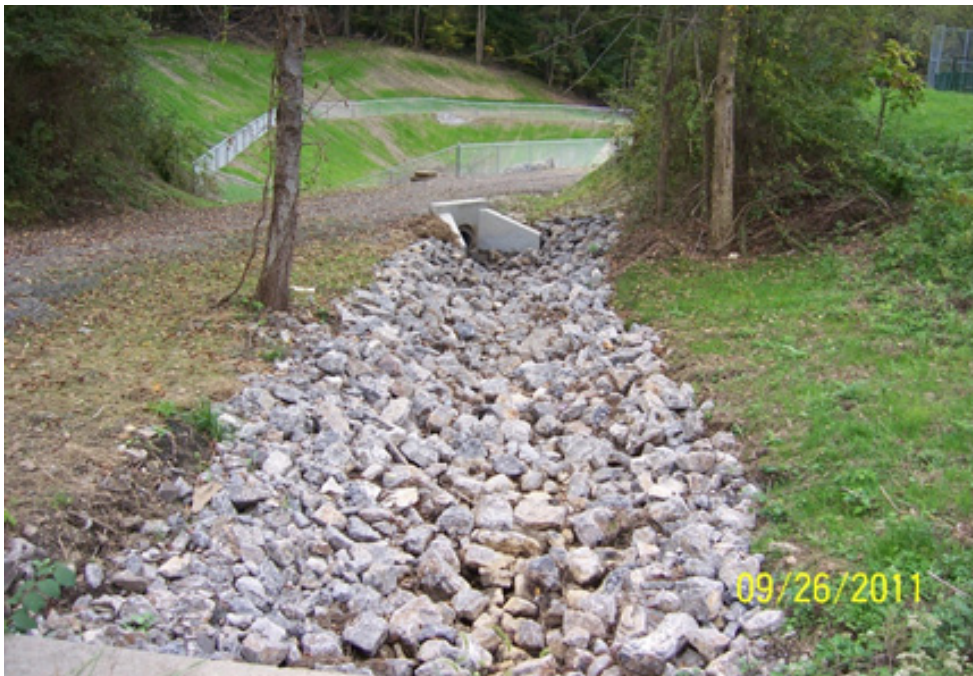
Site after construction with installed rock lined channel leading to the newly installed 400,000- gallon detention pond.
