Lydick Farm Sink Hole

Design Features: Riparian buffer, rip-rap, restoration of stream channel, updated and upgraded cross pipes

Date of Installation: 2008

Location: Route 982, Derry Township

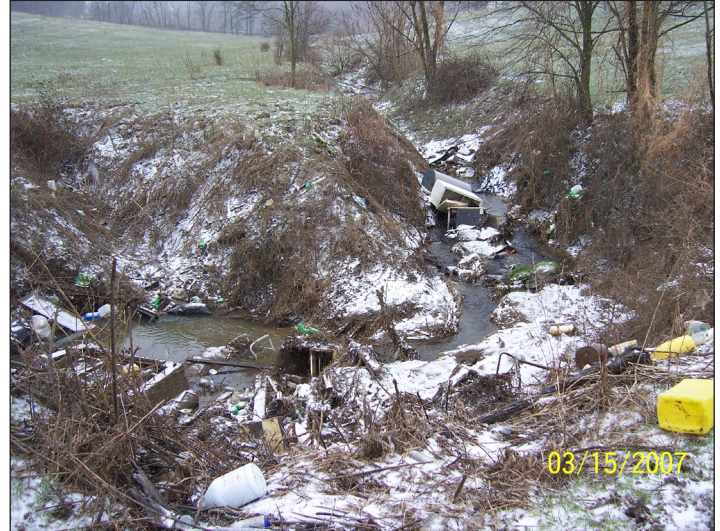
Empty sinkhole before mining and sealing of site

Many years ago, the area underneath Stony Run stream at the Lydick Farm was mined very shallowly for coal, and once it was abandoned, the mine subsided becoming a 20-foot-deep sinkhole. The stream disappeared into the hole and began carrying AMD into the stream, depositing iron and other pollutants.

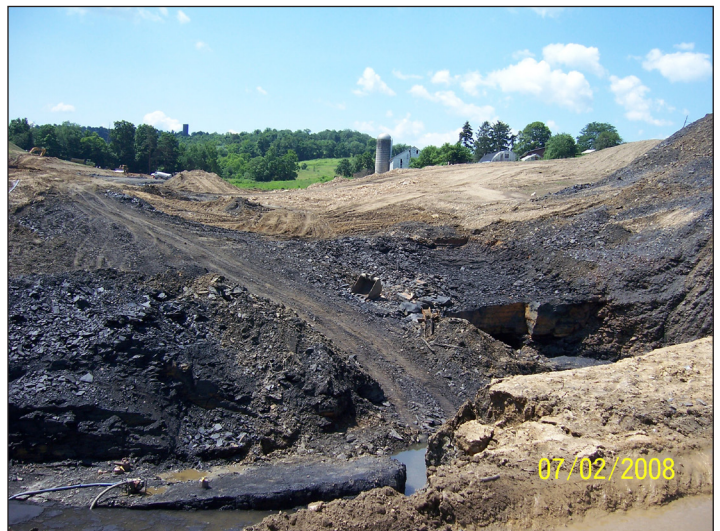
Re-mining in process at the sinkhole before sealing

The stream channel was restored to its historical location by excavating the streambed and returning the water to its original path on the surface of the ground. Rip-rap was used to stabilize the sides. Four stream crossings were installed with cross pipes to allow for the increased volume of water in the streambed to pass under the road crossings. The sinkhole was filled, and riparian buffers were planted in 2010.

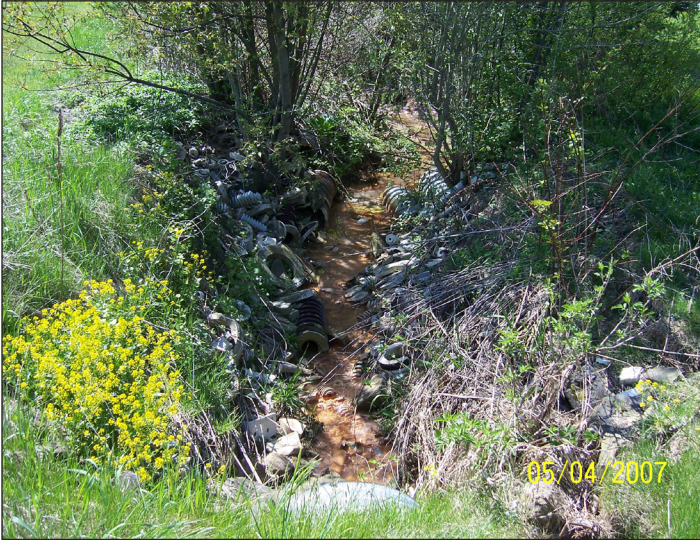
Old cross pipe and streambed before restoration began

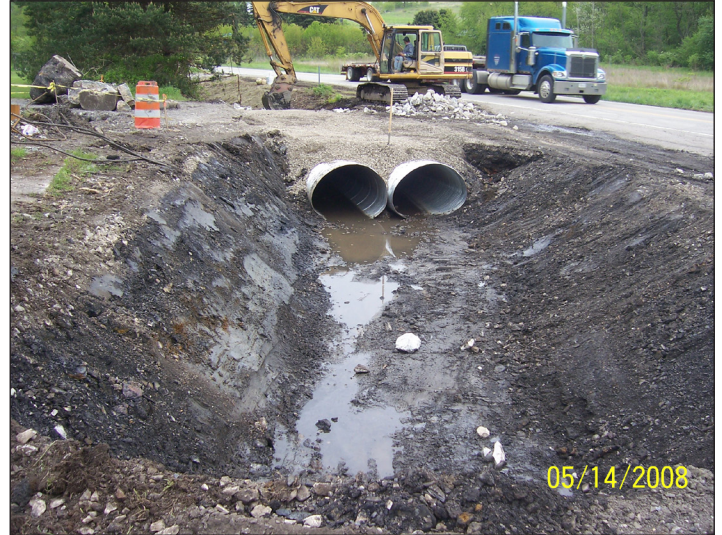
Installation of upgraded cross pipes at one of the four stream crossings

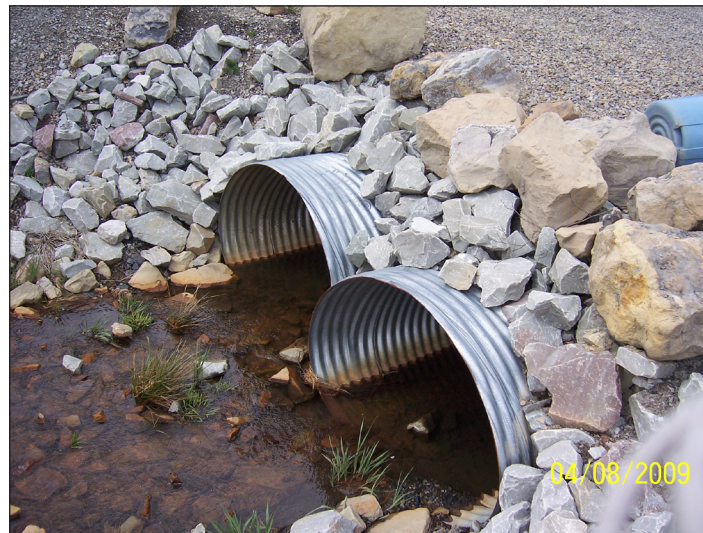
Finished cross pipes carrying Stony Run under a driveway
