## Shupe Run Streambank Restoration

**Design Features:** riparian buffer, stone deflectors, single log vane deflectors, regrading of streambank, rip-rap, rock toes

**Date of Installation:** Phase I: 2008, Phase II: 2013

**Location:** Willow Park, Center Ave.,  
Mt. Pleasant, PA 15666

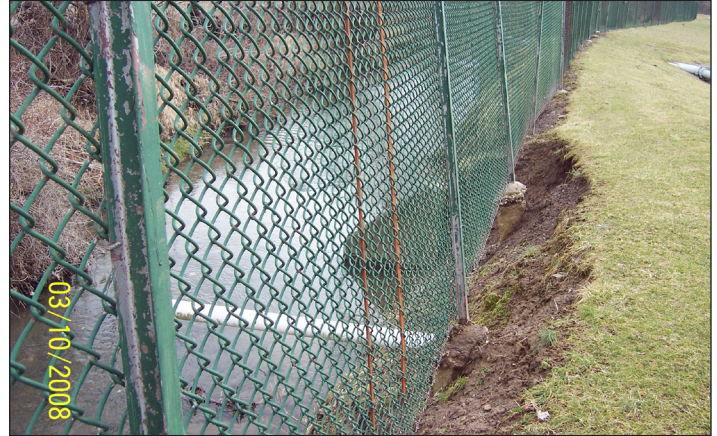
The area of Shupe Run in Willow Park near the soccer fields was severely eroding due to the high flows of stormwater entering the stream during rain events, which was threatening the fence and nearby soccer fields next to the stream. This had caused the banks of the area to become almost vertical with little to no vegetated buffer to help control the erosion.

*Severe erosion threatening the soccer fields' fence next to Shupe Run*

Phase I of this project was completed in the spring of 2008 and consisted of a number of BMPS. Large amounts of rip-rap and rock toes were placed along sections of the bank to reduce erosion. The steepest parts of the streambank were graded down to a shallower angle. Riparian buffers were planted all along the project area to stabilize the eroding streambank.

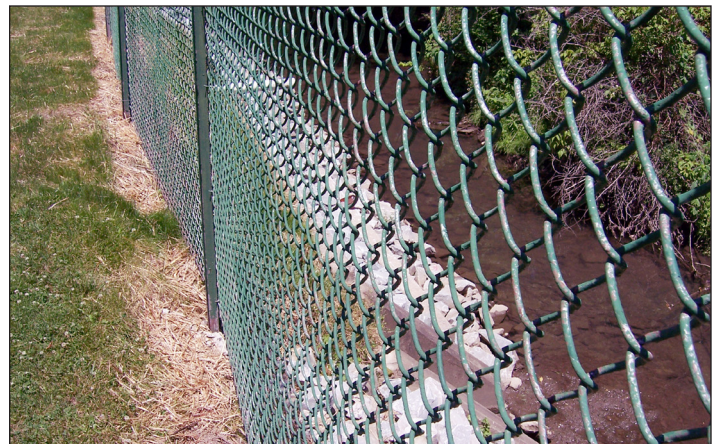
*Stabilized bank under fence after rip-rap and riparian buffer planting*

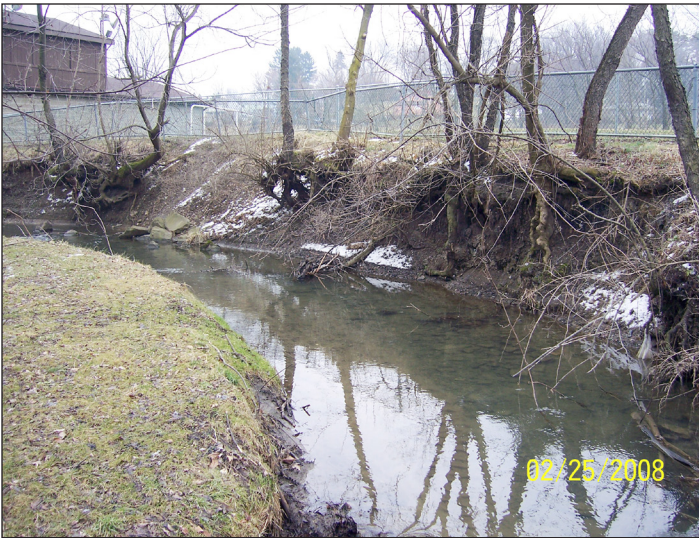
*Streambank before construction*

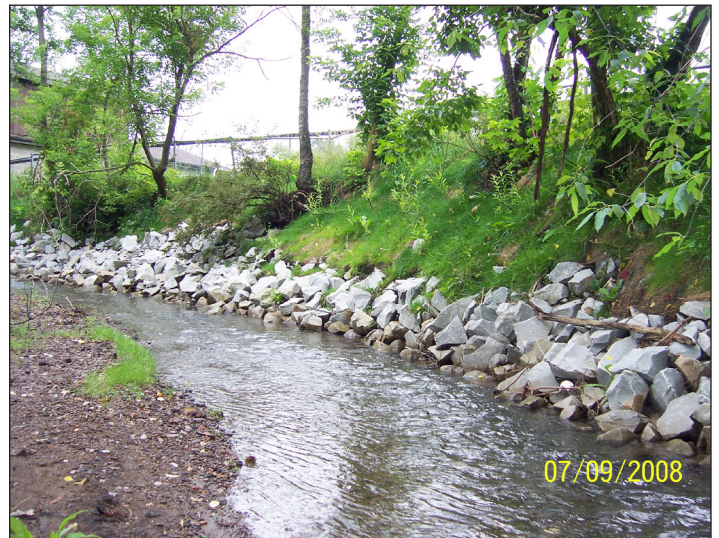
*Streambank a few months after construction*

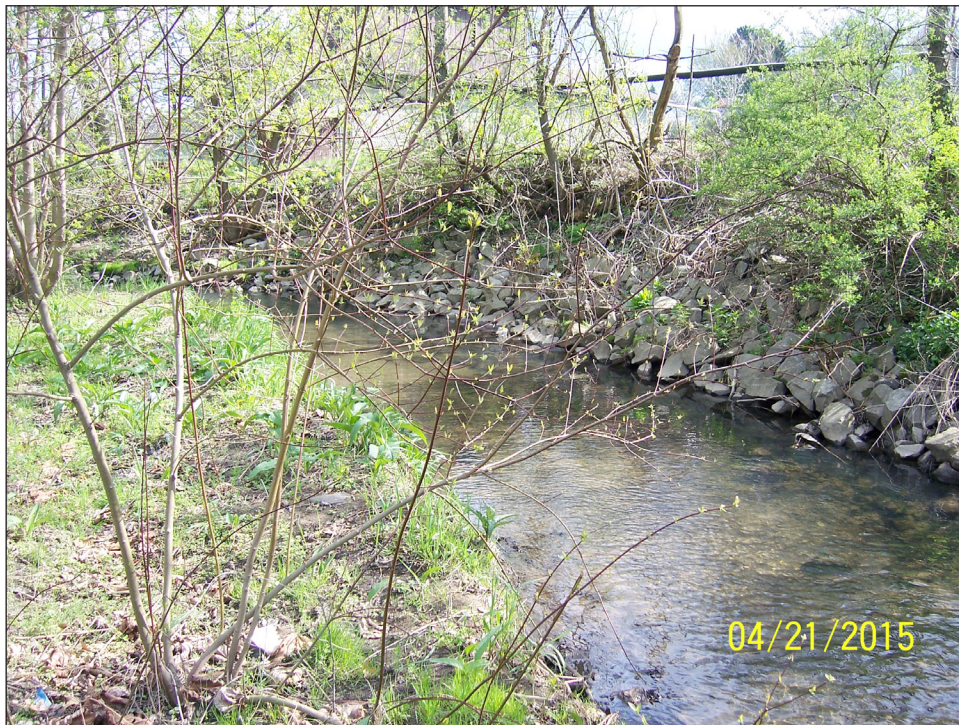
*Streambank seven years after construction.  
Note the amount of vegetation that has grown up*

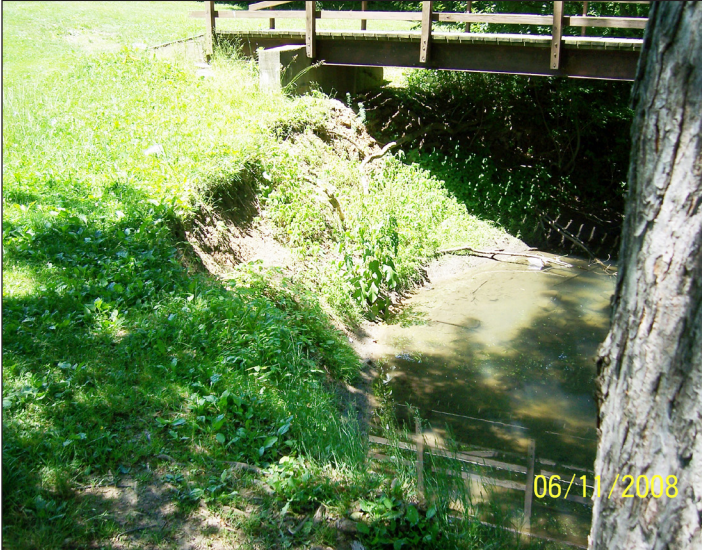
*Eroding bank near pedestrian bridge*

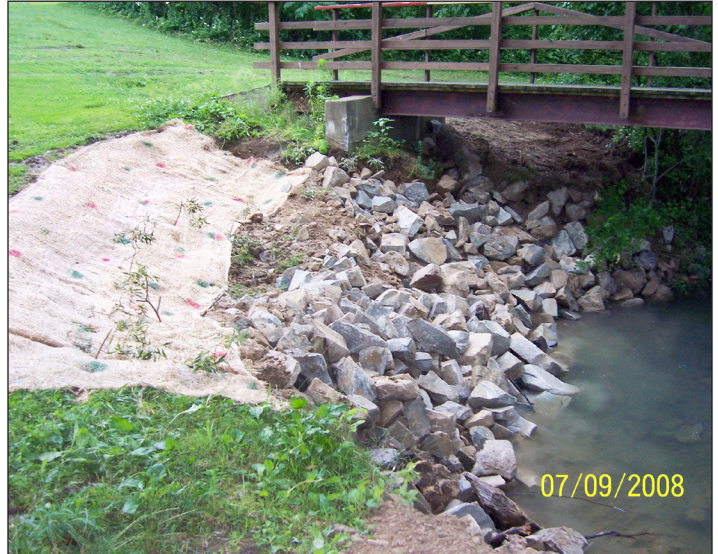
*Bank shortly after grading, rip-rap, and seed and mulch*

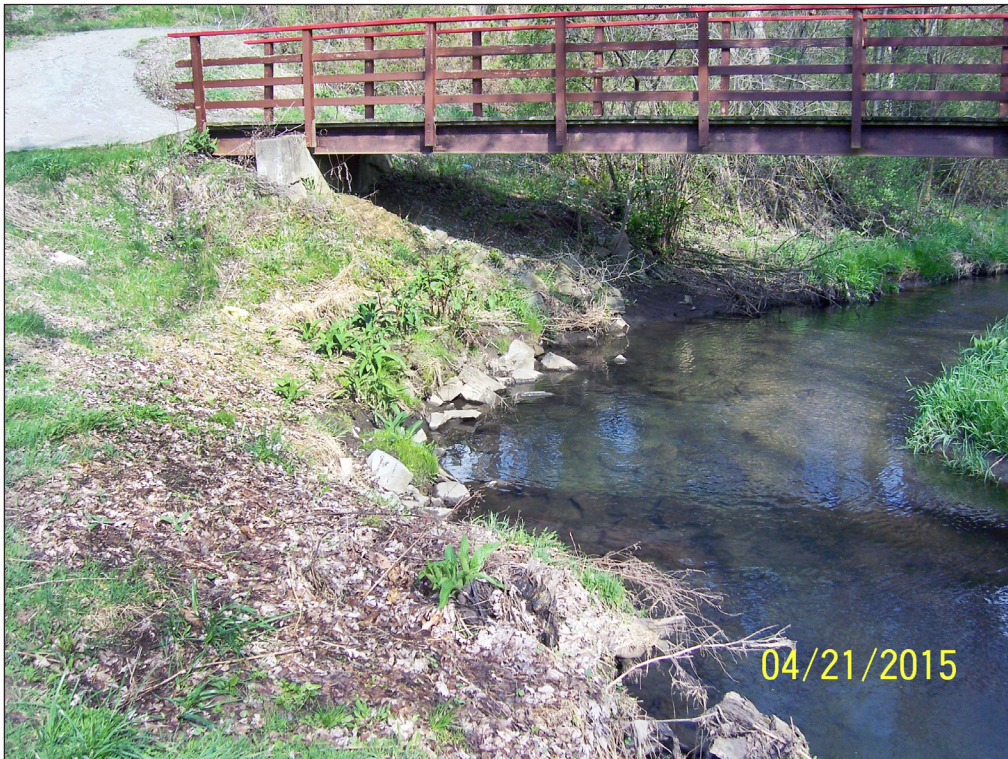
*Bank seven years after BMPs were installed*

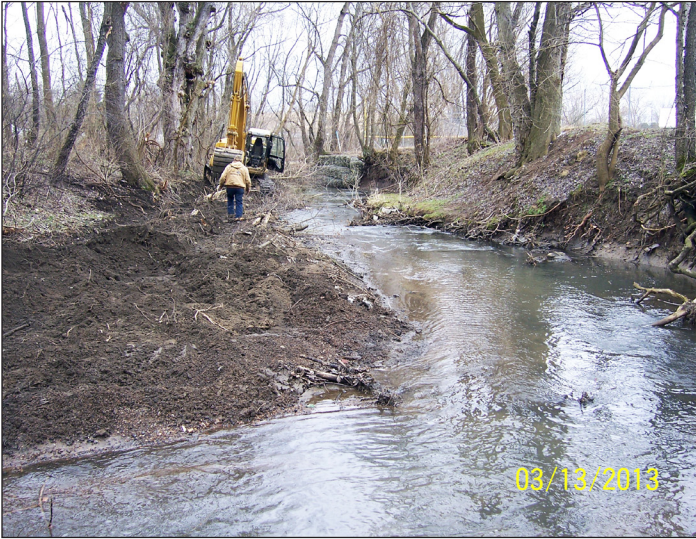
*A section of Phase II streambank before construction*

Phase II was completed in March of 2013 and built upon the previous work done in 2008. Stone deflectors, rock toes, and single log vanes were installed at five areas along Shupe Run, along with additional streambank grading and riparian buffers.

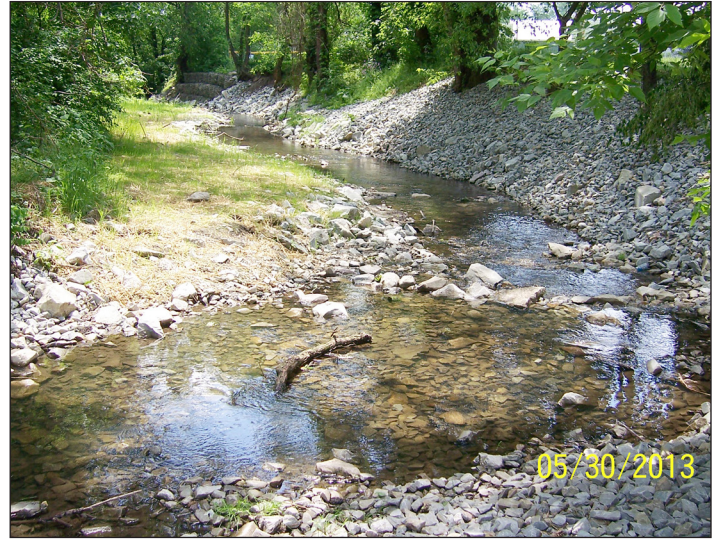
*Phase II streambank after construction*

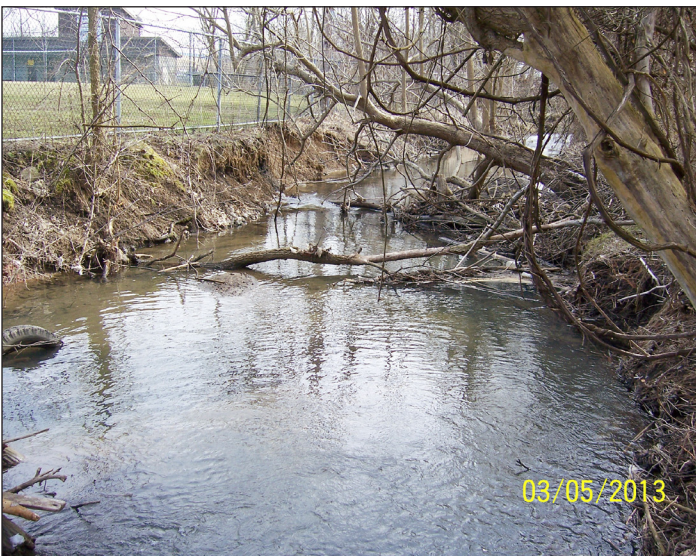
*Another Phase II streambank section before construction*

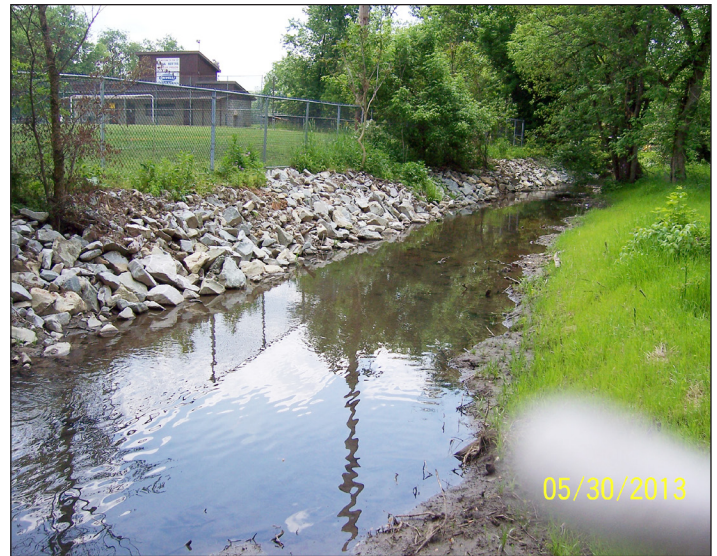
*The same section after construction*
