## Wolfpack Park Stream Restoration

**Design Features:** rock cross-vanes, j-hook rock structures, streambank grading, riparian buffer

**Date of Installation:** 2010, 2012

**Location:** Wolfpack Park, Lower Burrell, PA 15068

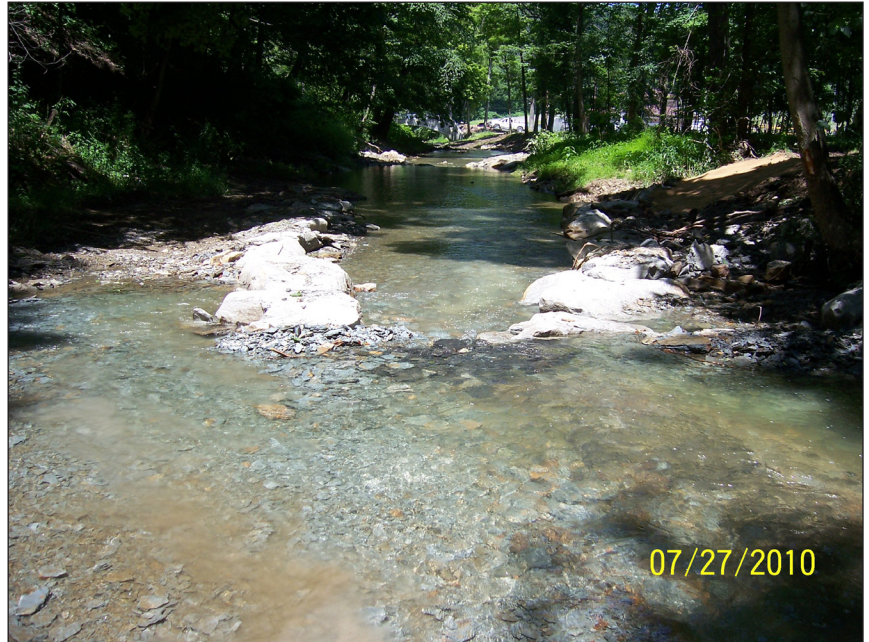
*Rock cross-vane installed in the Chartiers Run to redirect the flow of water back to the center of the channel*

In the summer of 2010, around 1,000 feet of streambank was stabilized by installing five rock cross vanes and four rock j-hook structures. The streambank was graded to a shallower slope and riparian buffers made of various native trees, shrubs, and grasses were planted to prevent further erosion.

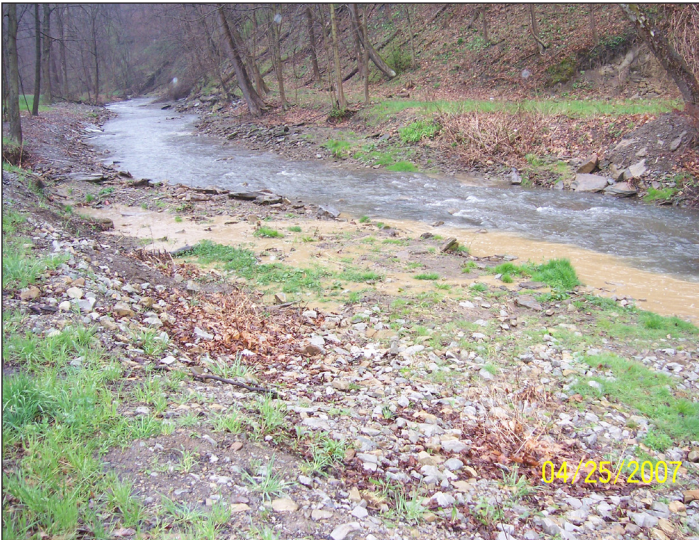
The project area of Chartiers Run within Wolfpack Park had been heavily affected by high-flow storm-water runoff events. The stream had begun to down cut and widen, which led to sediment deposits further downstream to shift the base flow of the stream. Major erosion of the banks was negatively affecting the water quality of Chartiers Run.

*Section of Chartiers Run before construction*

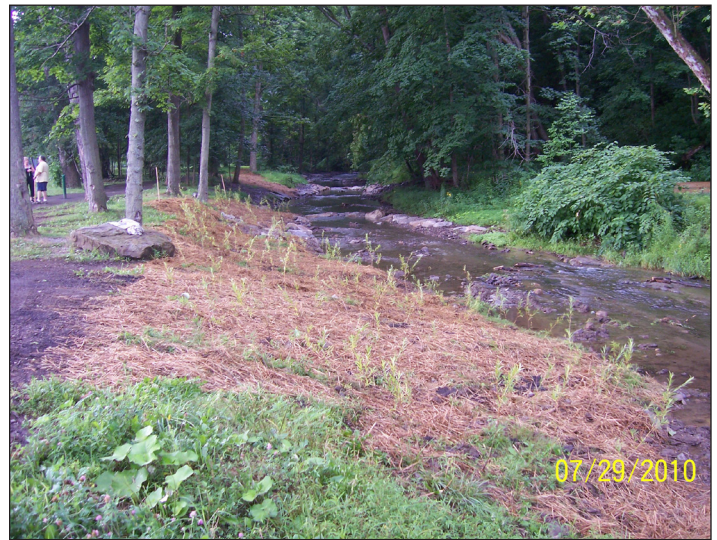
*Section of Chartiers Run after construction and riparian buffer planting*

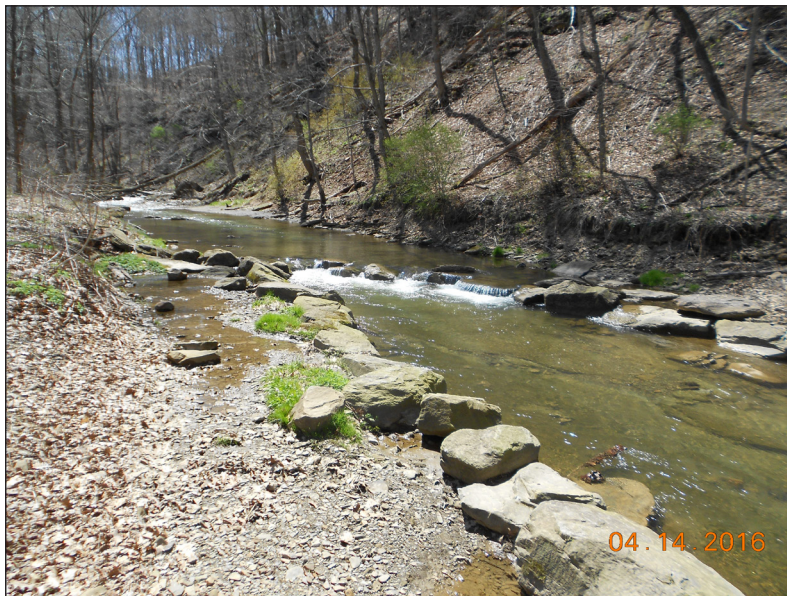
*Rock structures in Chartiers Run six years after construction*

In 2012, flooding moved a few large rocks placed during the stabilization project in 2010. WCD was granted a Western Pennsylvania Coalition for Abandoned Mine Reclamation (WPCAMR) Quick Response grant of \$800 to reposition these rocks, which protected the longevity and effectiveness of the project.
