Washington Township Exposed Sewer Streambank Stabilization

Design Features: Rip-rap, streambank grading, and gravel bar removal.

Date of Installation: May 2025

Location: Washington Township, PA

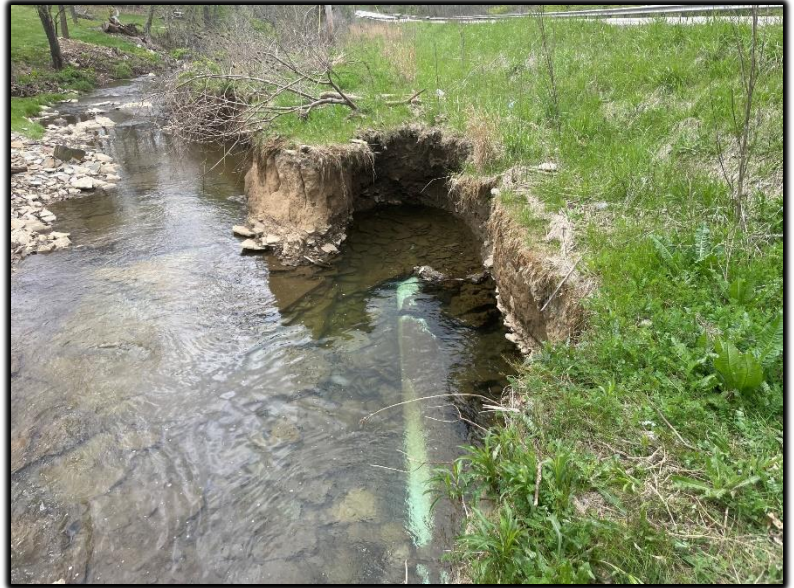
Severe streambank erosion around exposed sanitary sewer and threatening SR 366/ Greensburg Road.

The 27 feet of exposed sanitary sewer line was encased in concrete and R-8 sized rip-rap was placed along the toe of the slope and smaller R-6 size stone was used to stabilize the section of eroding streambank. A section of gravel bar material was removed to maintain a uniform stream width. The site was seeded and mulched.

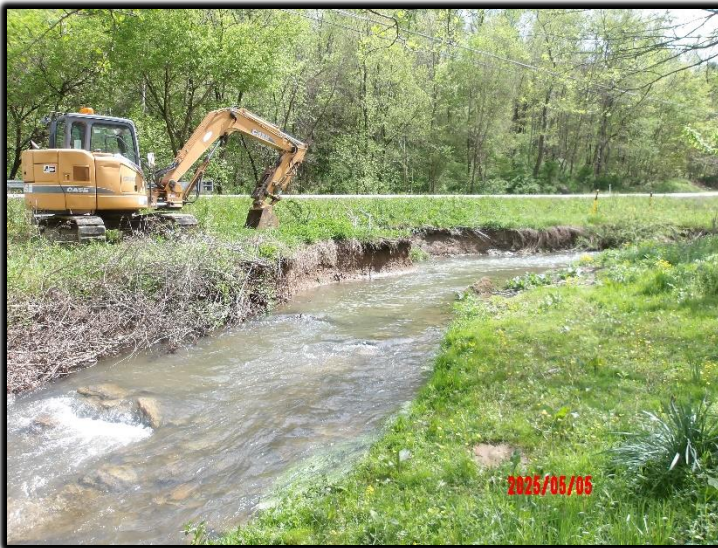
Before: Streambank erosion threatening utilities.

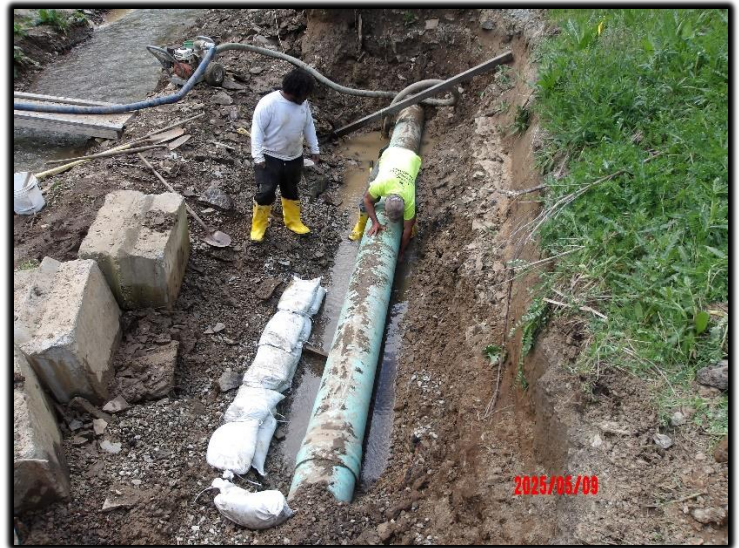
During: Preparing the sewer line for concrete.

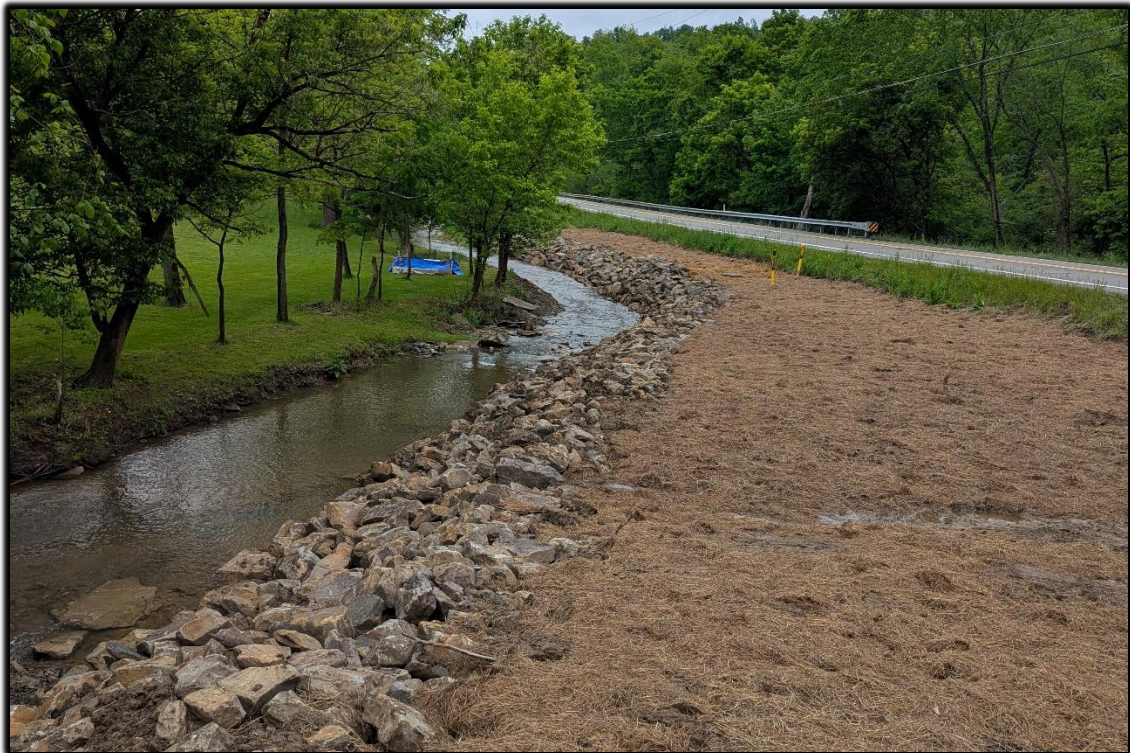
After: Stabilized streambank and yard area restored.

Overall, this project stabilized over 238 feet of actively eroding streambank and 27 feet of exposed sanitary sewer was incased in concrete. The Municipal Authority of Washington Township and adjacent landowner know that the streambanks are stabilized and sanitary sewer is protected.
