### **Watershed Restoration**

## **Latrobe Transfer Station Streambank Remediation Project**

**Design Features**: Cut slope to stable grade, armor toe of slope, riparian buffer tree planting, hydro-seeding slope.

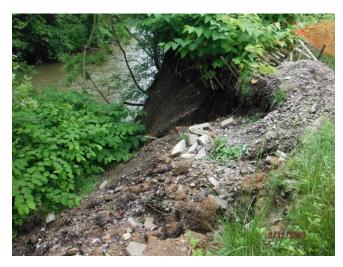
BEFORE CONSTRUCTION: Top of streambank. Note the loss of sediment and unconsolidated fill that has eroded into Loyalhanna Creek.

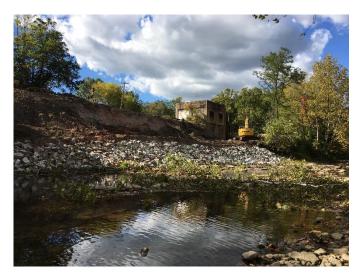
DURING CONSTRUCTION: Streambank terraced to allow for equipment to reach and place rip rap to armor toe of the slope.

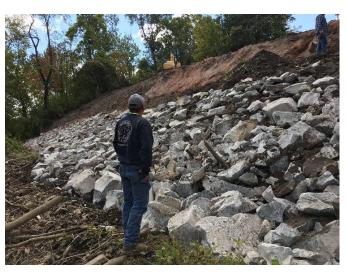
DURING CONSTRUCTION: Toe of slope armored with rip-rap.

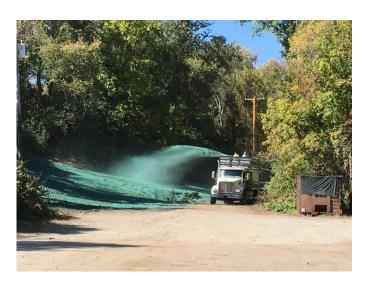
DURING CONSTRUCTION: Hydro-seeding the slope.

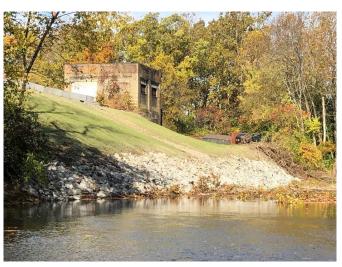
AFTER CONSTRUCTION: Stable slope.
