Irwin Park's Parking Lot and Streambank Stabilization

Design Features: Graded stream banks, armor toe of slope with rip-rap, single log vane deflectors installation, and two infiltration swales

Date of Installation: 2022

Location: Irwin Park, Irwin Borough, Westmoreland County

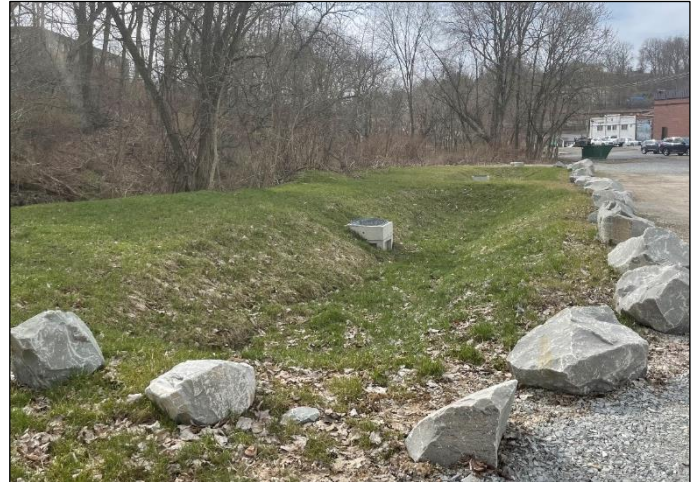
Parking lot retrofitted into two infiltration swales with large rock as natural guide rail.

This project aided in stabilizing approximately 450 feet of eroding streambank along an unnamed tributary (UNT) to Tinkers Run within the Turtle Creek watershed. The Irwin Borough reached out to the district for assistance because of the severe erosion in close proximity to the walking trail. In stabilizing the stream banks, ten single log vane deflectors and graded stream banks to a gentle slope and installed rip-rap reduced accelerating erosion along the UNT. Trees and shrubs were planted along the streambank to restore a native riparian buffer. In addition, some of the park's parking lot near the stream was retrofitted into two infiltration swales. These installed swales captured stormwater runoff from a 22,000 square foot parking lot. This decreased stormwater runoff from this impervious area from entering the stream.

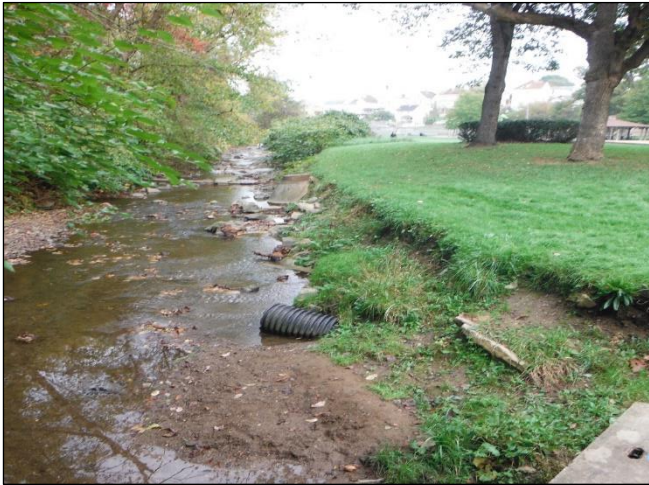
(Before) Eroding and vertical banks causing sediment to enter the stream

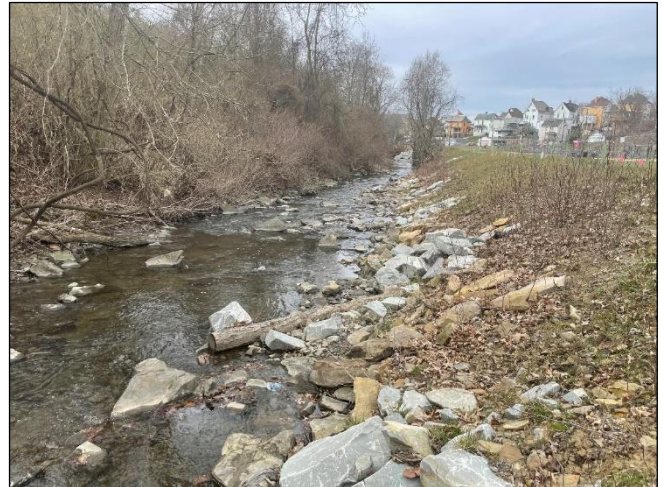
(After) Banks graded back to a stable slope and single log vane deflectors (10) installed to stabilize eroding streambank.

Irwin Park was impaired by accelerated streambank erosion and stormwater runoff from the park's parking lot. The Best Management Practices installed prevented additional sediment and pollutants flowing to this waterway. The log vanes help to direct streamflow into the middle of the channel and stabilizes the bank. The infiltration swales use an engineered soil mix that captures pollutants' runoff from the parking lot and allows for it to soak into the ground before entering the stream.

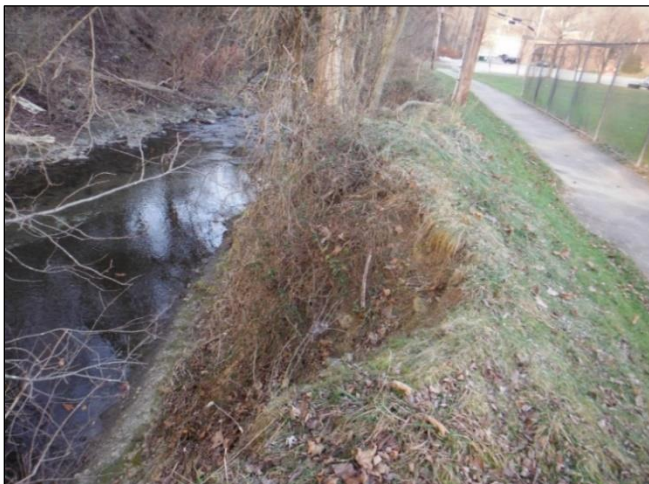
(Before) Eroding and vertical banks causing sediment to enter the stream.

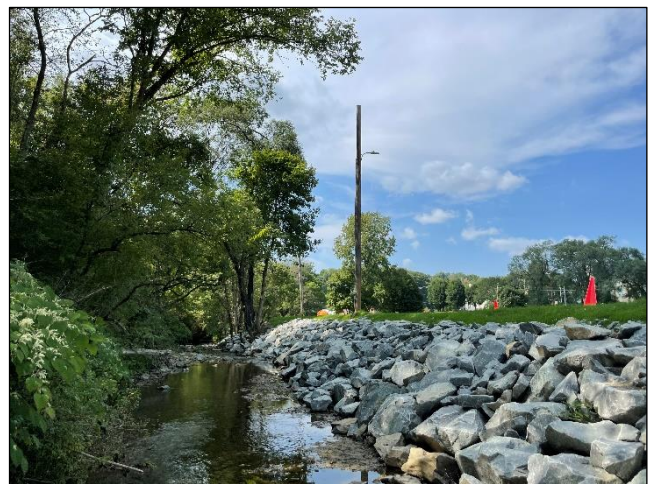
(After) Banks graded back to a stable slope and rock added to the toe of the slope.
