T. Frescura Grazing System Project

Location: Unity Township

Design Features Completed: Animal Walkway, Conveyor Belt Diversions, and Electric High Tensile Fence

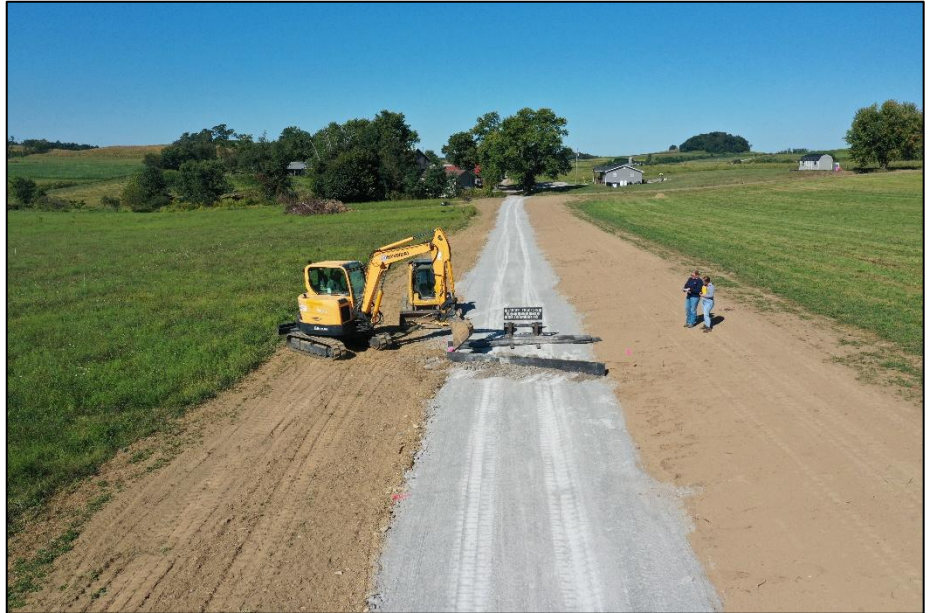
Stabilized Animal Walkway with Conveyor Belt Diversion Installation

Approximately 12,000 square feet of animal walkway was improved with the additions of fill to reduce the walkway entrenchment and stabilized with layers of stone. An additional 12,000 square feet of walkway was improved by grading with additional fill placement to prevent entrenchment, then topsoiled and stabilized with vegetation. The entire length of the walkway was graded to ~4% cross slope to encourage stormwater to sheet flow across the width. Additionally, four conveyor belt diversions were installed along the walkway. The conveyor belt diversions reduce the slope length along the walkway and direct water away from the surface before it increases in velocity and causes erosion. Approximately 8,628 linear feet of electric high tensile fencing was installed to help rotate the cattle through the rotational grazing system. Best management practices (BMPs) were imperative to reduce the accelerated erosion and sedimentation occurring at this farm. This project is located near the headwaters of the Sewickley Creek Watershed, which is classified as a High Quality (HQ) Cold Water Fishery (CWF) by the Department of Environmental Protection.

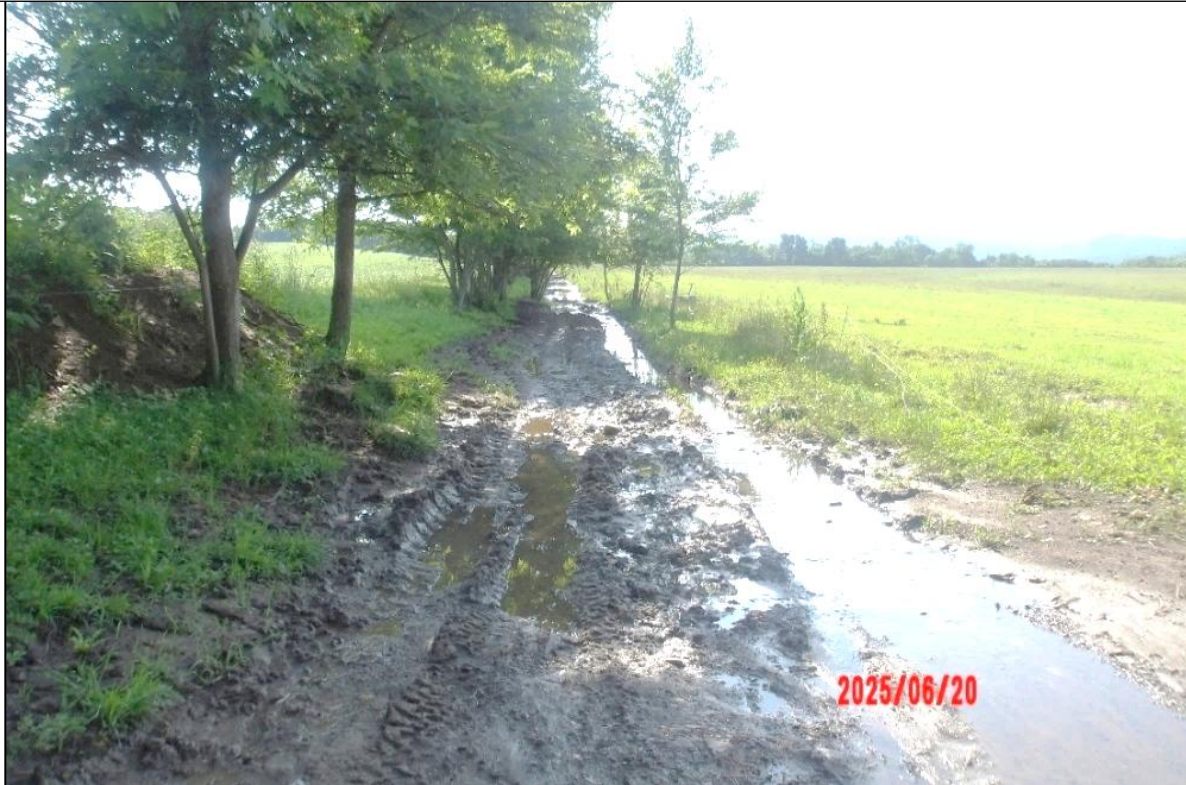
Before: Muddy and eroded animal walkway with runoff leading directly to a ditch that entered near the headwaters of Sewickley Creek, designated as a High Quality watershed.

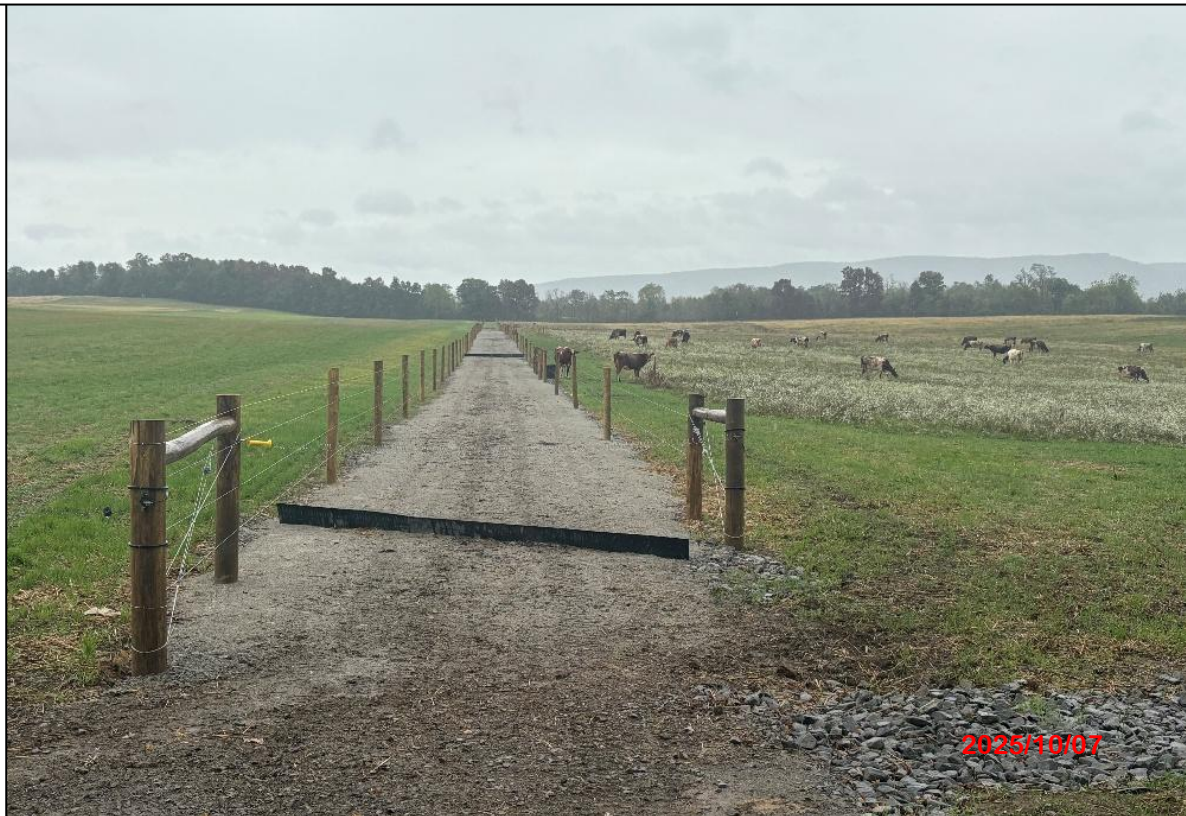
After: Stabilized animal walkway with conveyor belt diversions to prevent erosion of the surface, which will prevent sediment from entering Sewickley Creek.
