T. Frescura Grazing System Project

Location: Unity Township

Date of Installation: Fall 2025

Design Features Completed: Animal Walkway, Conveyor Belt Diversions, and Electric High Tensile Fence

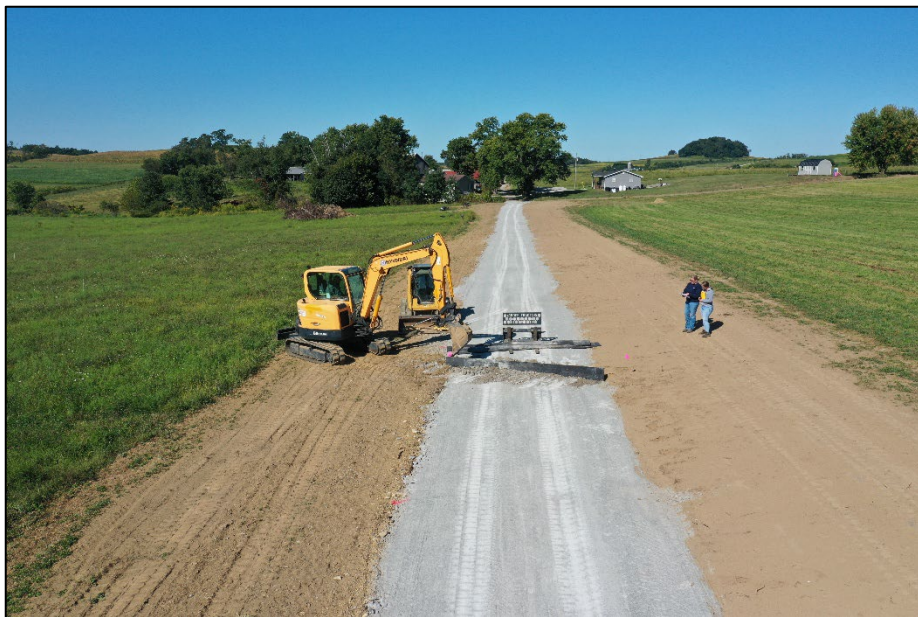
Stabilized Animal Walkway with Conveyor Belt Diversion Installation

Approximately 12,000 square feet of animal walkway was improved with the additions of fill to reduce the walkway entrenchment and stabilized with layers of stone. An additional 12,000 square feet of walkway was improved by grading with additional fill placement to prevent entrenchment, then topsoiled and stabilized with vegetation. The entire length of the walkway was graded to ~4% cross slope to encourage stormwater to sheet flow across the width. Additionally, four conveyor belt diversions were installed along the walkway. The conveyor belt diversions reduce the slope length along the walkway and direct water away from the surface before it increases in velocity and causes erosion. Approximately 10,040 linear feet of electric high tensile fencing was installed to help rotate the cattle through the rotational grazing system. Best management practices (BMPs) were imperative to reduce the accelerated erosion and sedimentation occurring at this farm. This project is located near the headwaters of the Sewickley Creek Watershed, which is classified as a High Quality (HQ) Cold Water Fishery (CWF) by the Department of Environmental Protection.

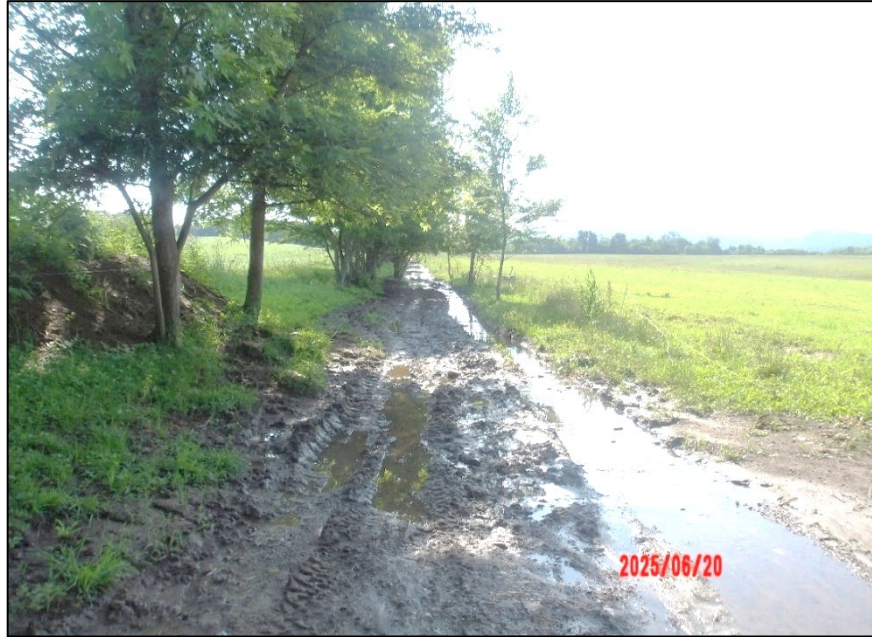
Before: Muddy and eroded animal walkway with runoff leading directly to a ditch that entered near the headwaters of Sewickley Creek, designated as a High Quality watershed.

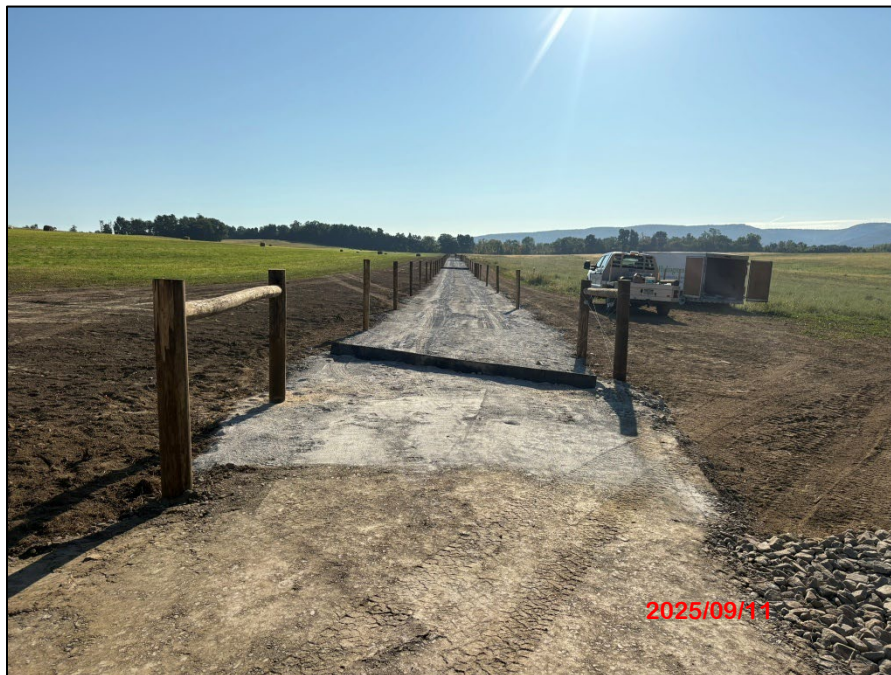
After: Stabilized animal walkway with conveyor belt diversions to prevent erosion of the surface, which will prevent sediment from entering Sewickley Creek.
