### Camp Run Road, Dirt Gravel Road Project

**Design Features:** filling and raising of the road, grade breaks with crosspipes, infiltration trenches

**Location:** Camp Run Road, Donegal Township, Westmoreland County

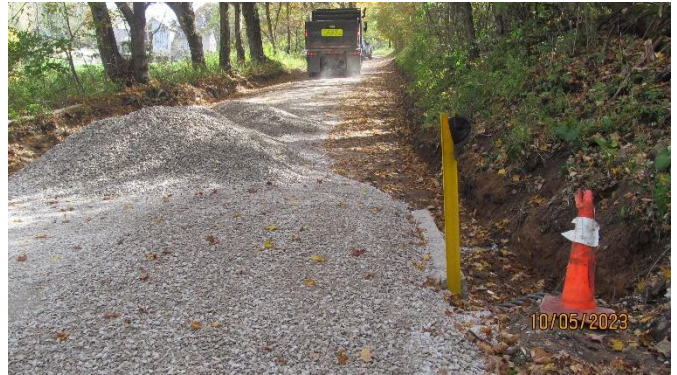
*Gravel was added to raise the road and add stability to driving surface.*

Previously, rainfall was trapped and concentrated on the driving surface due to the entrenchment of the road. This caused large amounts of erosion in the ditch lines and driving surface, which carried sediment and storm water to the nearby stream as well as caused flooding issues for residents. The road was filled to eliminate the entrenchment and allow for sheet flow of water. Several grade breaks with crosspipes helped to divert the water off the roadway, as well as encourage infiltration at stabilized outlets.

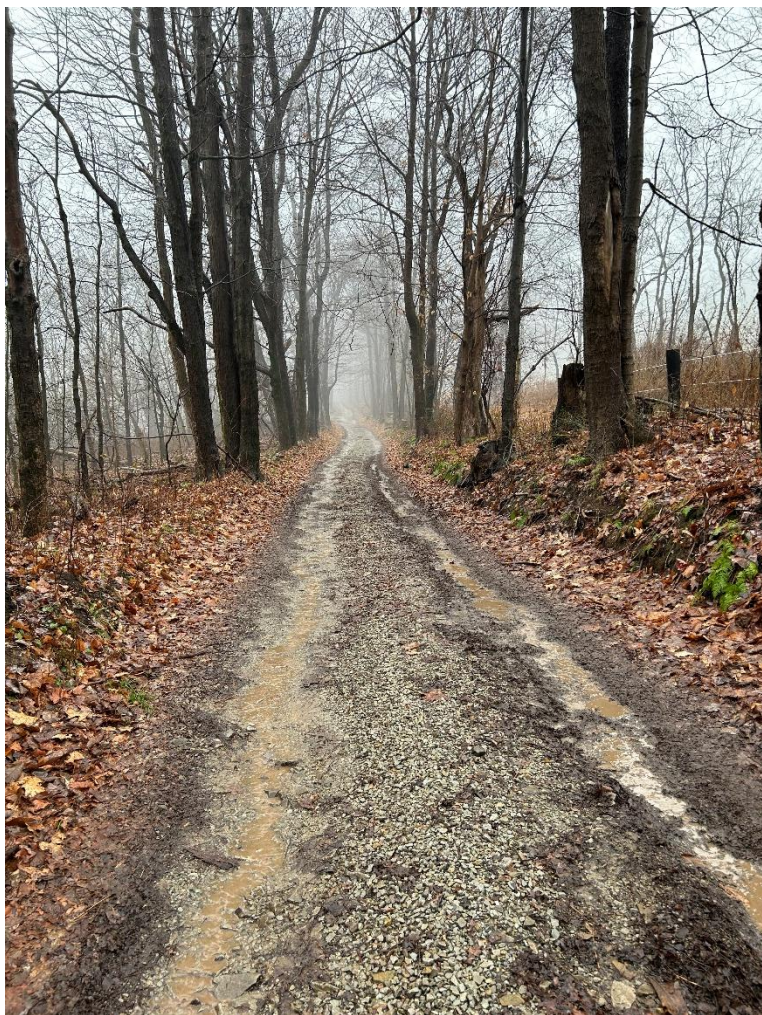
*(Before) Water and erosion on road impairing driving and stability.*

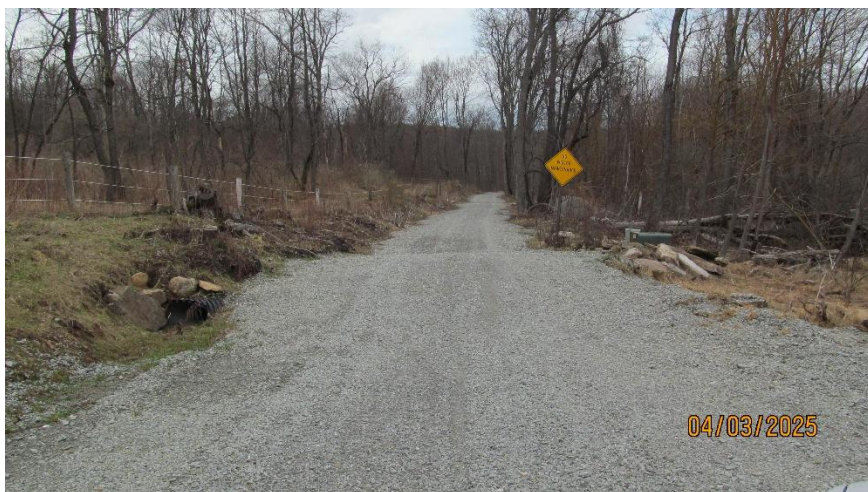
*(After) Road built up with gravel and grade breaks to divert the flow of water and stabilize driving surface.*

Through the installation of grade breaks, the stormwater no longer has the opportunity to erode the road surface. The crosspipes then convey the water through the roadway into infiltration trenches where the pollutants can drop out.
