Hempfield Park Stormwater Retrofits

Design Features: Two new rain gardens totaling 900 ft², 400 feet of streambank stabilization, 40,000 ft² of native pollinator mix, 23 tree plantings, a concrete ramp for stream access, and an educational sign

Location: Hempfield Park, Greensburg PA

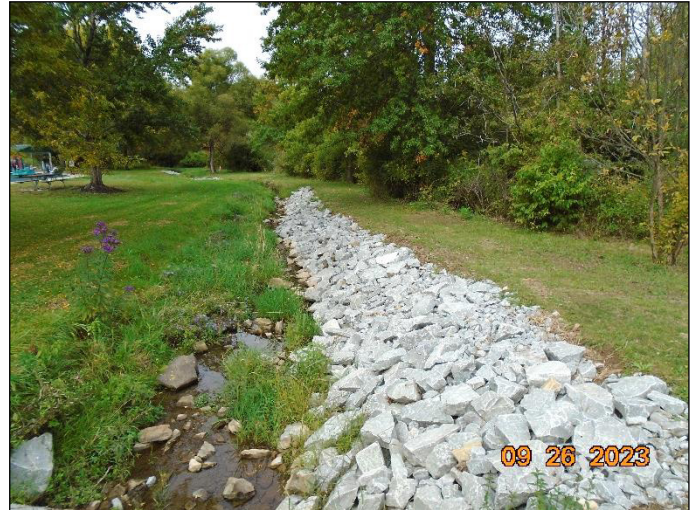
Stabilized streambank by means of bank and dumped rock protection

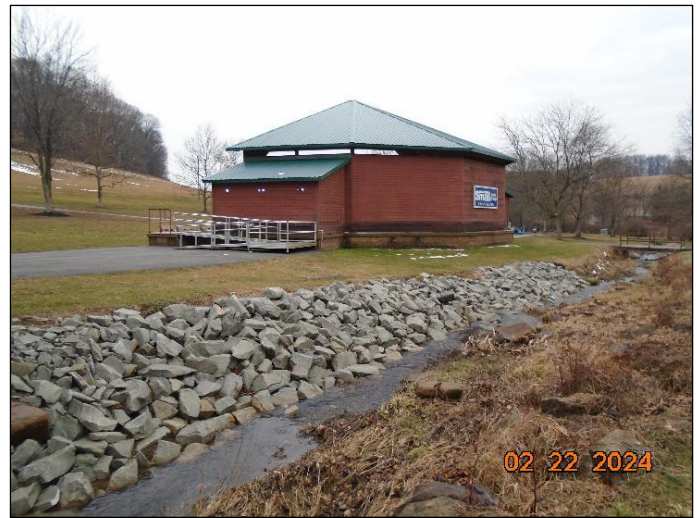
After Construction

Streambank stabilization by means of bank grading and dumped rock protection

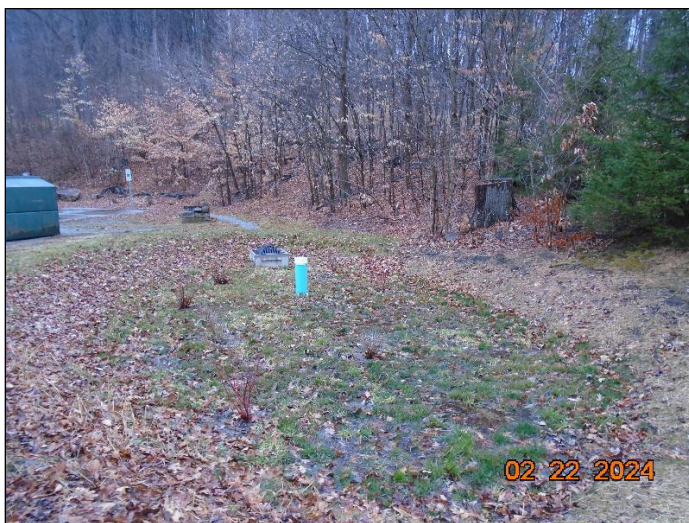
New rain garden with shrub plantings

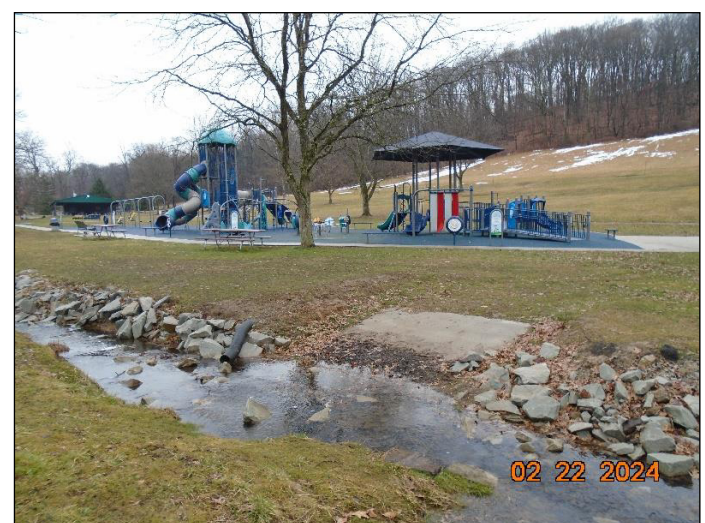
New concrete ramp to allow for educational stream access

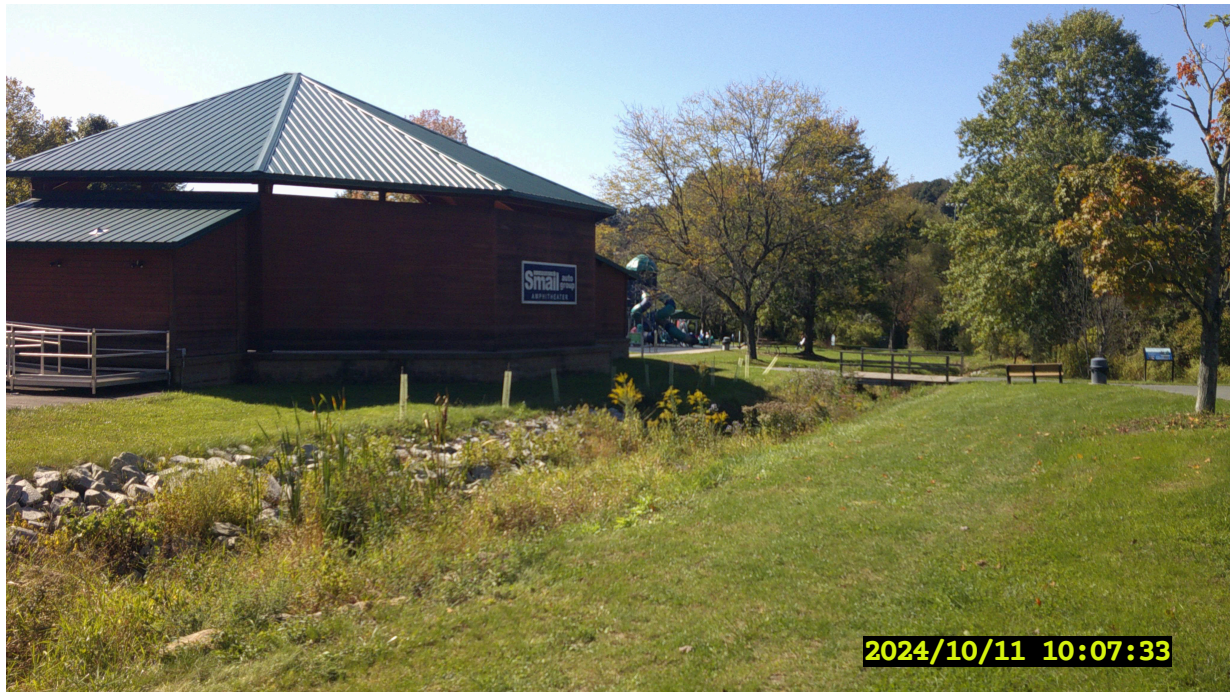
Streambank stabilization methods several months after installment

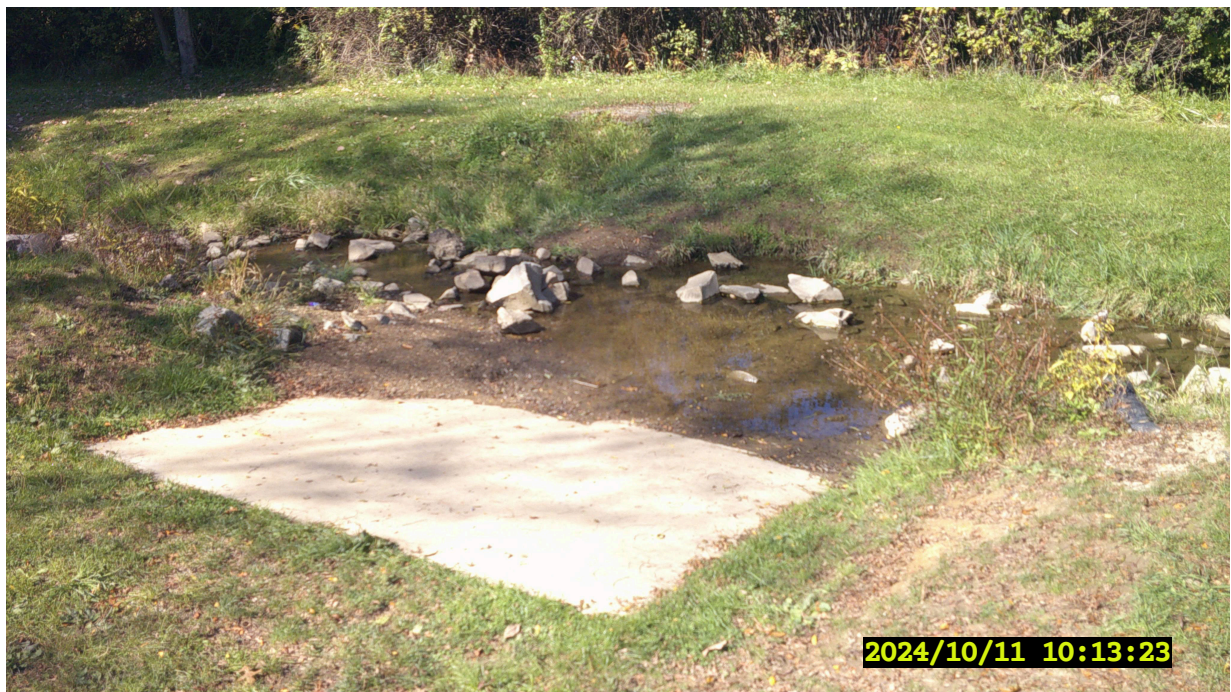
Stream access ramp several months after construction
