Irwin Park's Parking Lot and Streambank Stabilization

Design Features: Graded stream banks, armor toe of slope with rip-rap, single log vane deflectors installation, and two infiltration swales

Location: Irwin Park, Irwin Borough, Westmoreland County

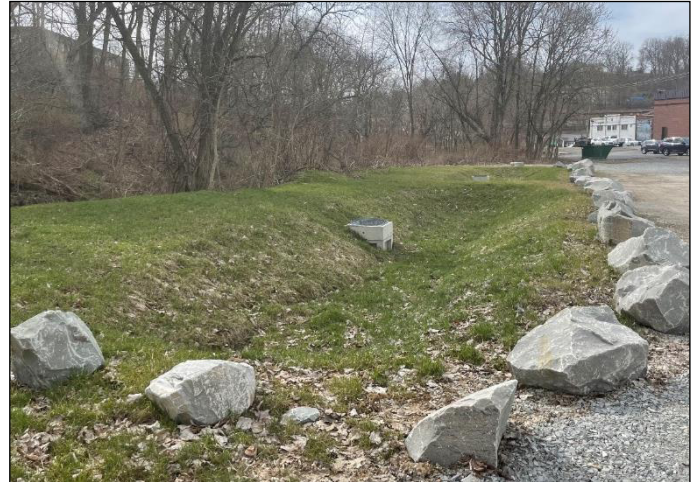
Parking lot retrofitted into two infiltration swales with large rock as natural guide rail.

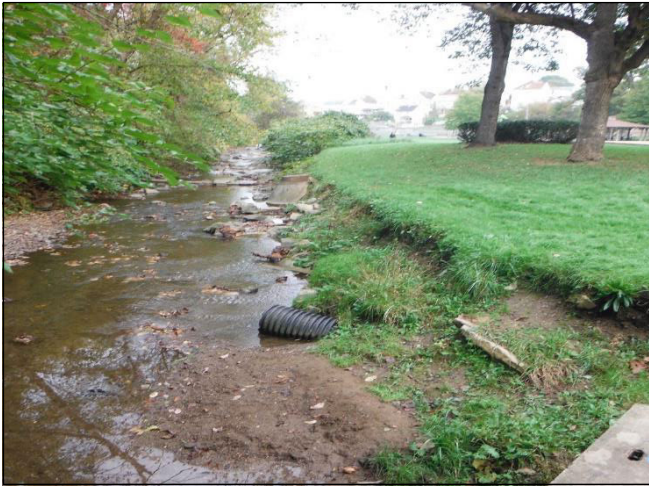
(Before) Eroding and vertical banks causing sediment to enter the stream

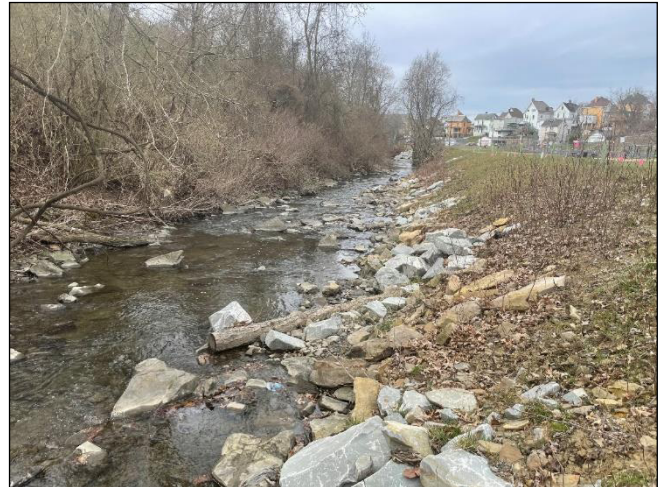
(After) Banks graded back to a stable slope and single log vane deflectors (10) installed to stabilize eroding streambank.

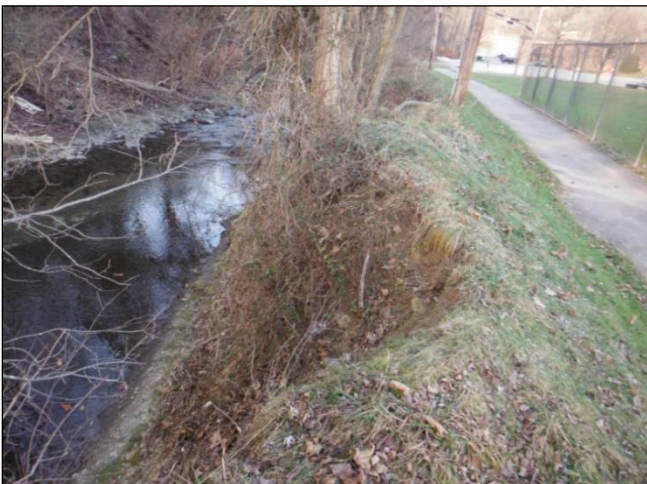
(Before) Eroding and vertical banks causing sediment to enter the stream.

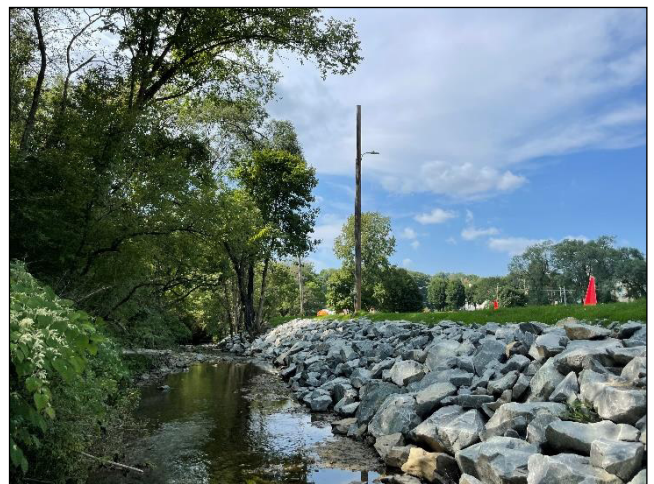
(After) Banks graded back to a stable slope and rock added to the toe of the slope.

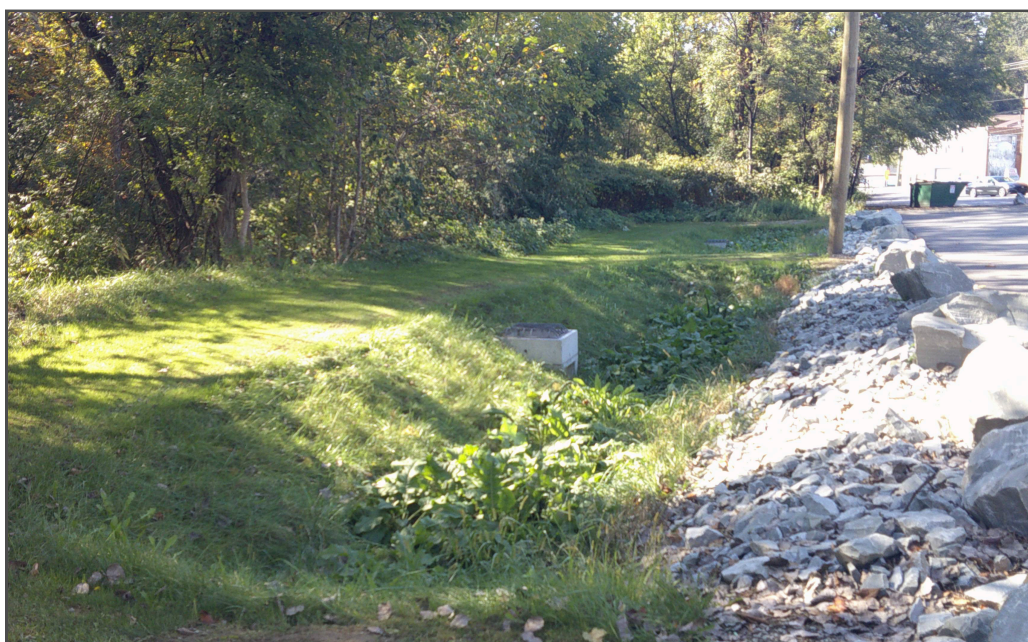
Infiltration swale two years after construction

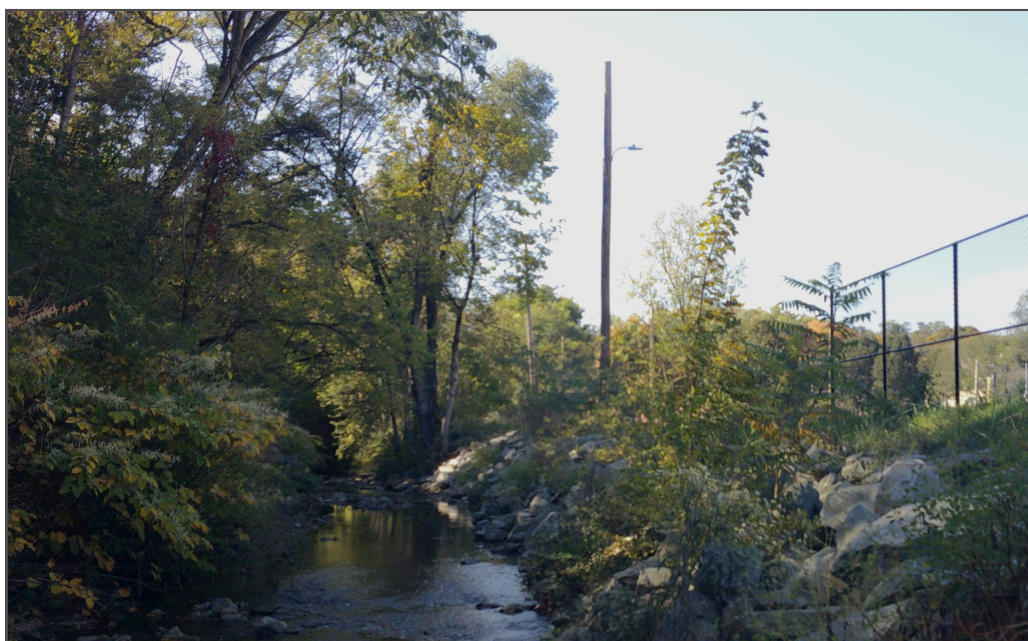
Stabilized slope two years after construction
