Poole Farm Manure Management Improvements Project

Location: East Huntingdon Township

Date of Installment: Fall 2024

Design Features: Liquid Manure Storage, Reception Pit, Waste Transfer Pump, Access Road Stabilization With Stone, Subsurface Drainage, Culvert Replacement, Surface Inlet, Outlet Pipe, Concrete Heavy Use Area.

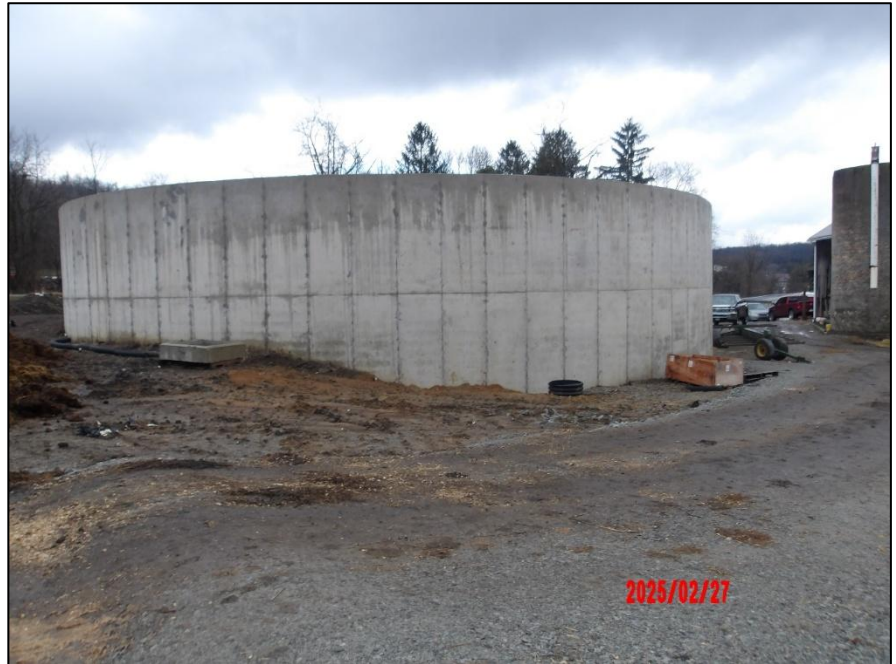
Installed liquid manure storage

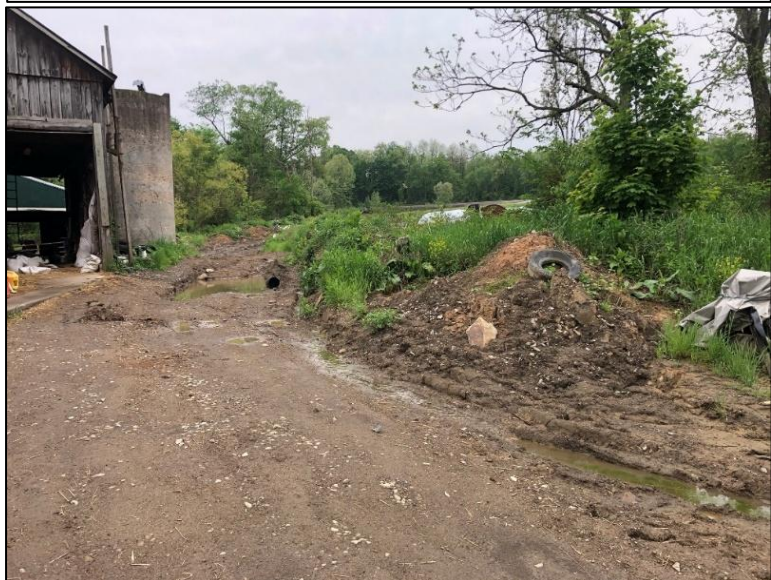
Before: Eroded farm access road.

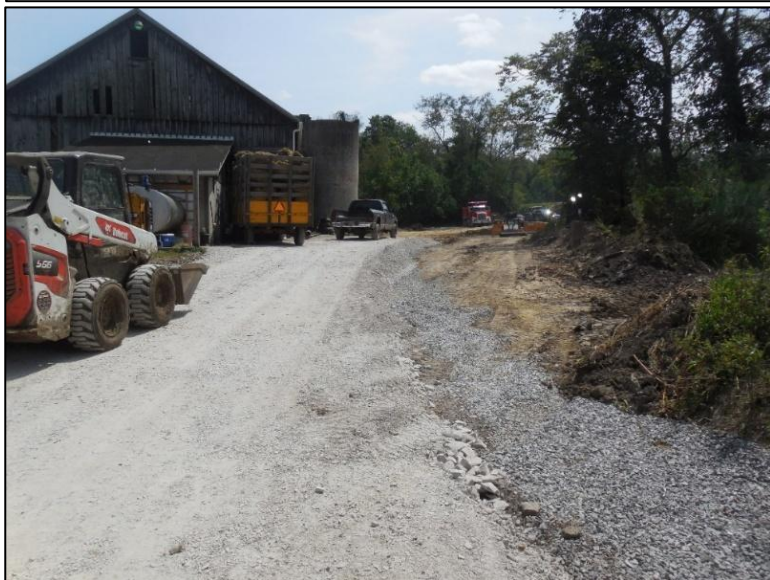
After: Farm access road stabilized with stone and subsurface drainage installed.

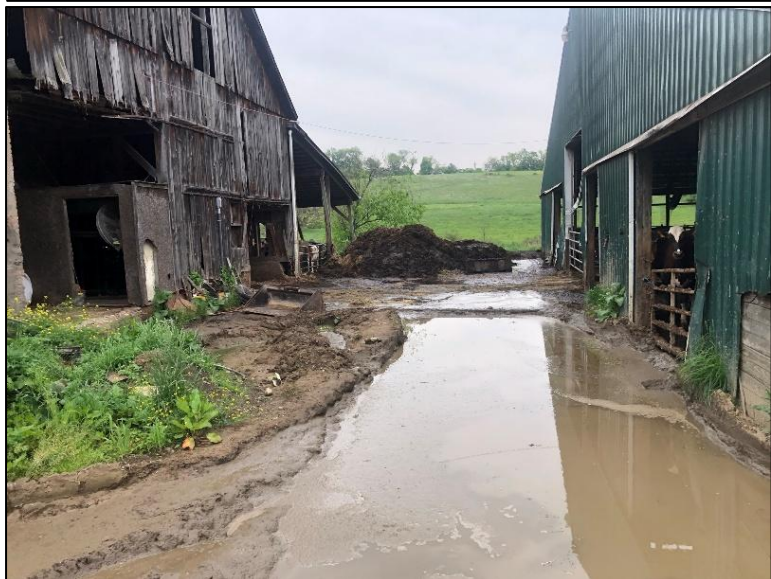
Before: Eroded heavy use area.

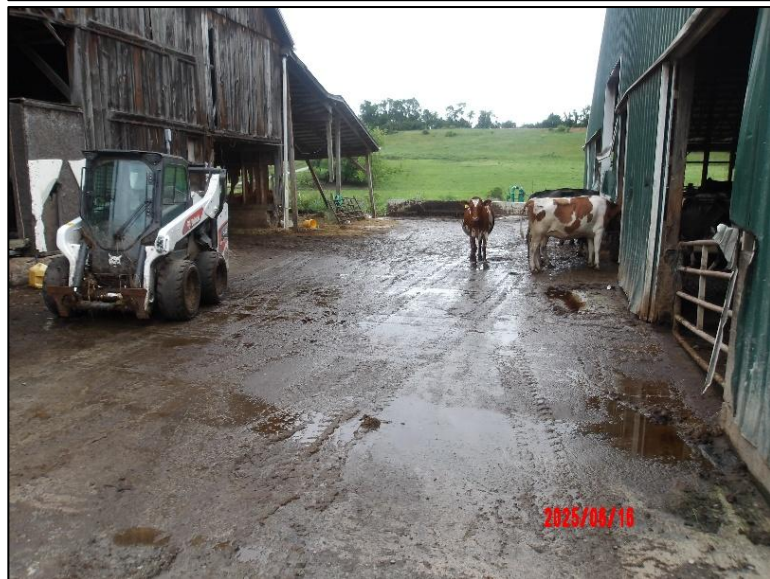
After: Installed concrete heavy use area between milking parlor and barn.
