Cedar Creek Streambank Stabilization

Location: Great Allegheny Passage at Cedar Creek Park, Rostraver Township

Client: Westmoreland Conservation District, Pennsylvania Department of Transportation (PennDOT)

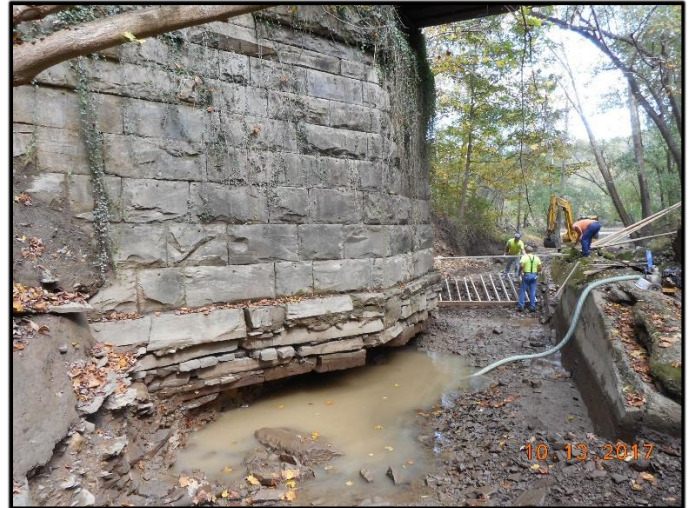
Phase 1 Before:

Crews stabilizing the eroded foundation of the bridge.

In late summer of 2017, the 30-foot-high cut-stone bridge abutment that supported the Great Allegheny Passage trail over Cedar Creek showed severe erosion. Water from an old water-wheel upstream undercut 7 feet of the foundation of the bridge resulting in an unstable support structure.

The Westmoreland Conservation District acted swiftly to obtain permits, design, issue construction bids, and identify a construction firm to repair the bridge using over 120 yards of concrete to build up the foundation and provide streambank stabilization. Funds were acquired through the Regional Trail Corporation.

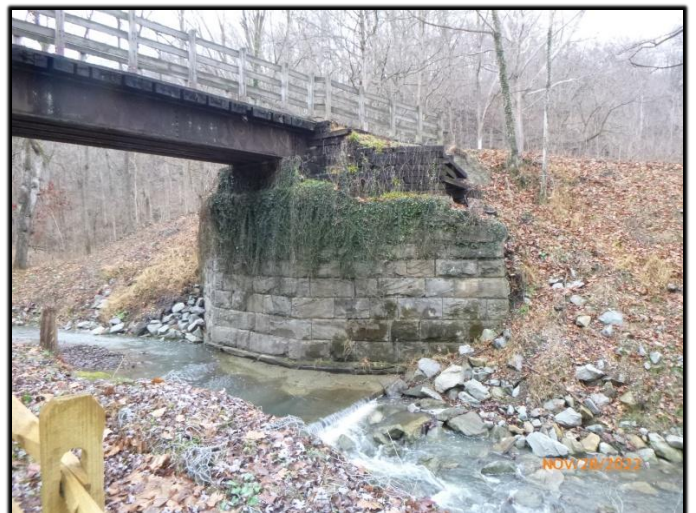
Phase 1 After:

Concrete added stability to bridge foundation to minimize future erosion.

Phase 1 stabilized the stone pedestrian bridge abutment over Cedar Creek in an emergency effort. The bridge foundation was restored and re-opened to the public.

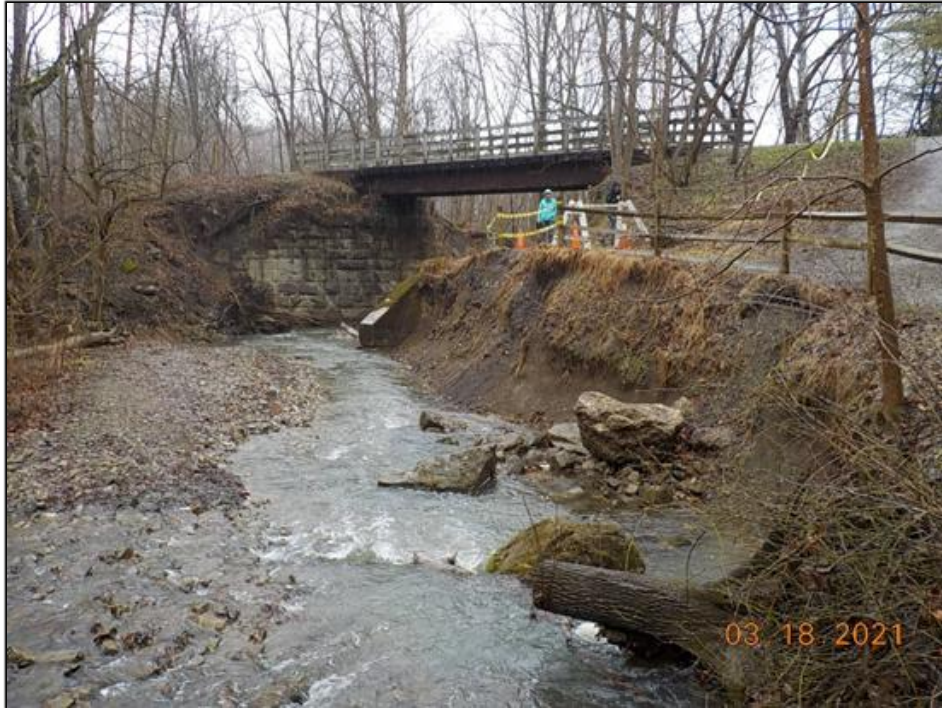
Phase 2A Before:

Streambank erosion threatening the existing walking trail.

Phase 2A stabilized over 900 feet of eroding streambank from the confluence of the Youghiogheny River upstream to a pedestrian bridge that crosses over to other trails in Cedar Creek Park.

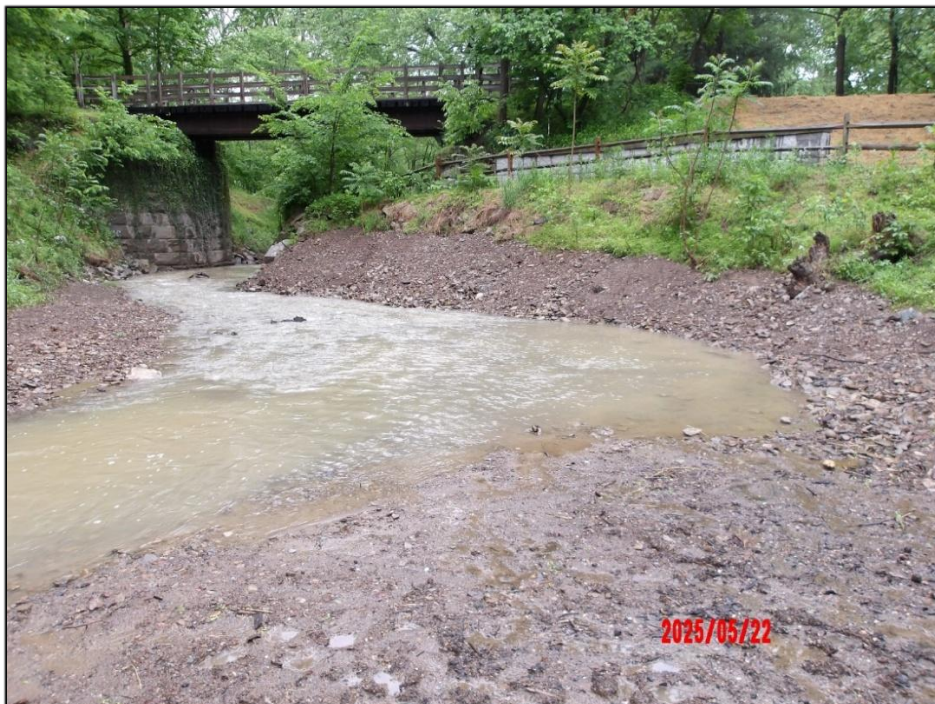
Phase 2A After:

Streambank is stabilized with the riparian buffer and mud-sills.

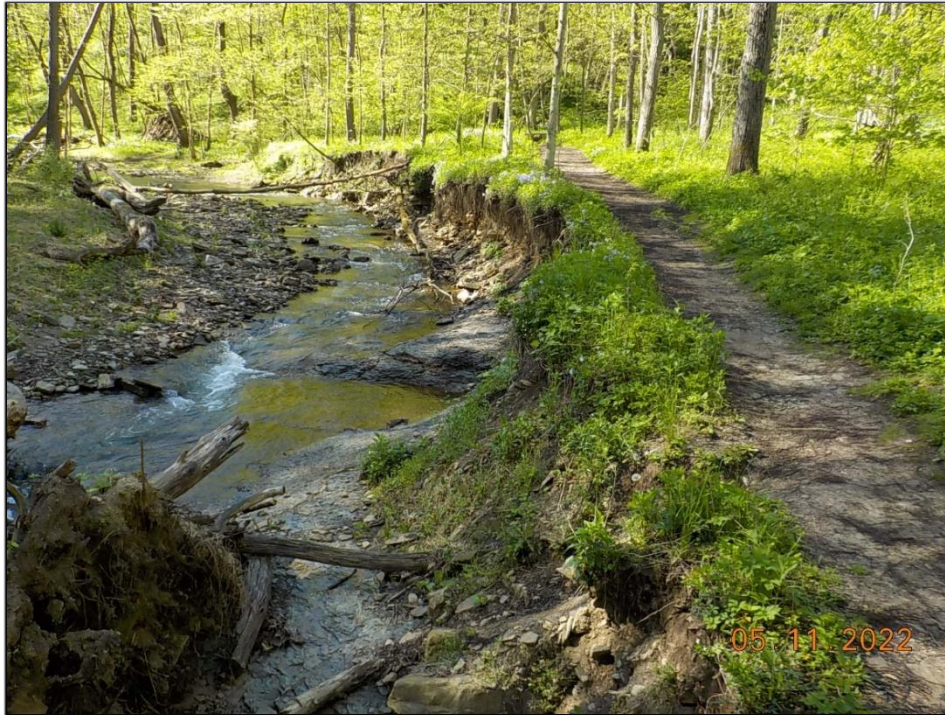
Phase 2B Before:

Walking trail alongside the creek showed erosion.

Phase 2B completed approximately 1800 feet of stream mitigation. This restored public access to the park's internal trail parallel to Cedar Creek. Additionally, approximately 2100 linear feet of trail was restored.

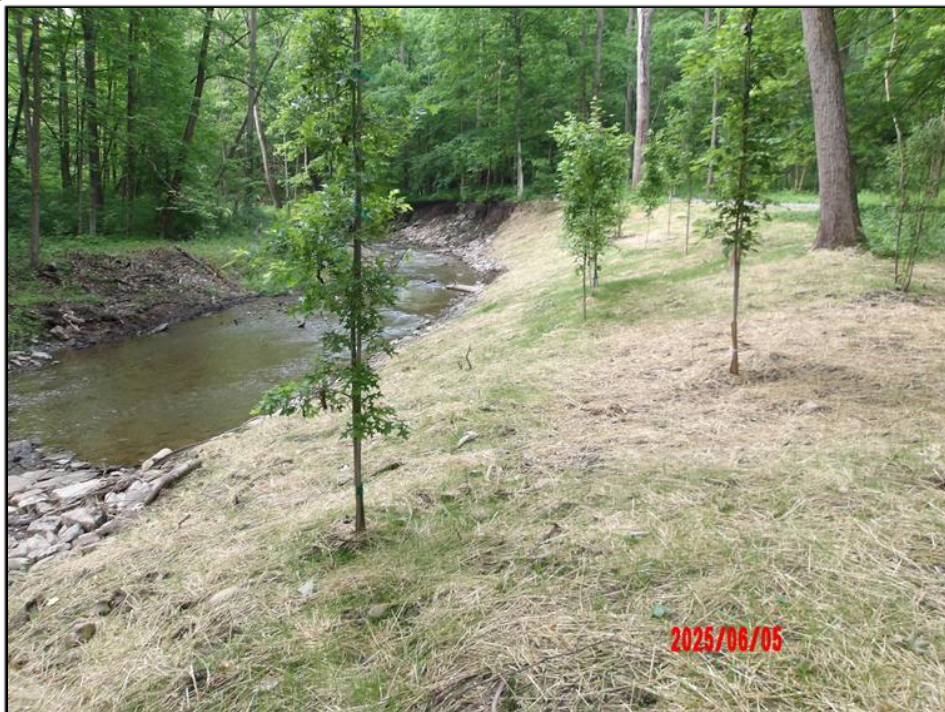
Phase 2B After:

Streambank finished with riparian buffer and grass seed.
