Environmentally Sensitive Maintenance for Dirt, Gravel, and Low-Volume Roads

Stream Crossings

Road/Stream Crossings

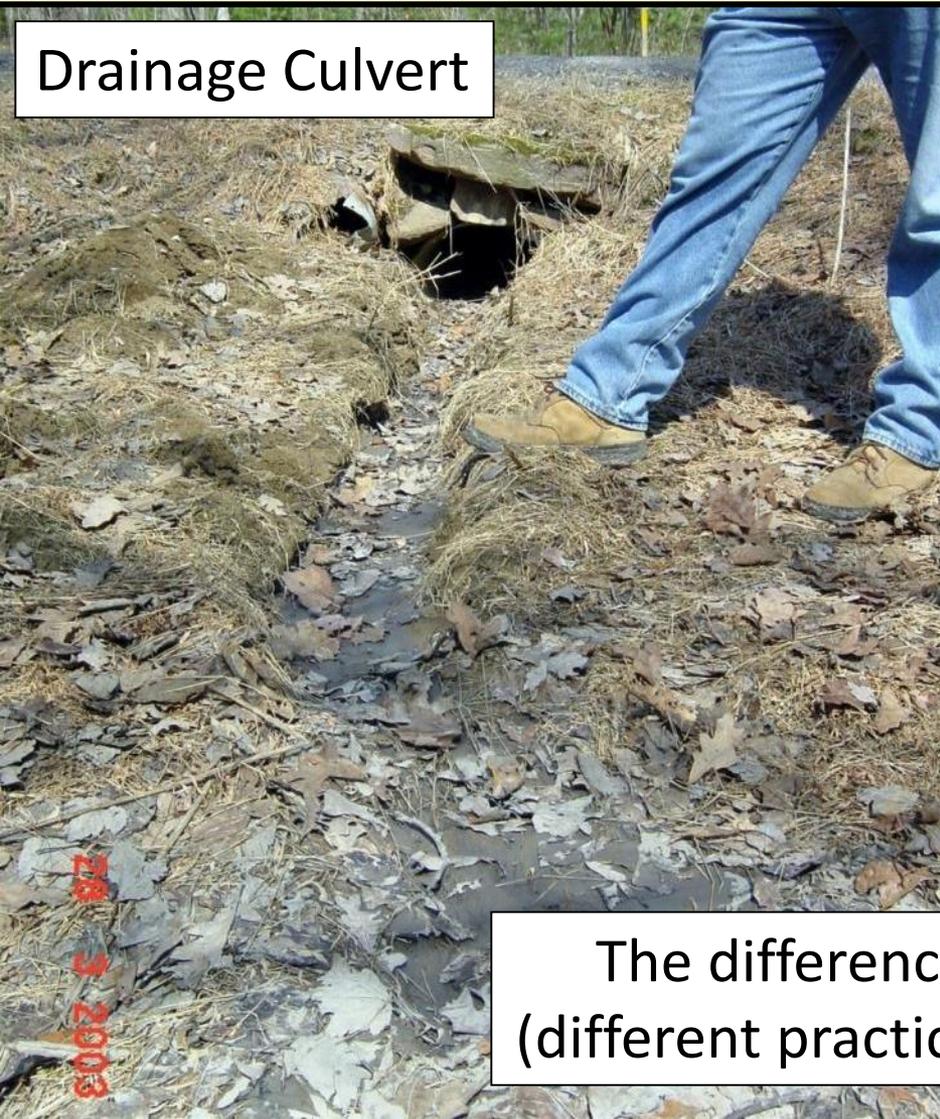
Drainage Culvert

This section deals with STREAMS, not drainage.

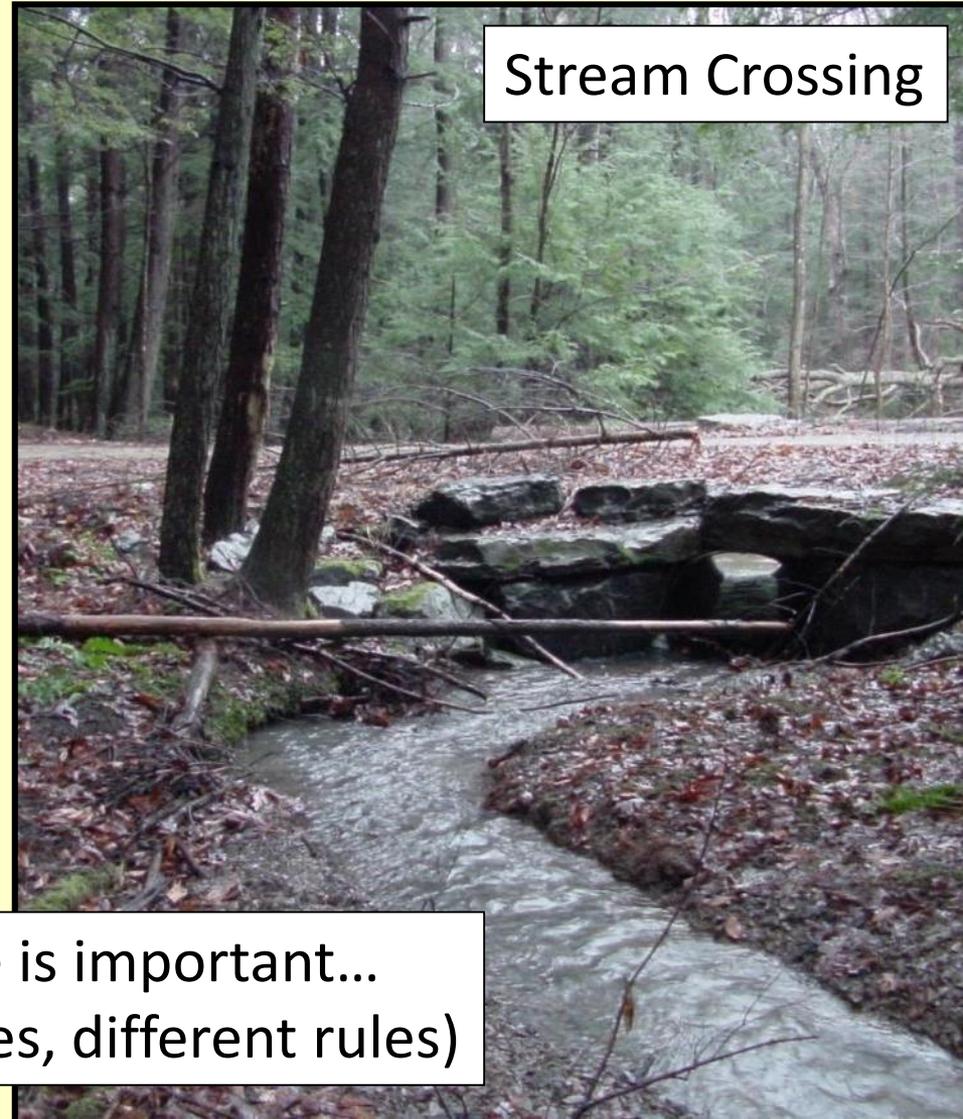
Stream Crossing

The difference is important...
(different practices, different rules)

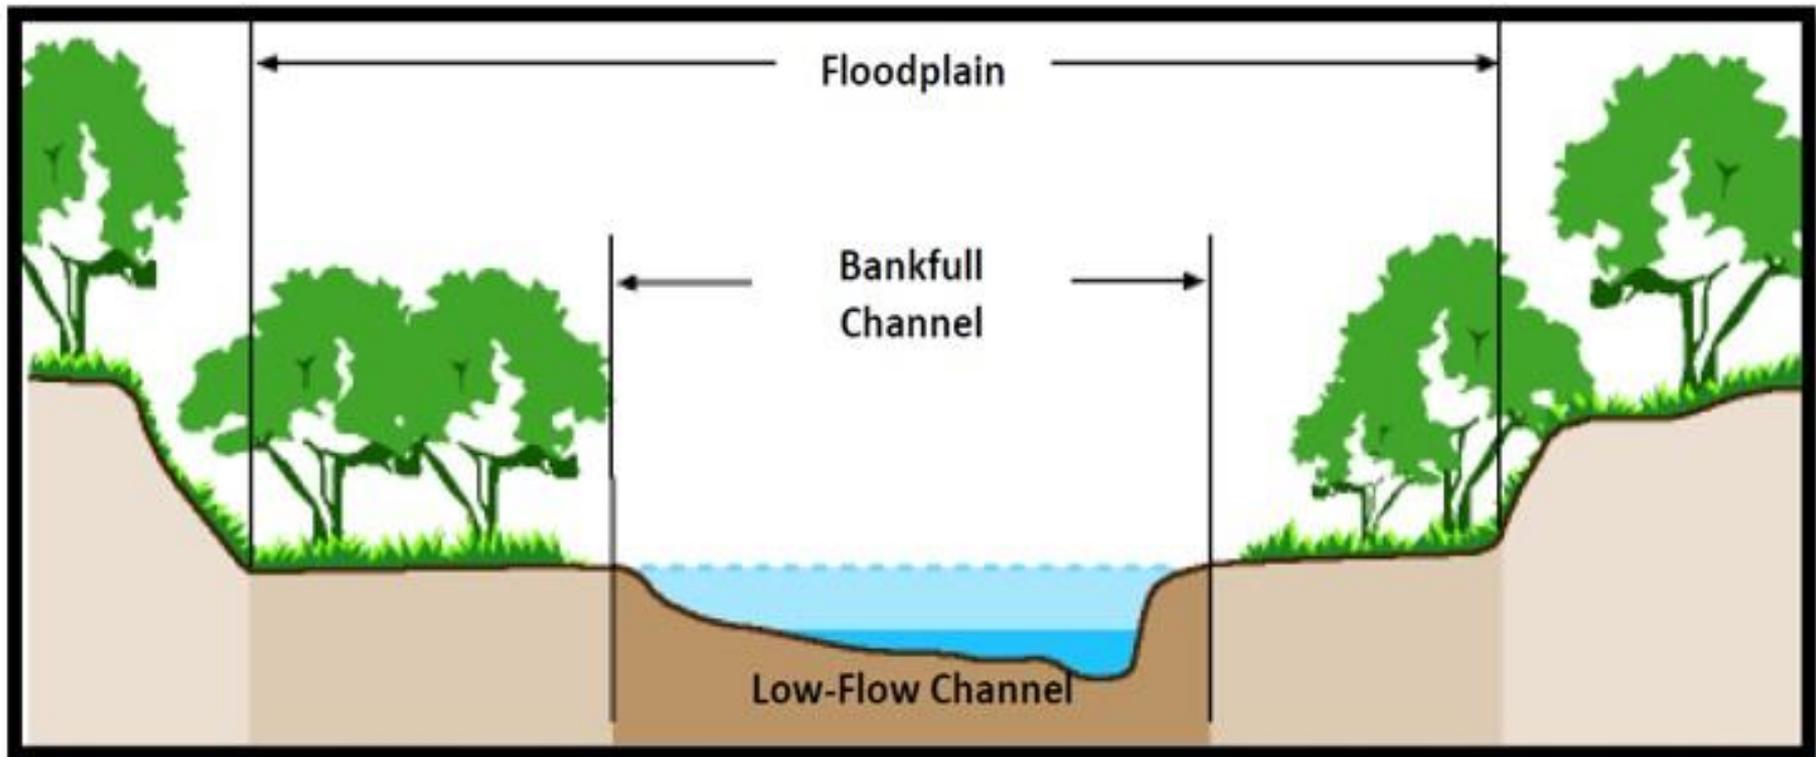
Channel Shape:

- **Bankfull Width:** Width of stream channel just before water reaches its floodplain
- This level of flow defines common stream features (shape, slope, streambed material)

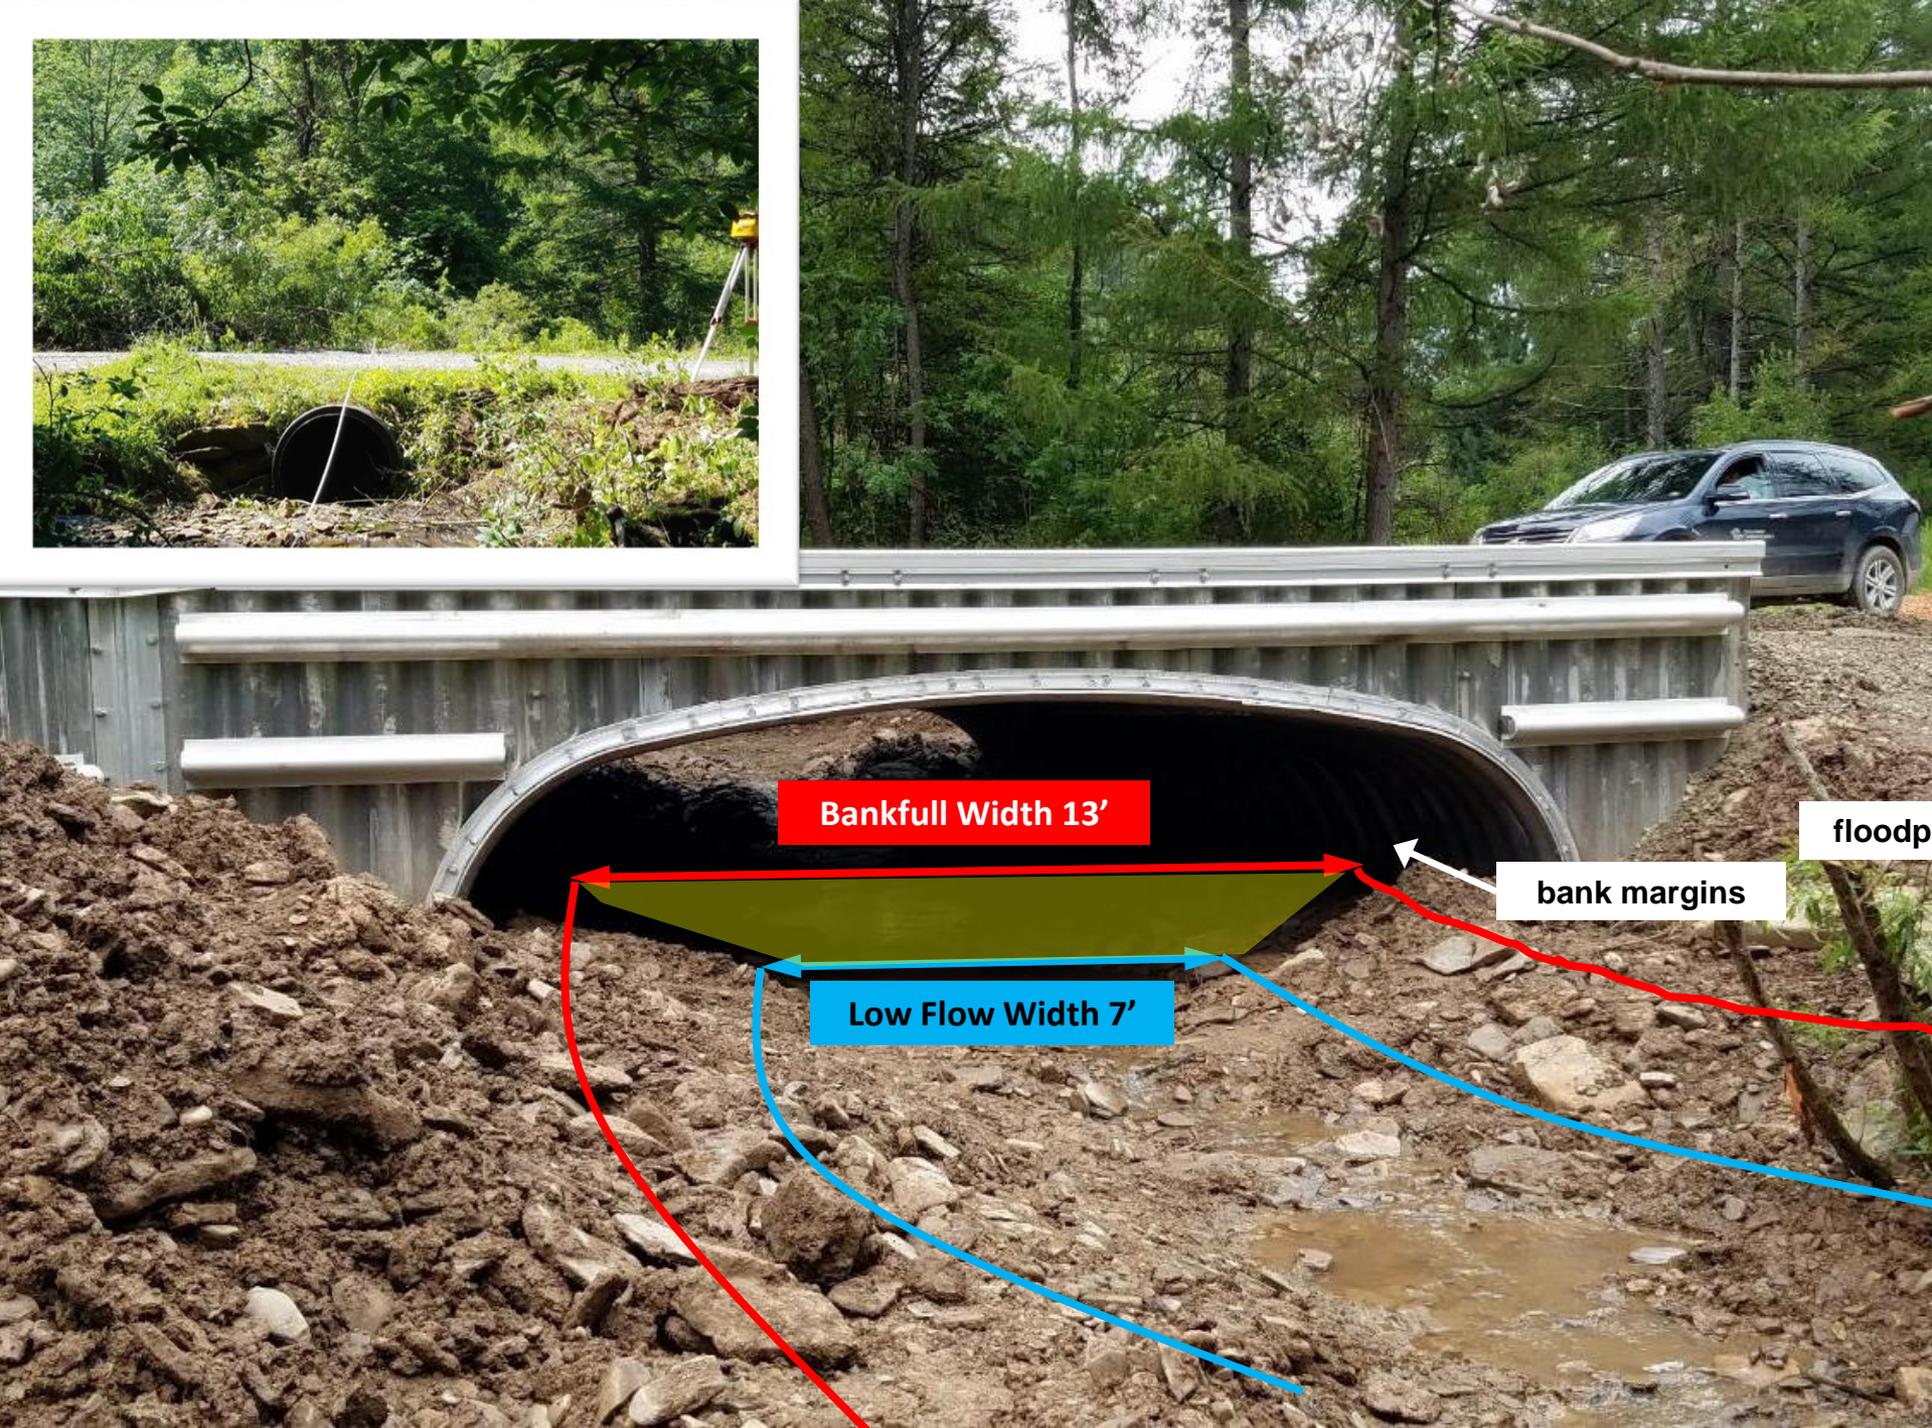
Bankfull width and the low-flow channel will become the “foundation” for how the stream would be built through a DGLVR funded replacement structure...

Bankfull Width 13'

Low Flow Width 7'

bank margins

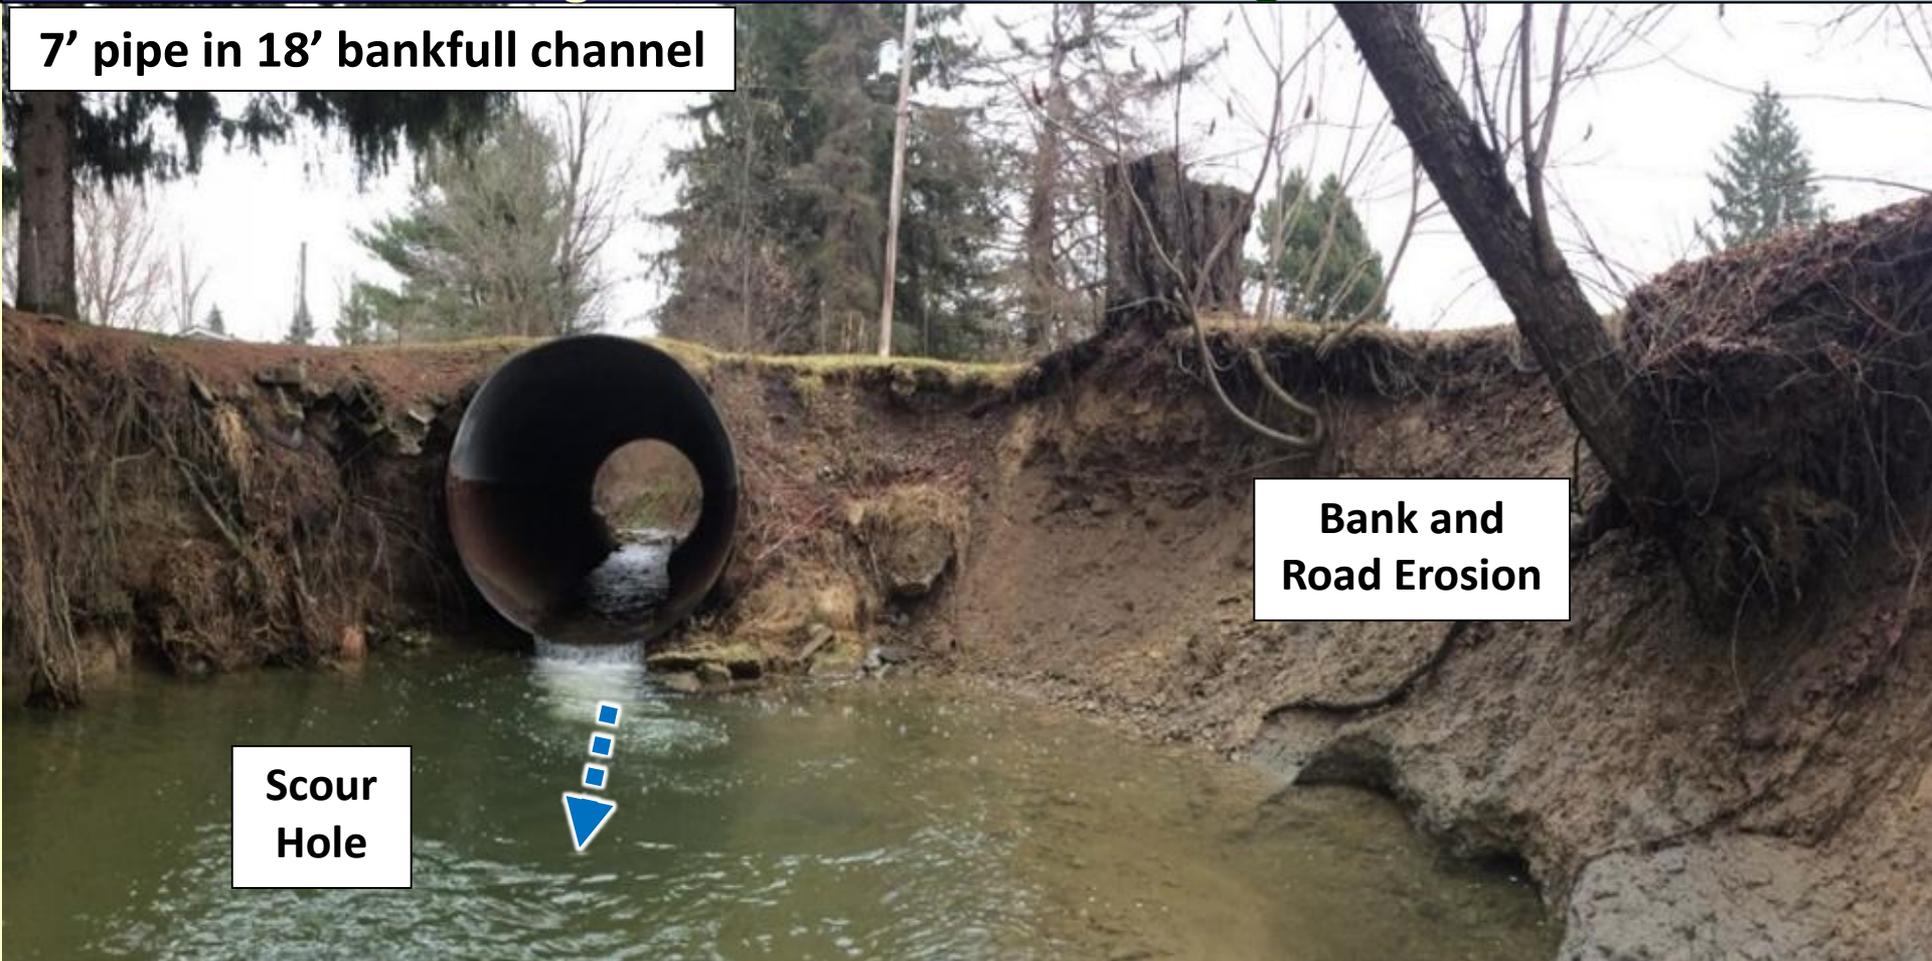
7' pipe in 18' bankfull channel

Scour
Hole

Bank and
Road Erosion

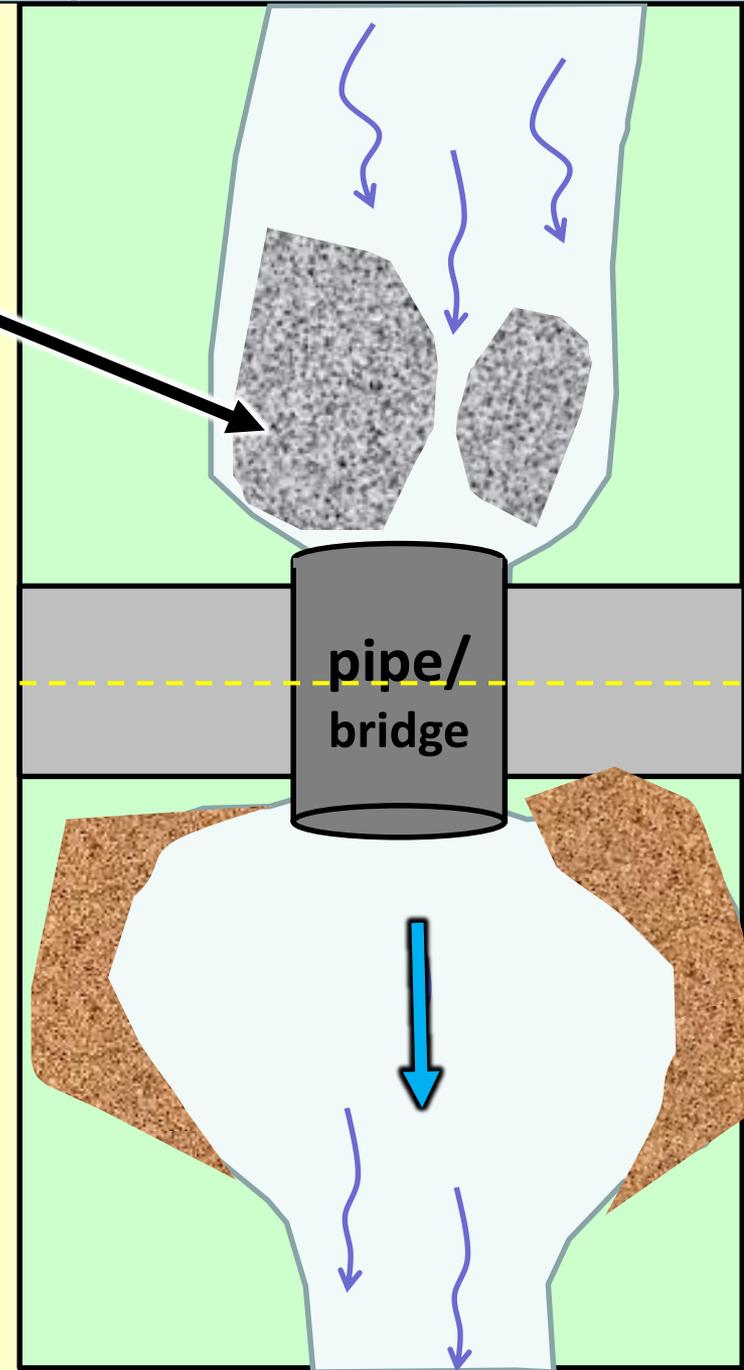
Upstream issues

- **Gravel bar formation**
 - Stream widens / meanders
 - Capacity reduced
 - Increased flooding / washouts
 - **More maintenance!**

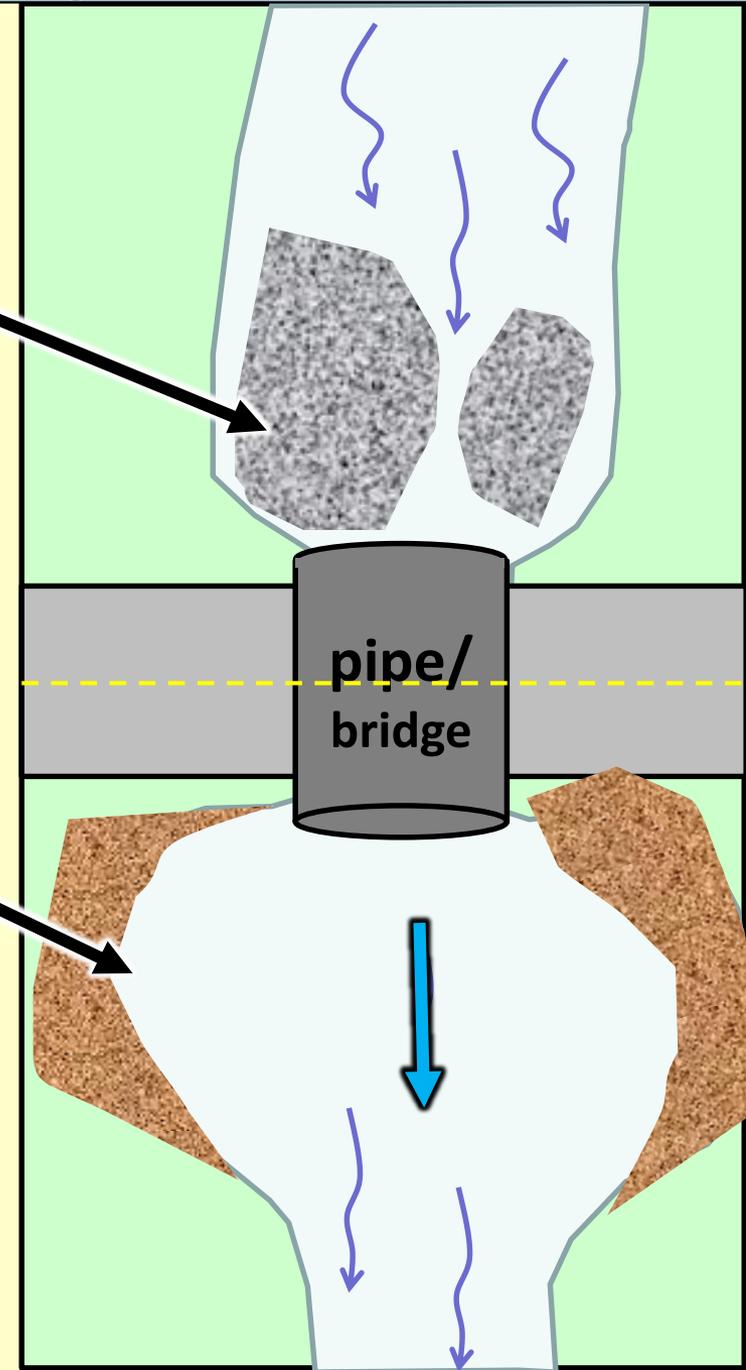
Downstream issues

- **Erosion of bed and banks** (Firehose effect)
 - Stream widens
 - Waterfall at outlet
 - Bank failure
 - Structure undermined
 - **LOTS of sediment made!**

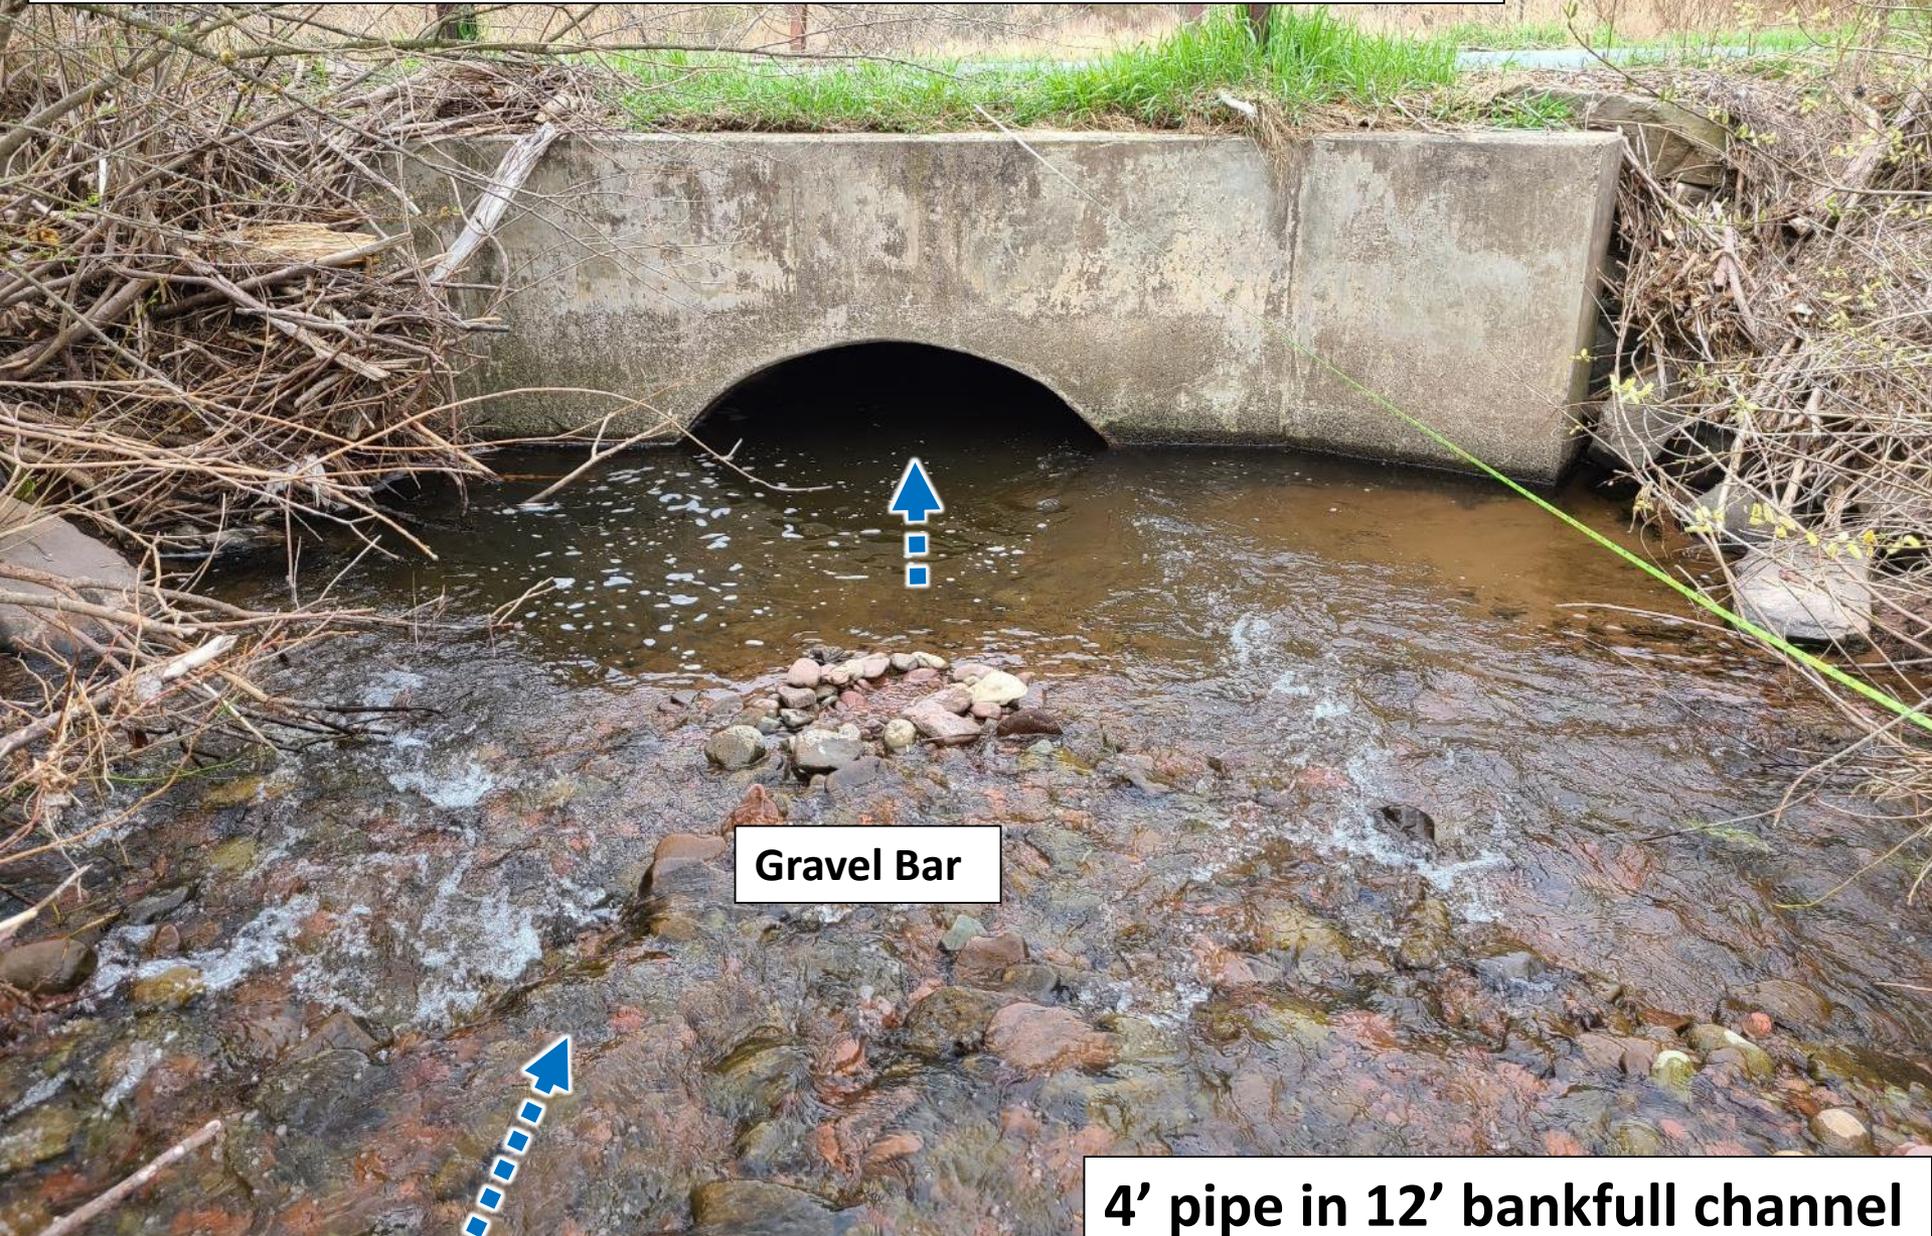
Undersized Structures = Gravel Bars

Gravel Bar

4' pipe in 12' bankfull channel

Undersized pipe caused this sediment bar – which causes stream to meander

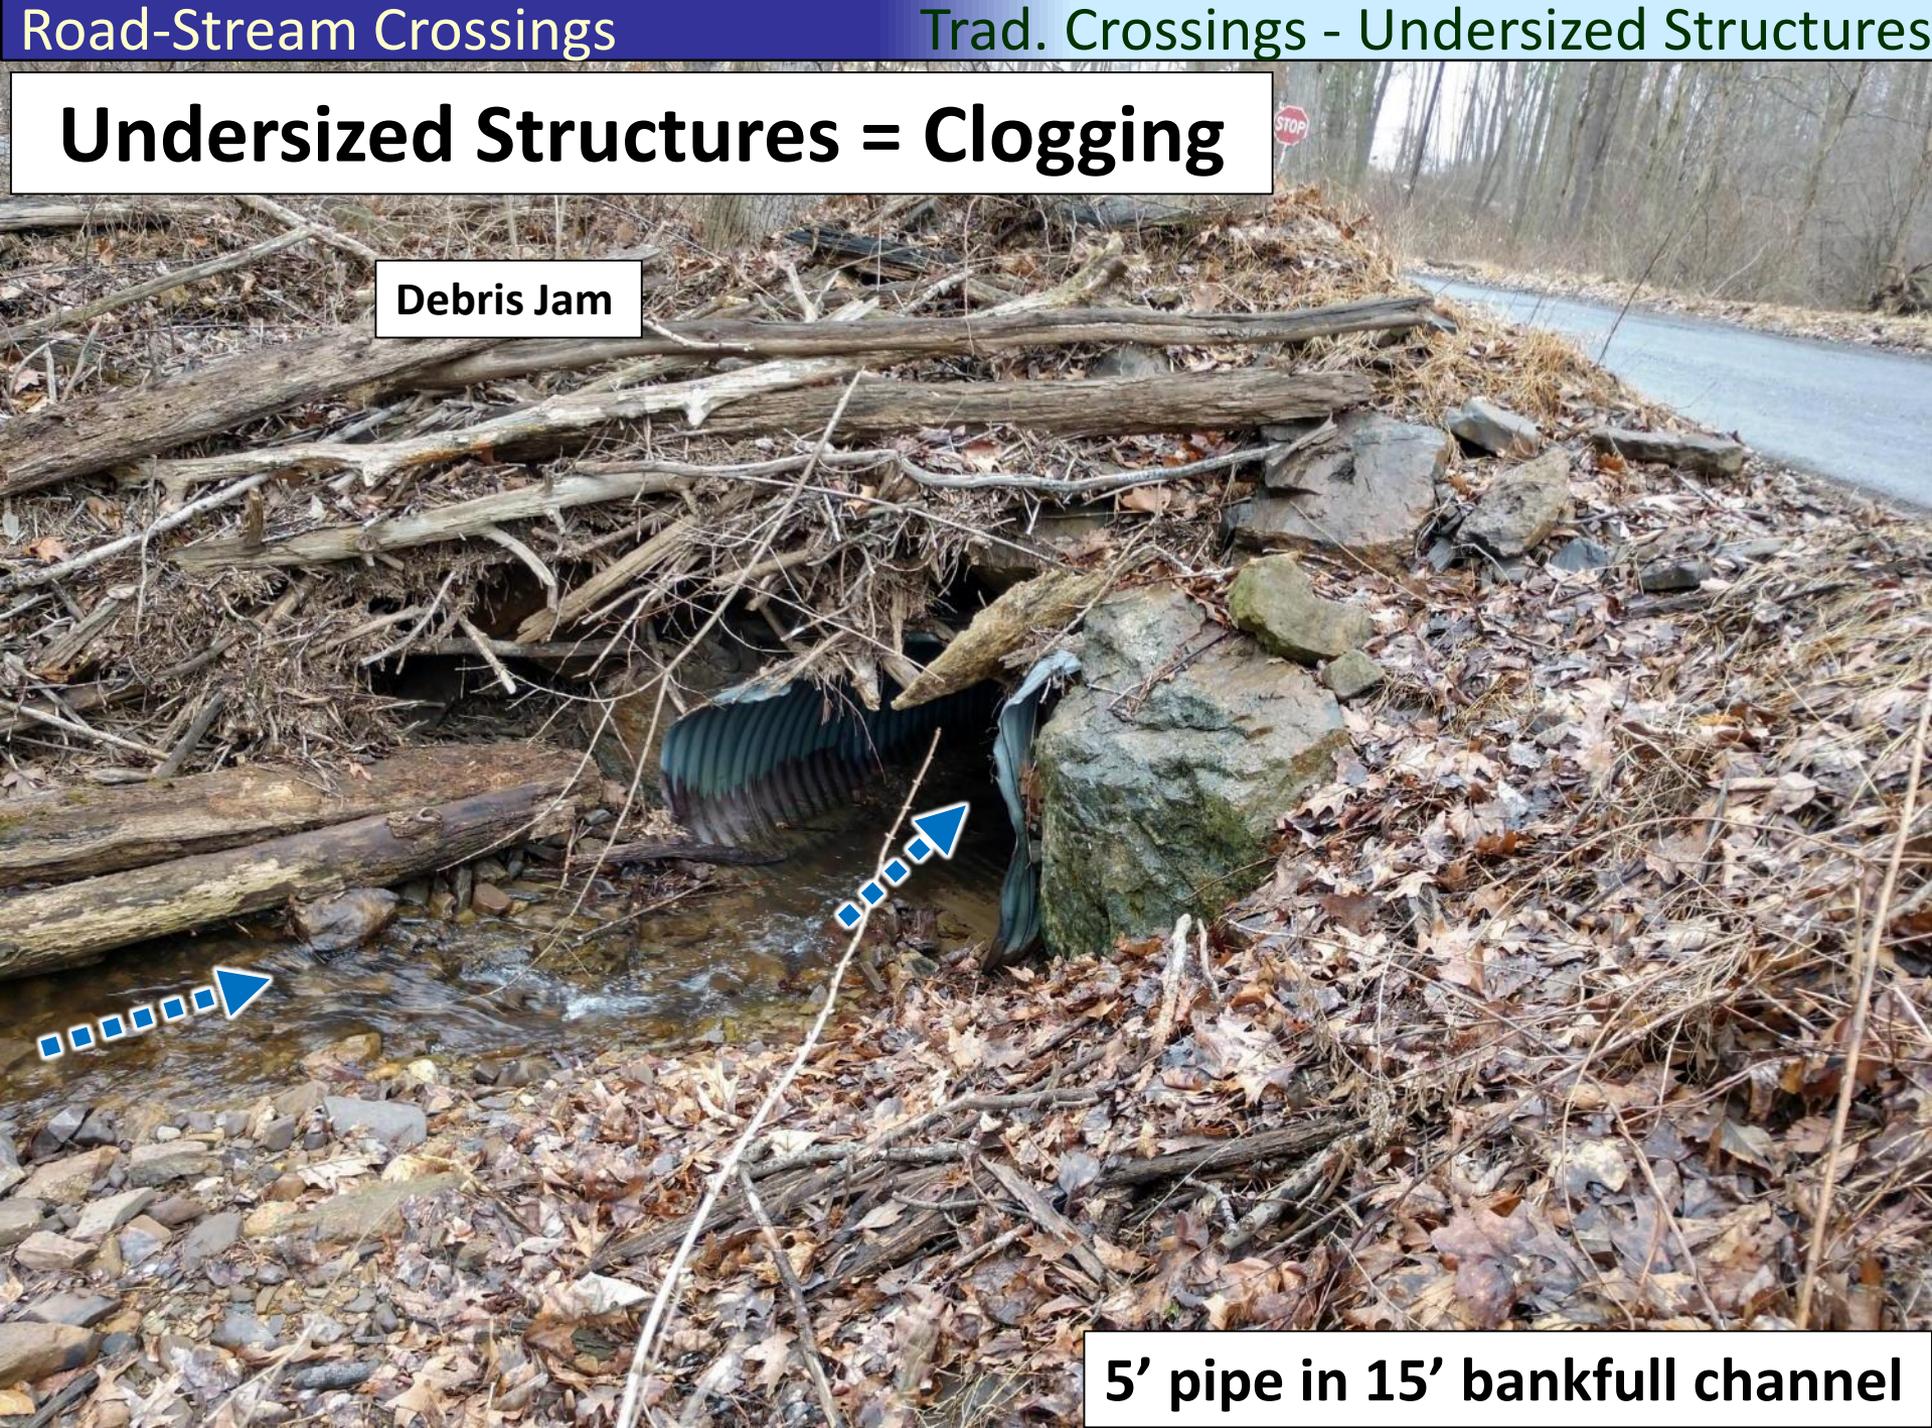
Undersized Structures = Clogging

Debris Jam

5' pipe in 15' bankfull channel

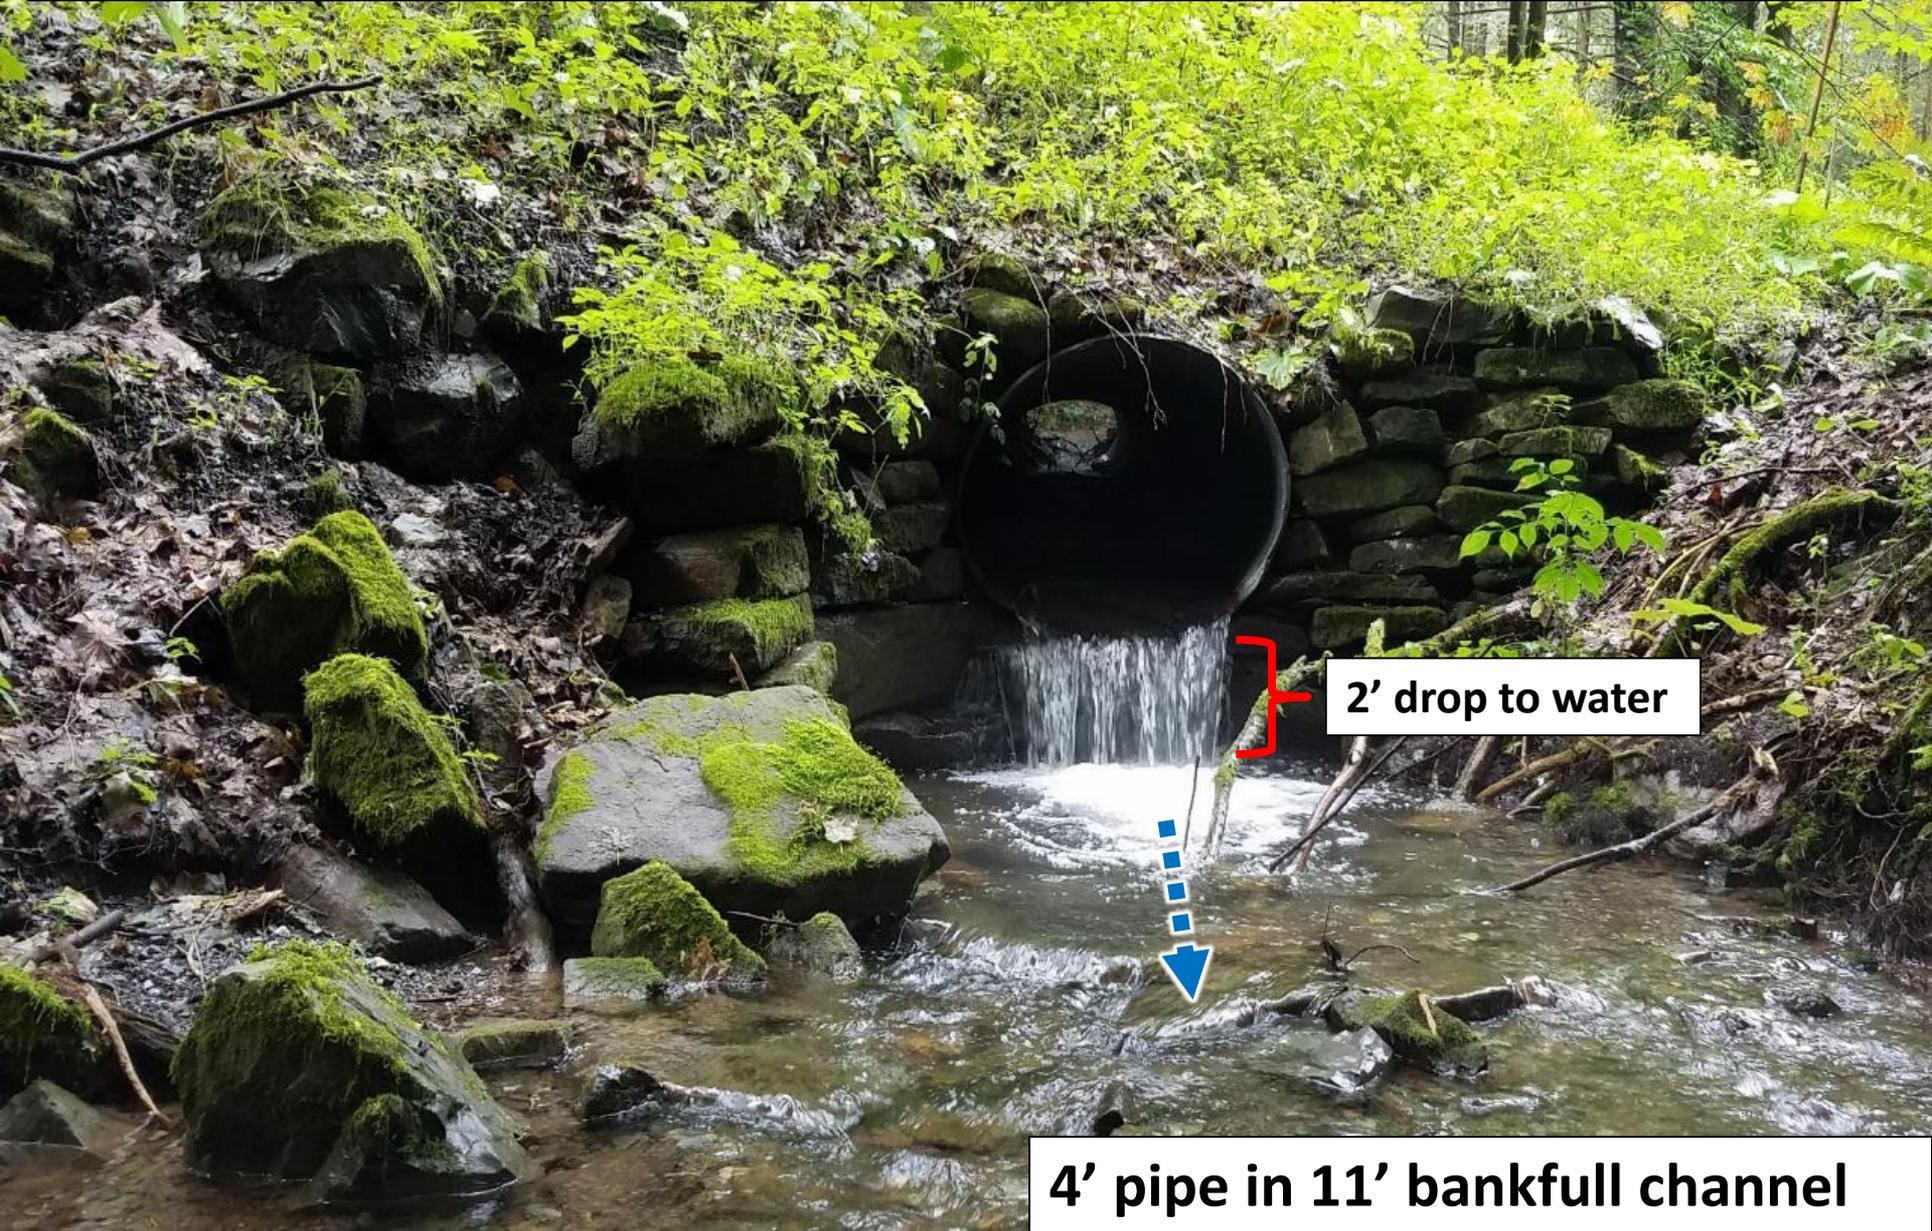
Undersized Structures = Erosion + Aquatic Barrier

2' drop to water

4' pipe in 11' bankfull channel

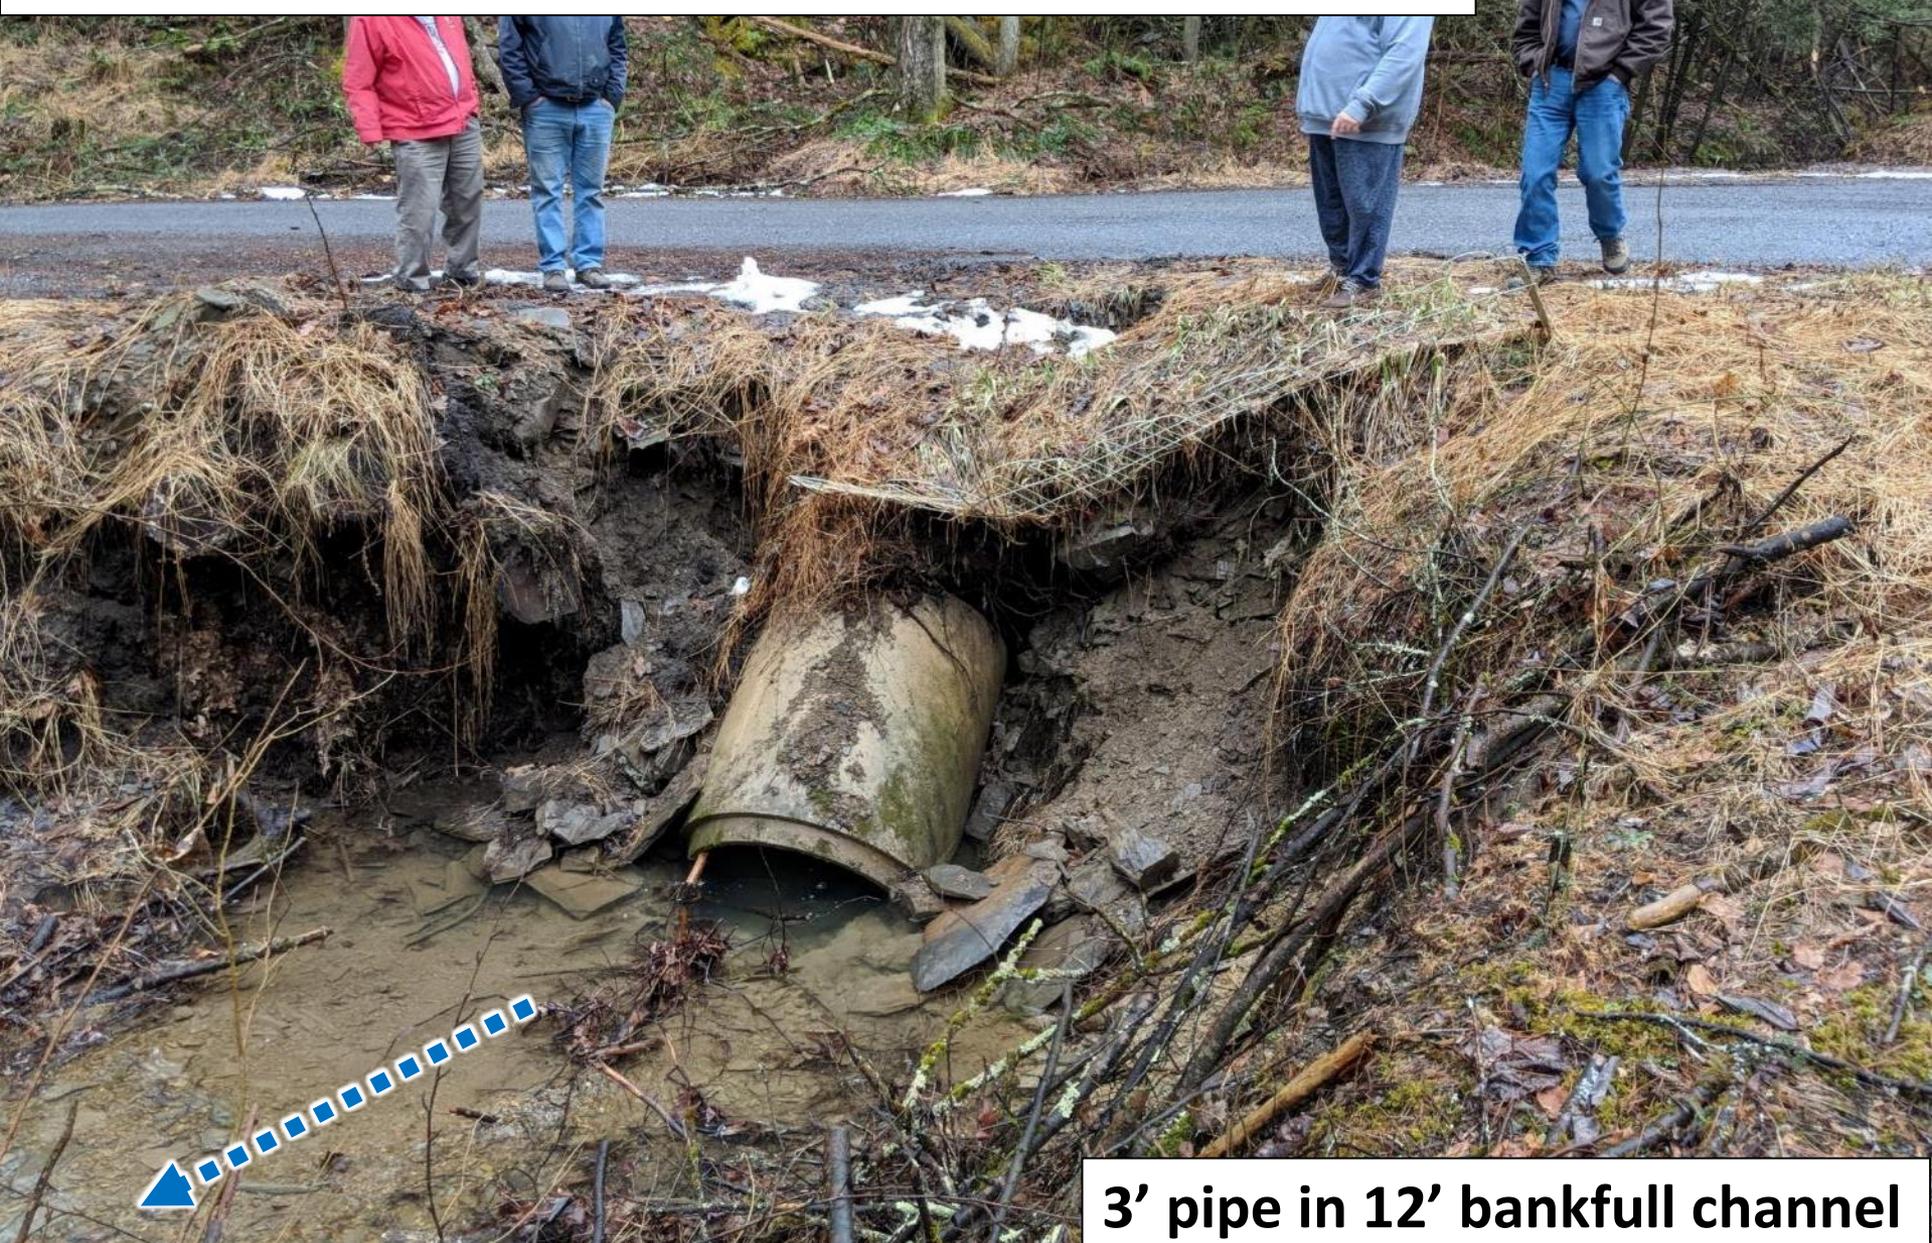
Undersized Structures = Pipe Washout

3' pipe in 12' bankfull channel

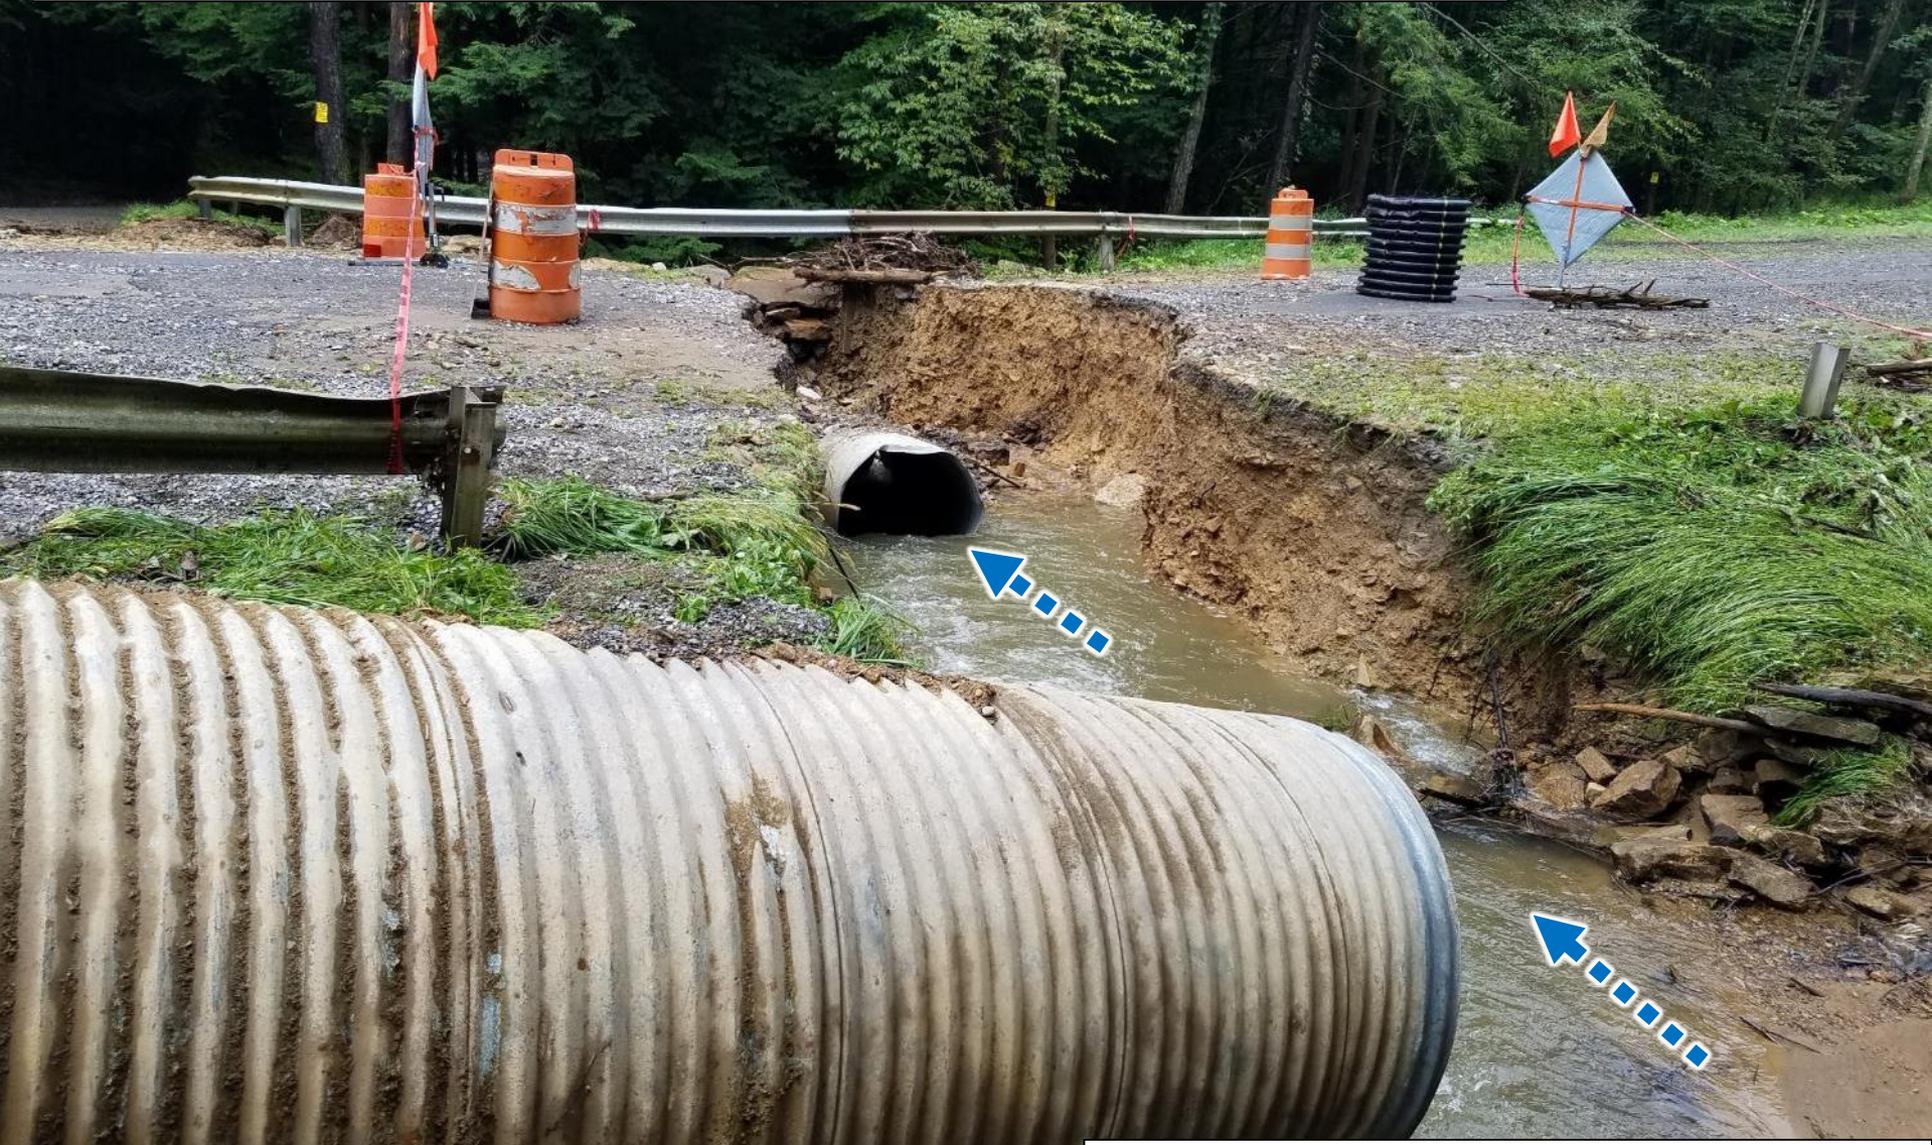
Undersized Structures = Road Washout

5' pipe in 16' bankfull channel
