Environmentally Sensitive Maintenance for Dirt, Gravel, and Low-Volume Roads

Stream Crossings

Road/Stream Crossings

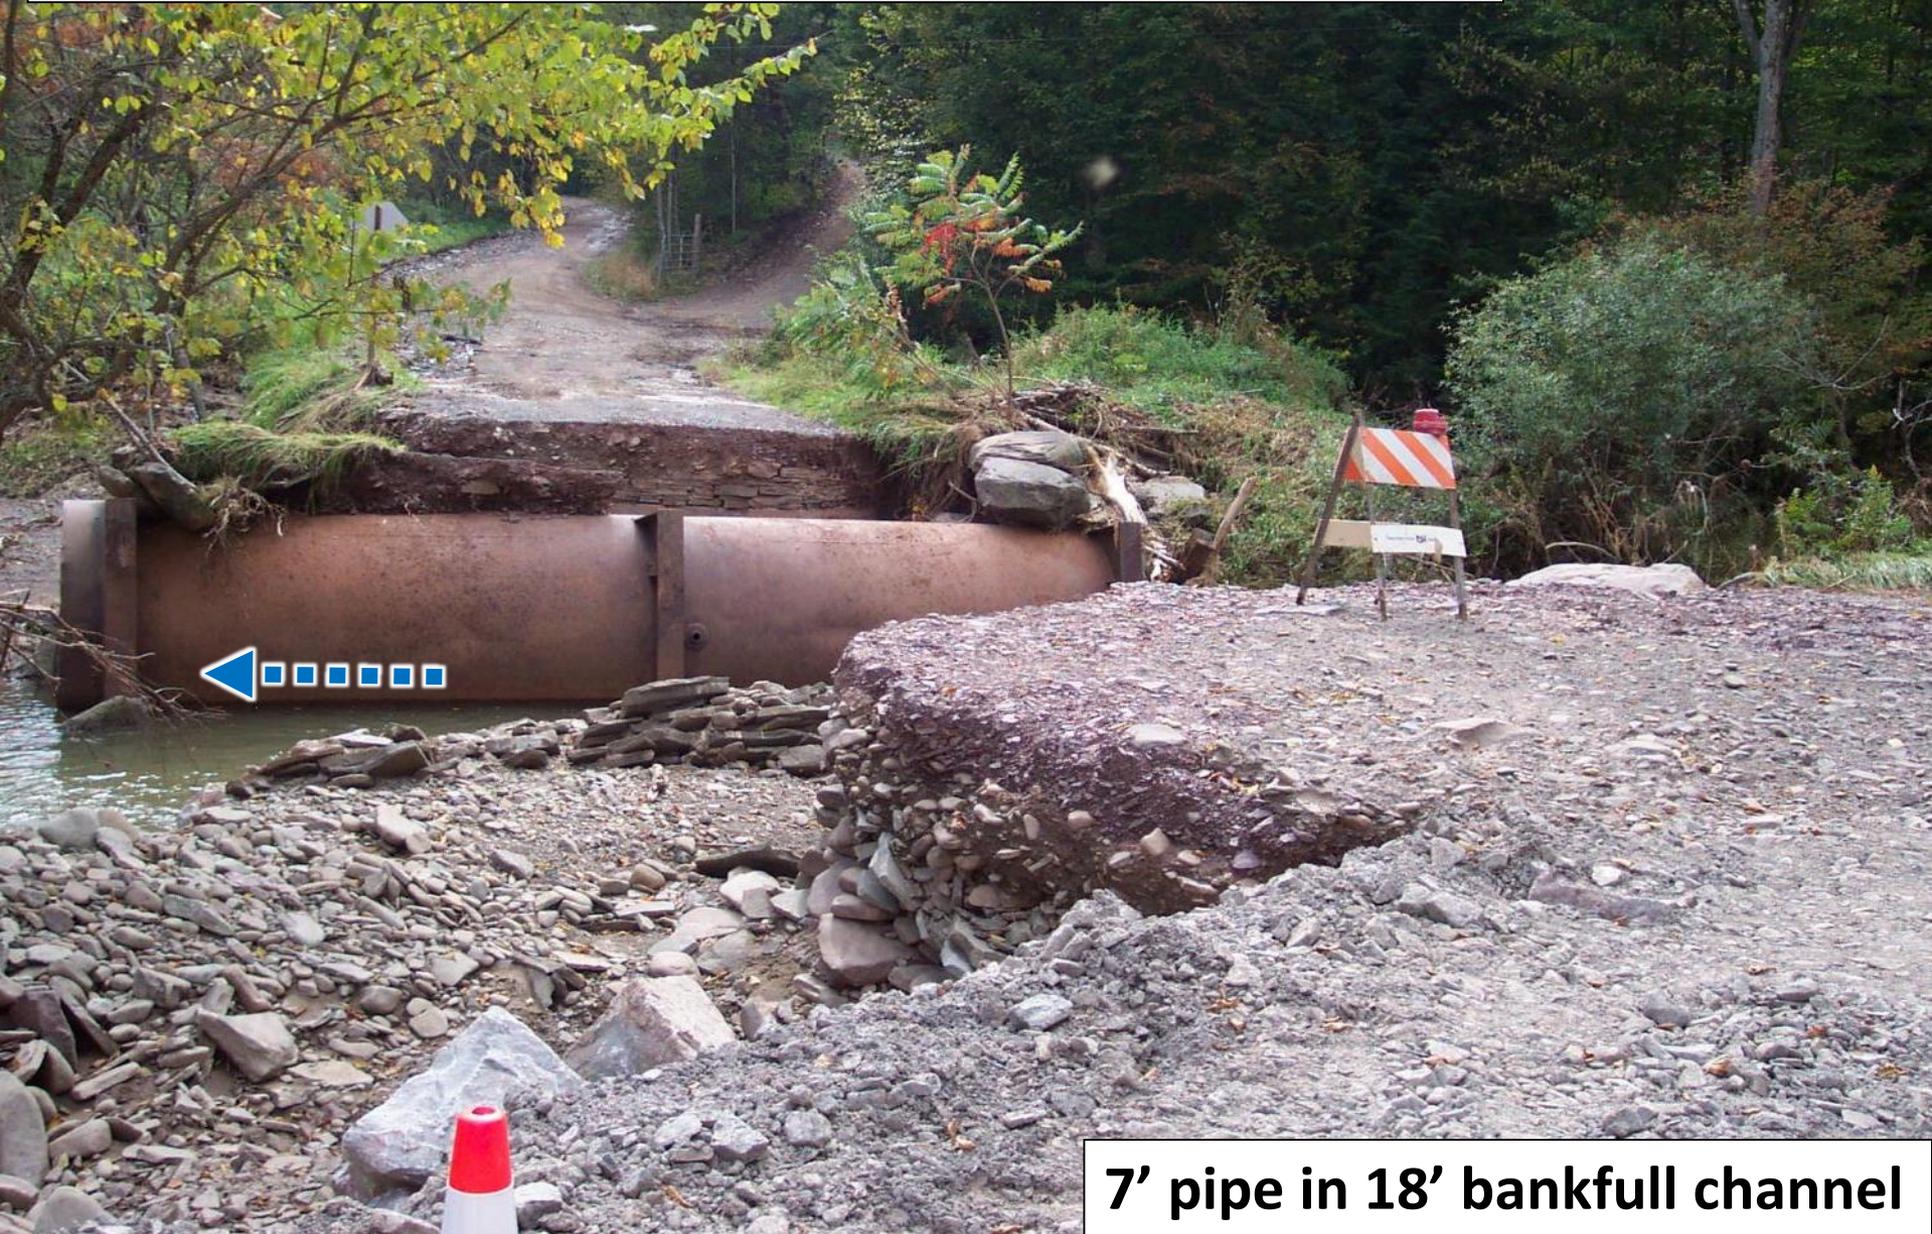
Undersized Structures = Road Washout

7' pipe in 18' bankfull channel

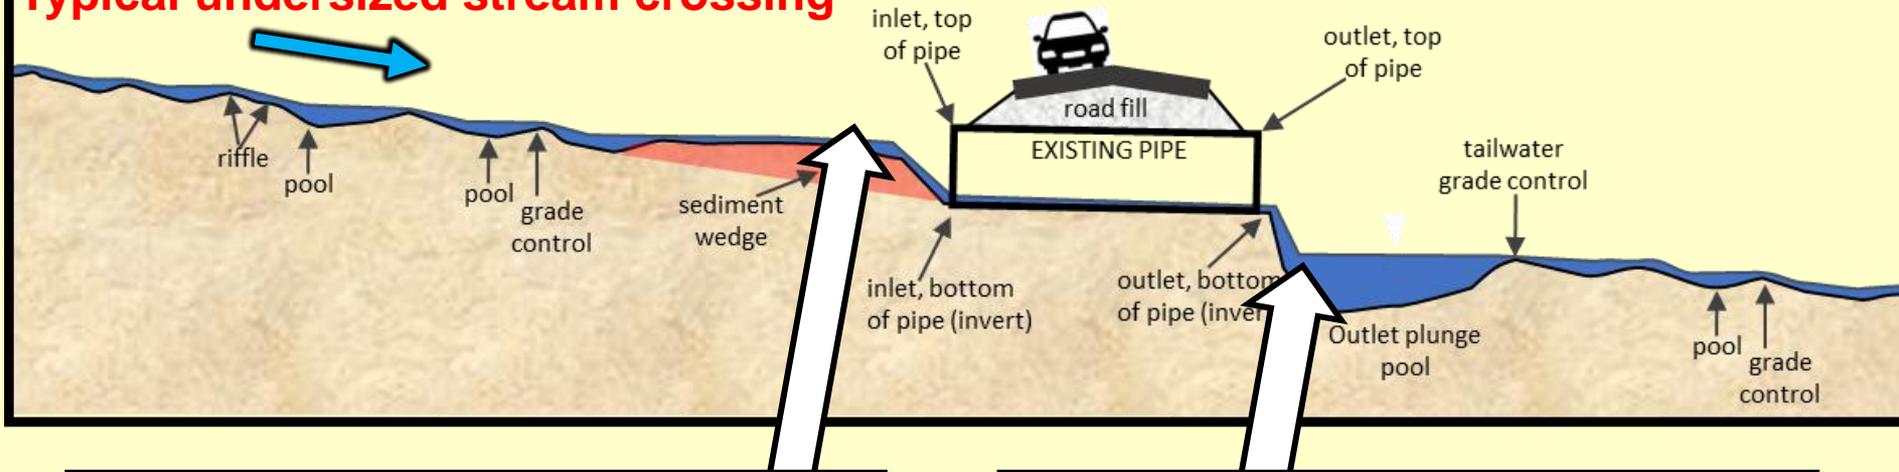
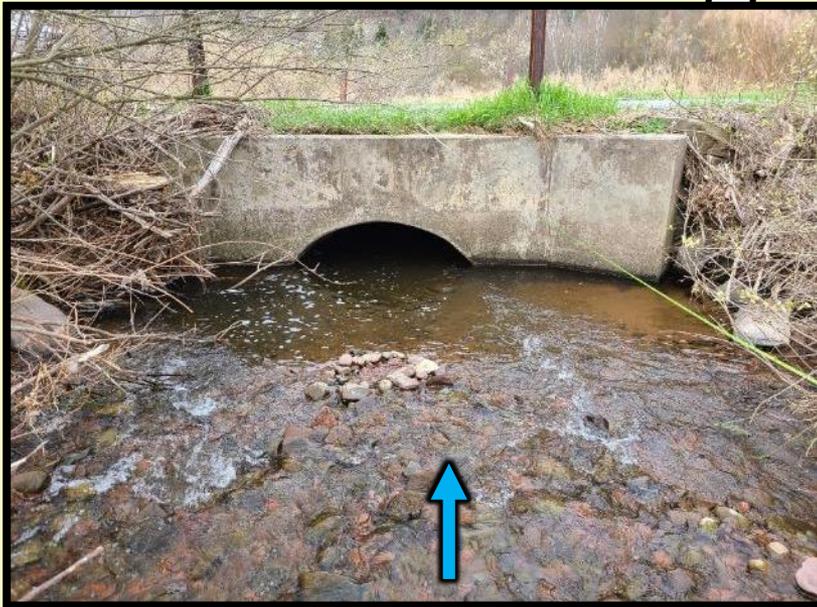
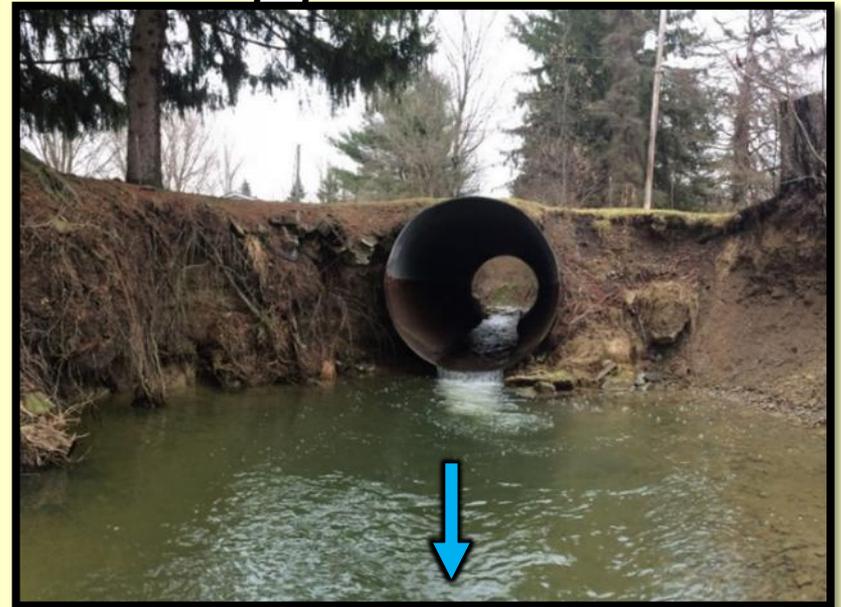
Typical undersized stream crossing

Trap sediment/debris upstream + Scour/undermine banks downstream

= Less capacity

= more flooding

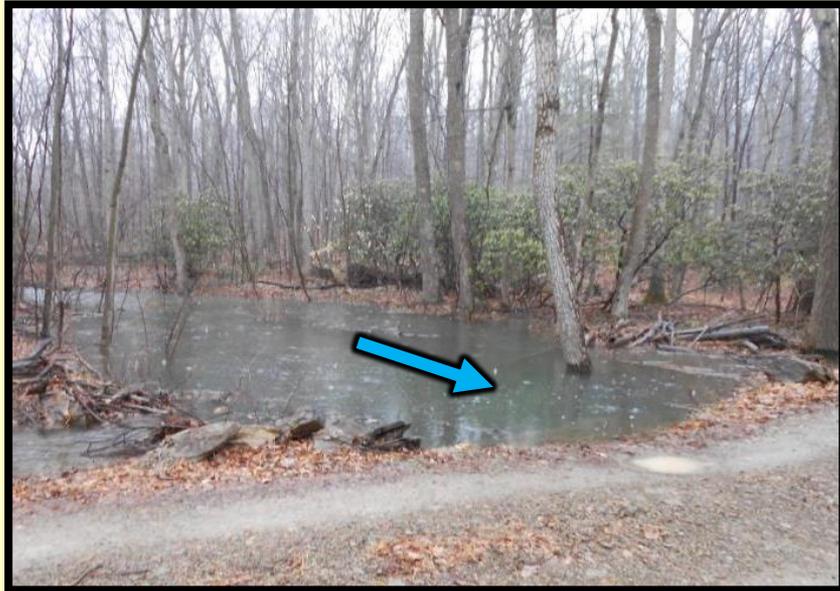
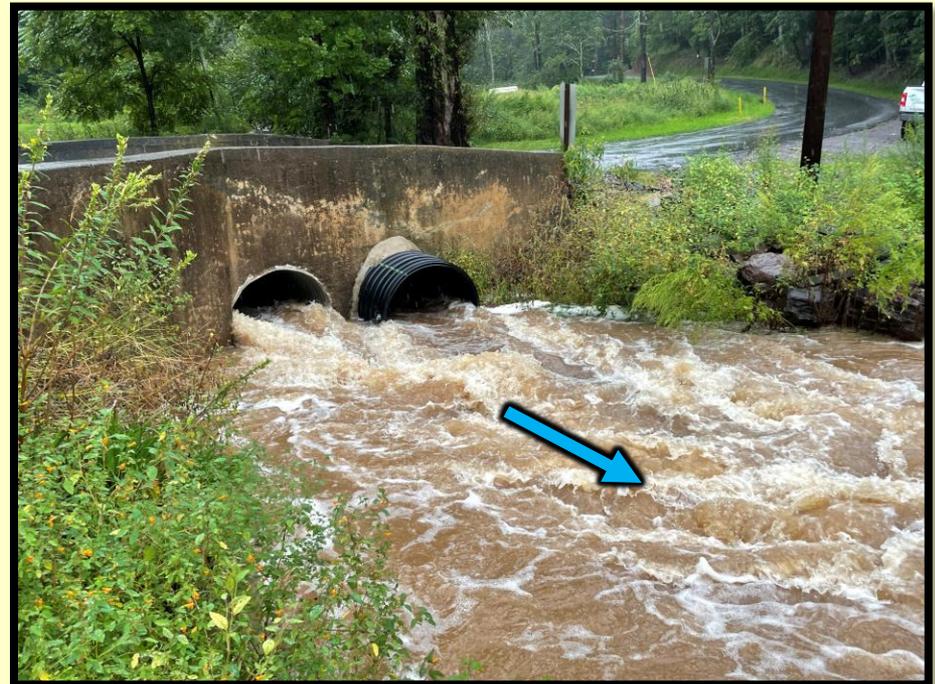
What happens during High flows?

~1-year storm

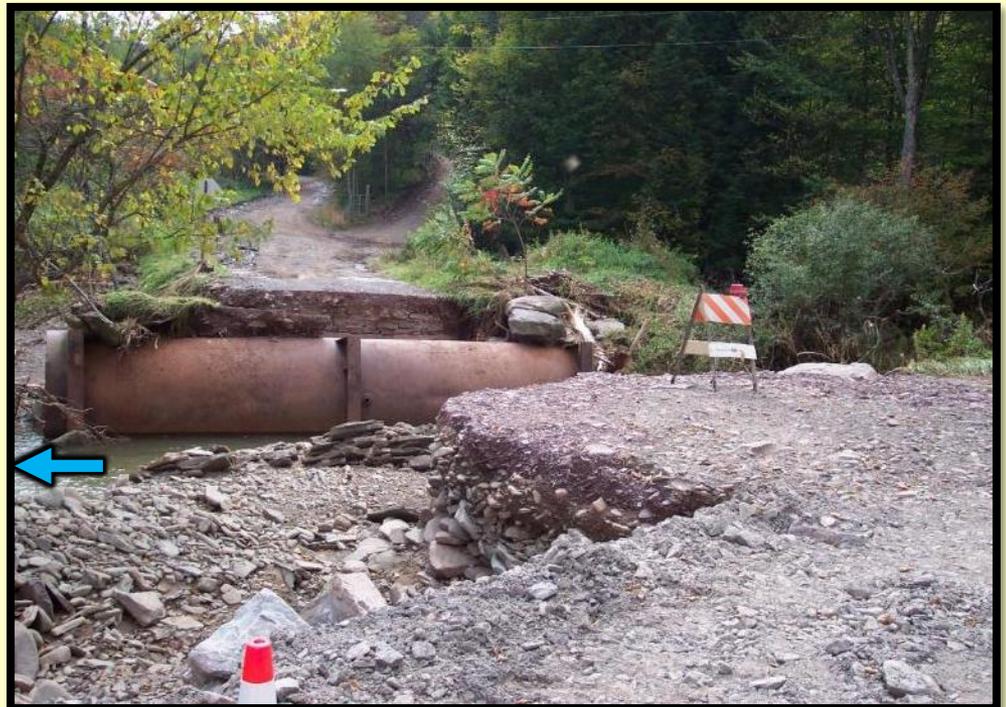
What happens during High flows?

~10-year storm

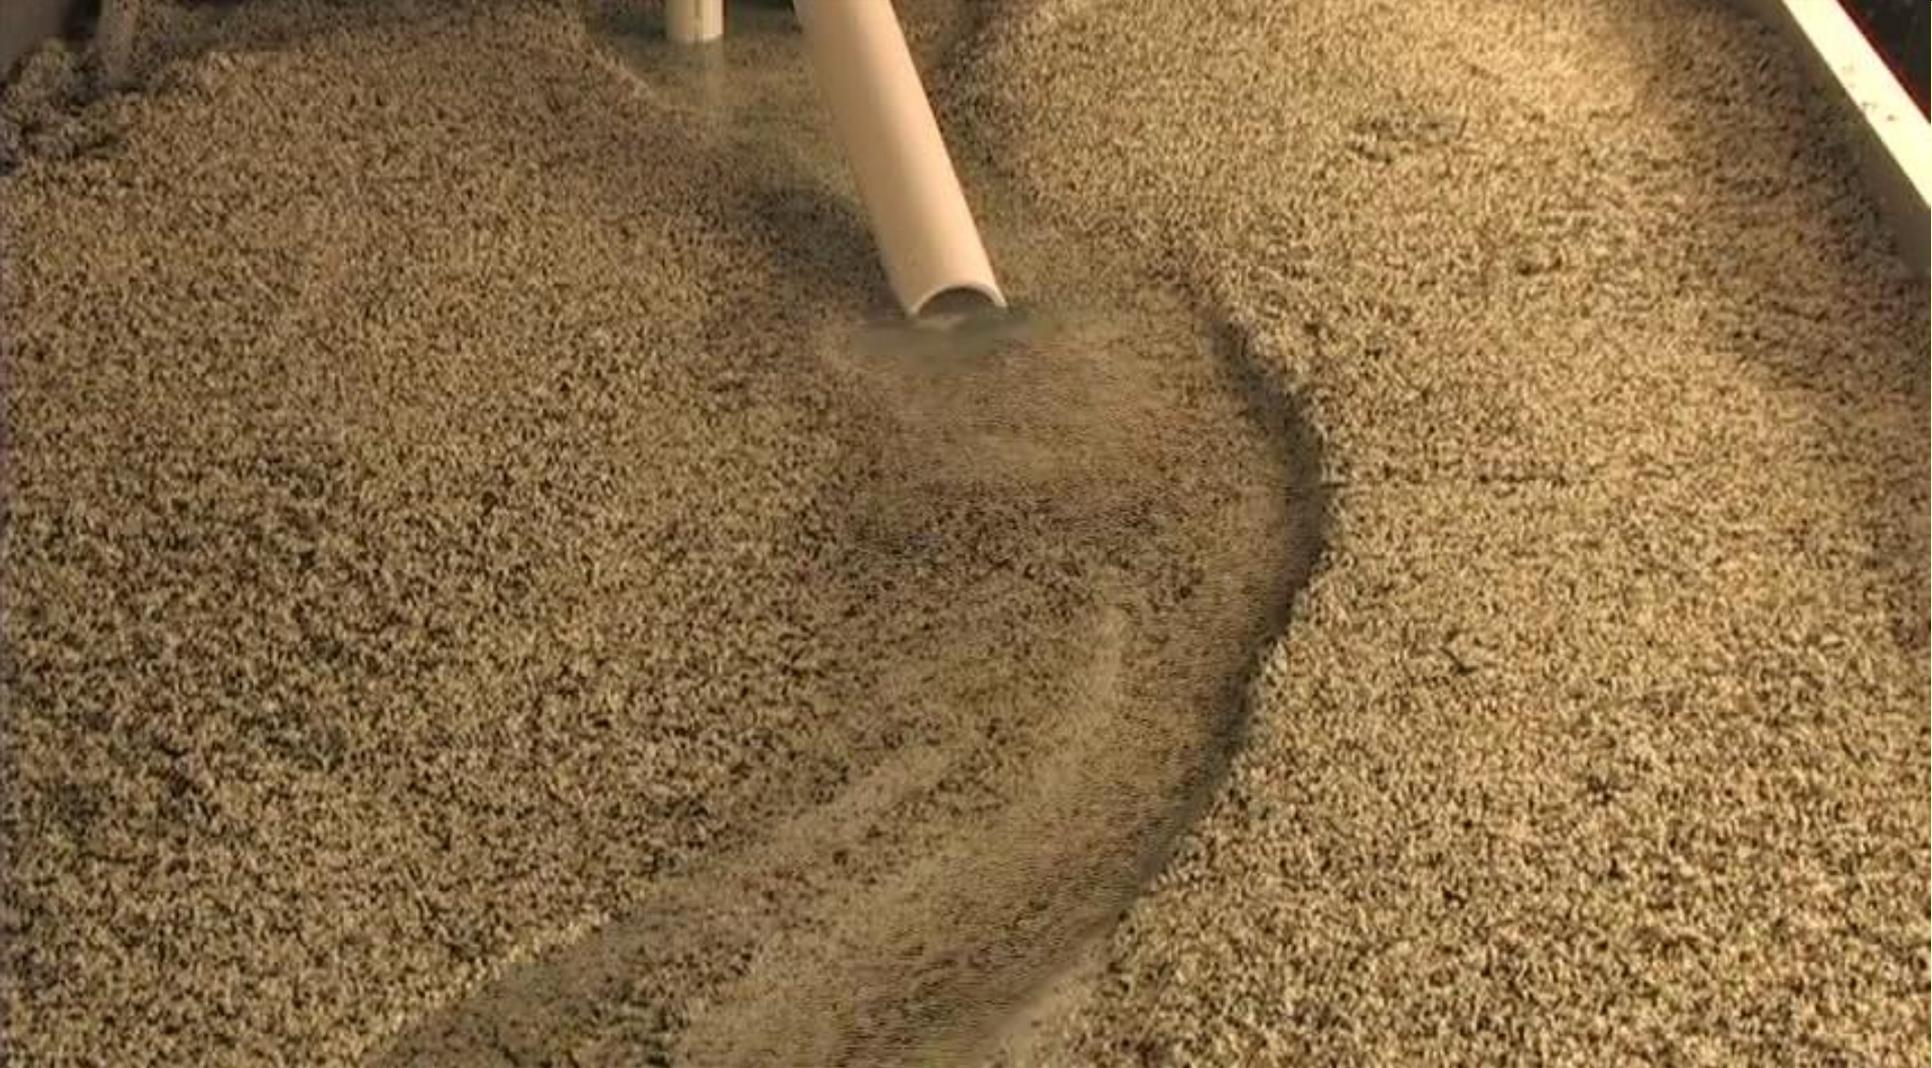
- Sand Table
- Effect of undersized pipe

Sand Table Simulation – Undersized Structures

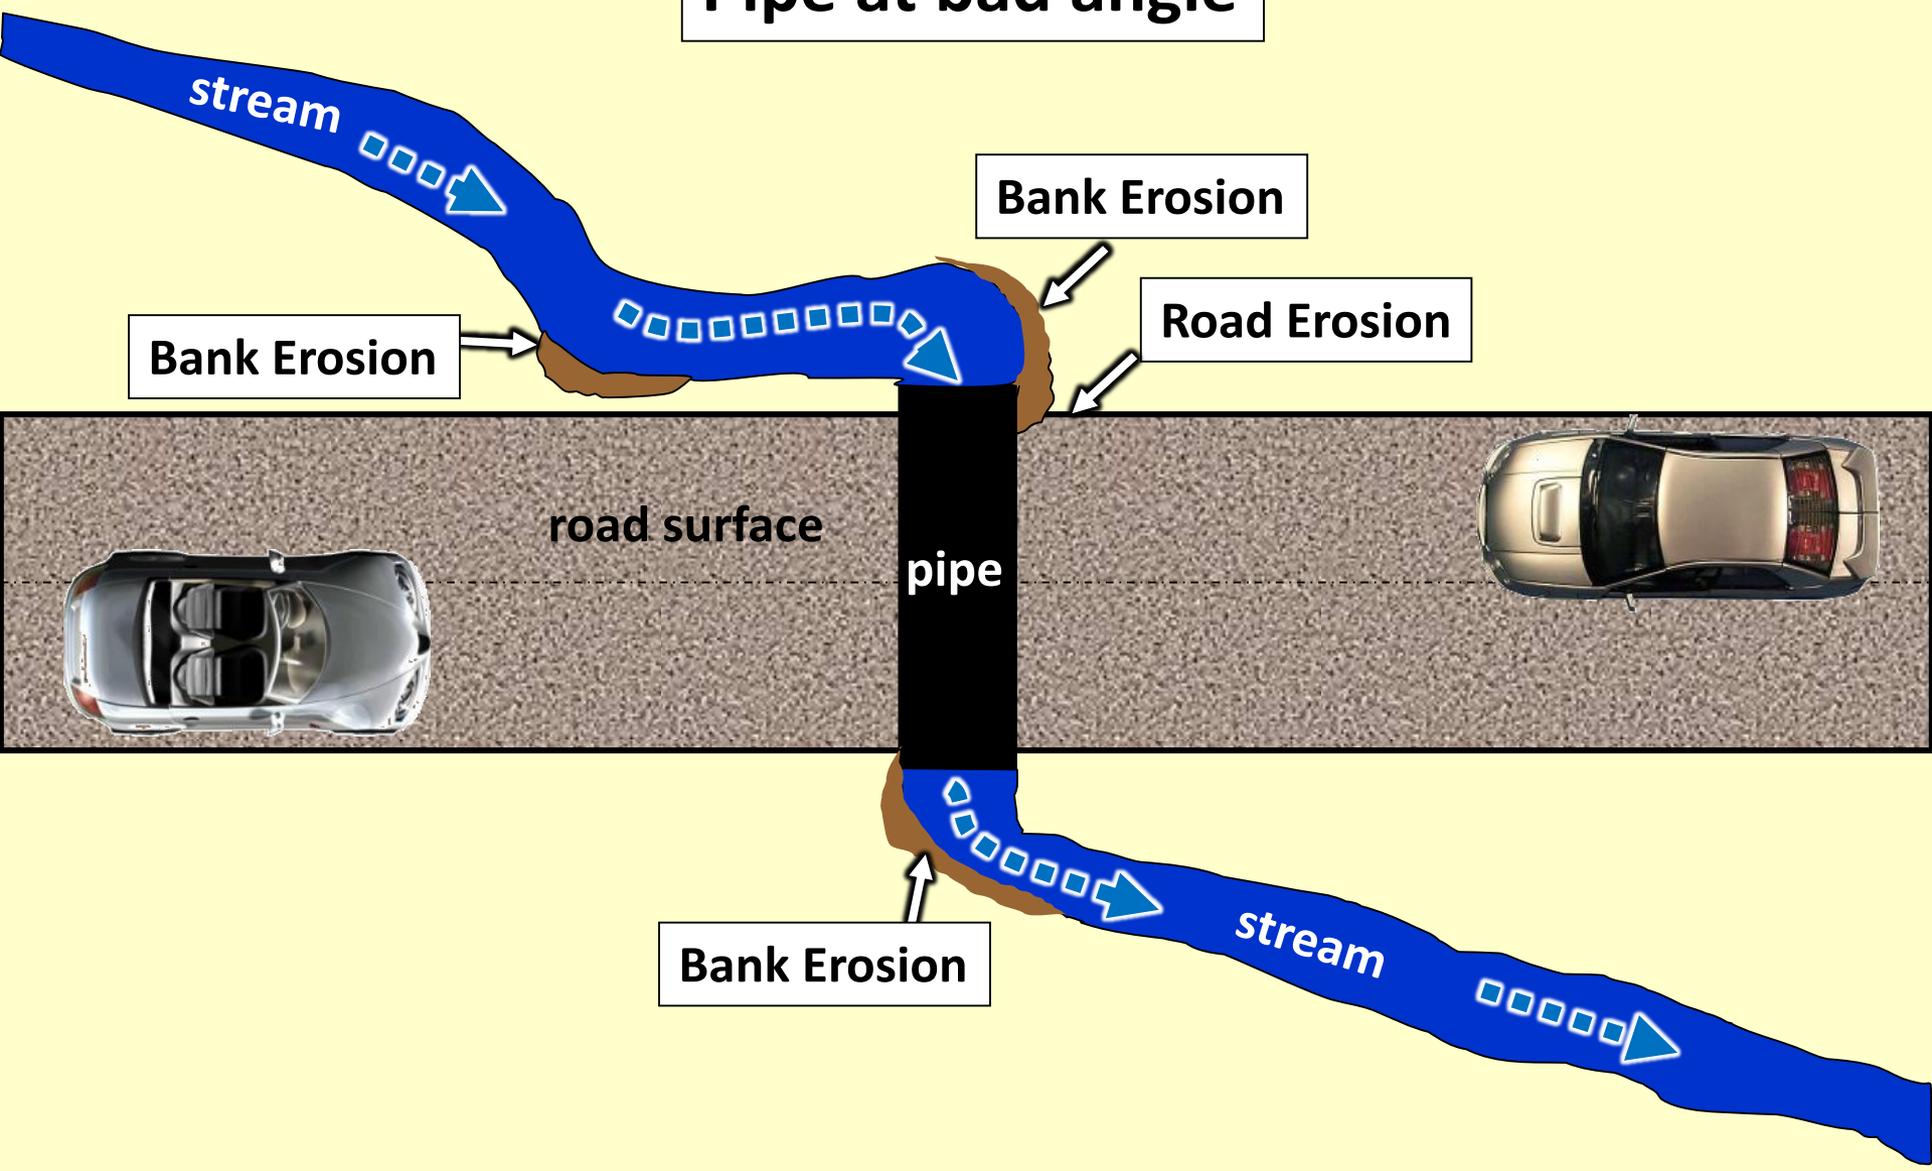
Pipe at bad angle

Bank Erosion

Road Erosion

Poor alignment = Poor conveyance

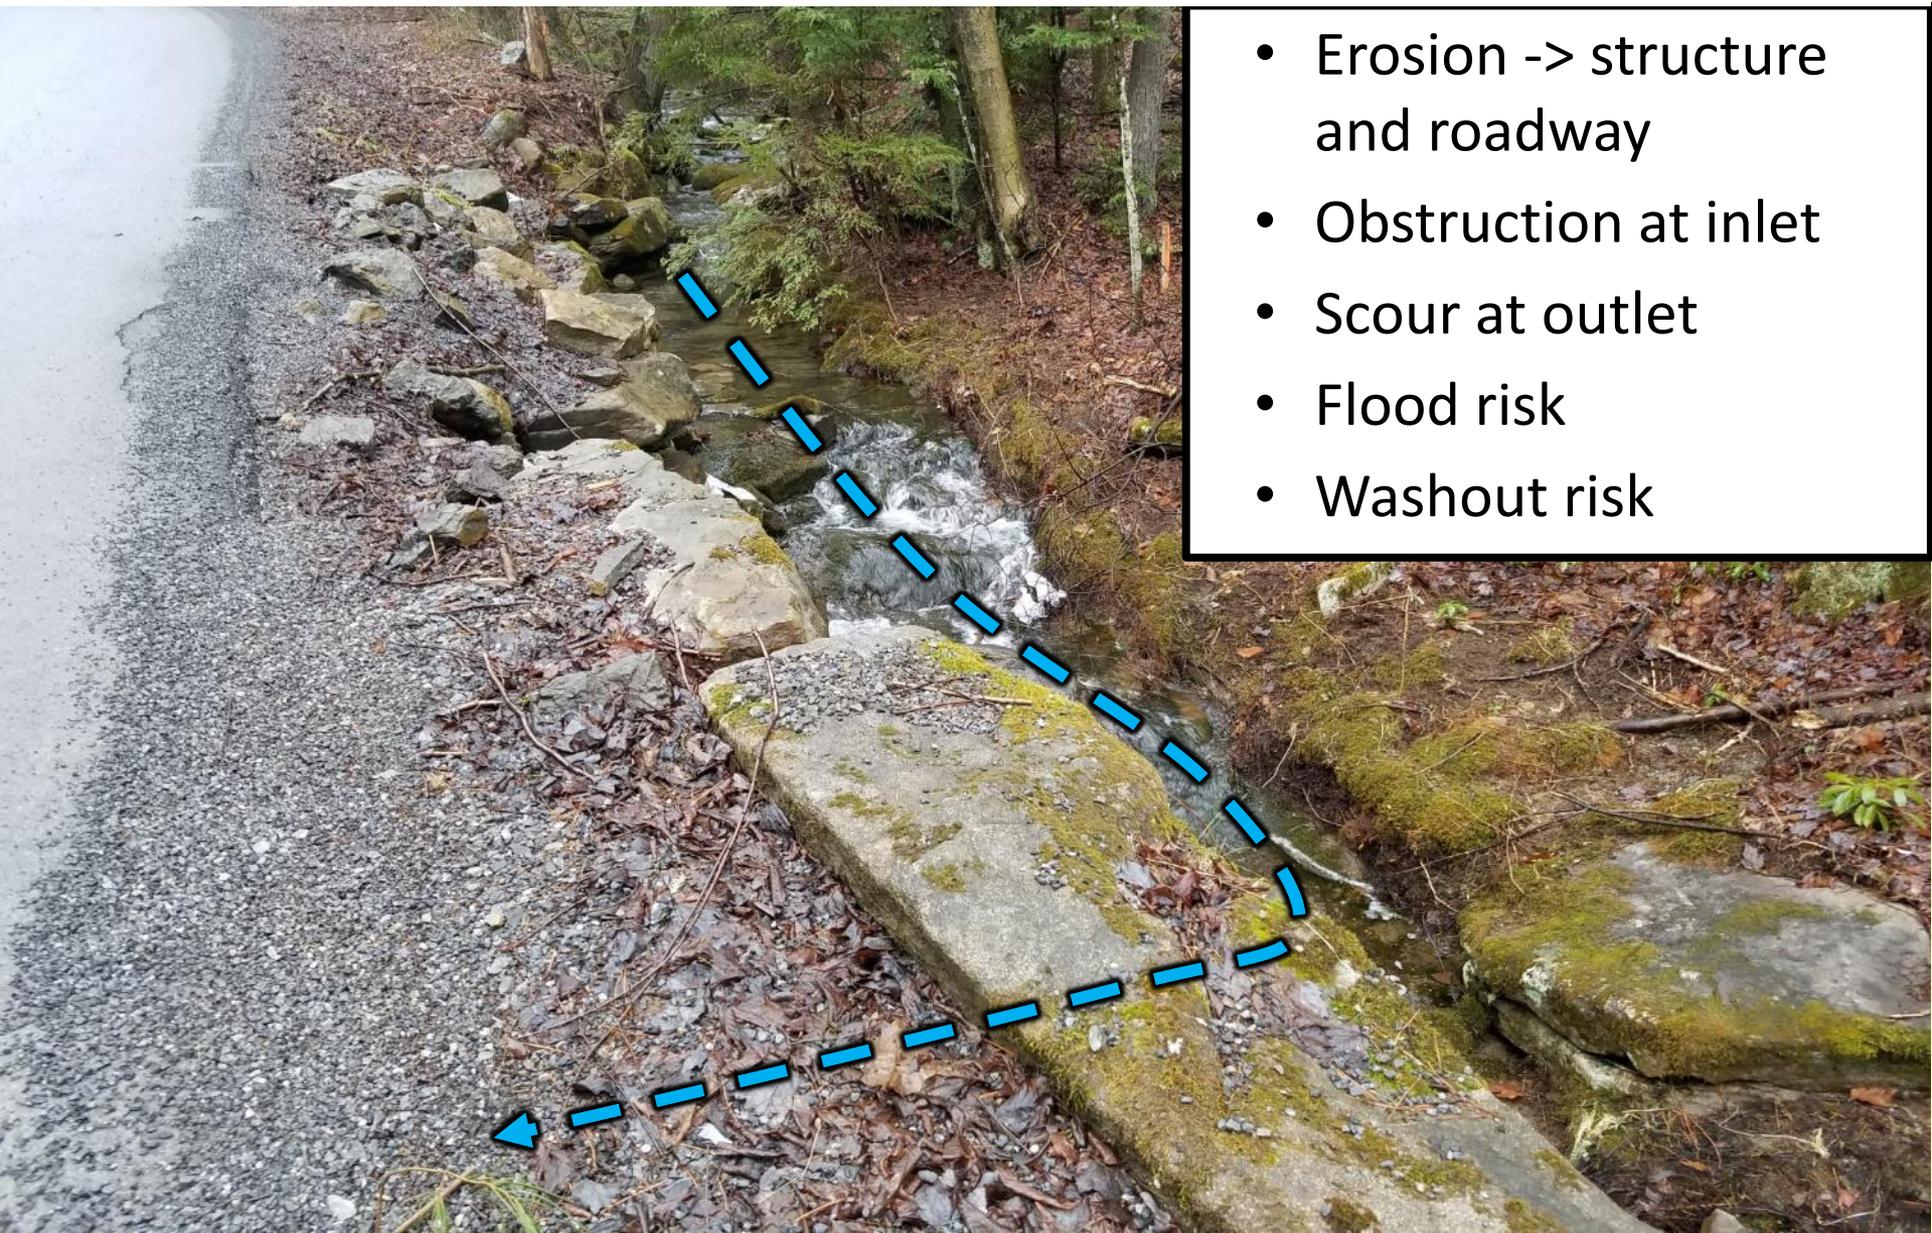
- Erosion -> structure and roadway
- Obstruction at inlet
- Scour at outlet
- Flood risk
- Washout risk

Big rocks can't fix the problem long-term...

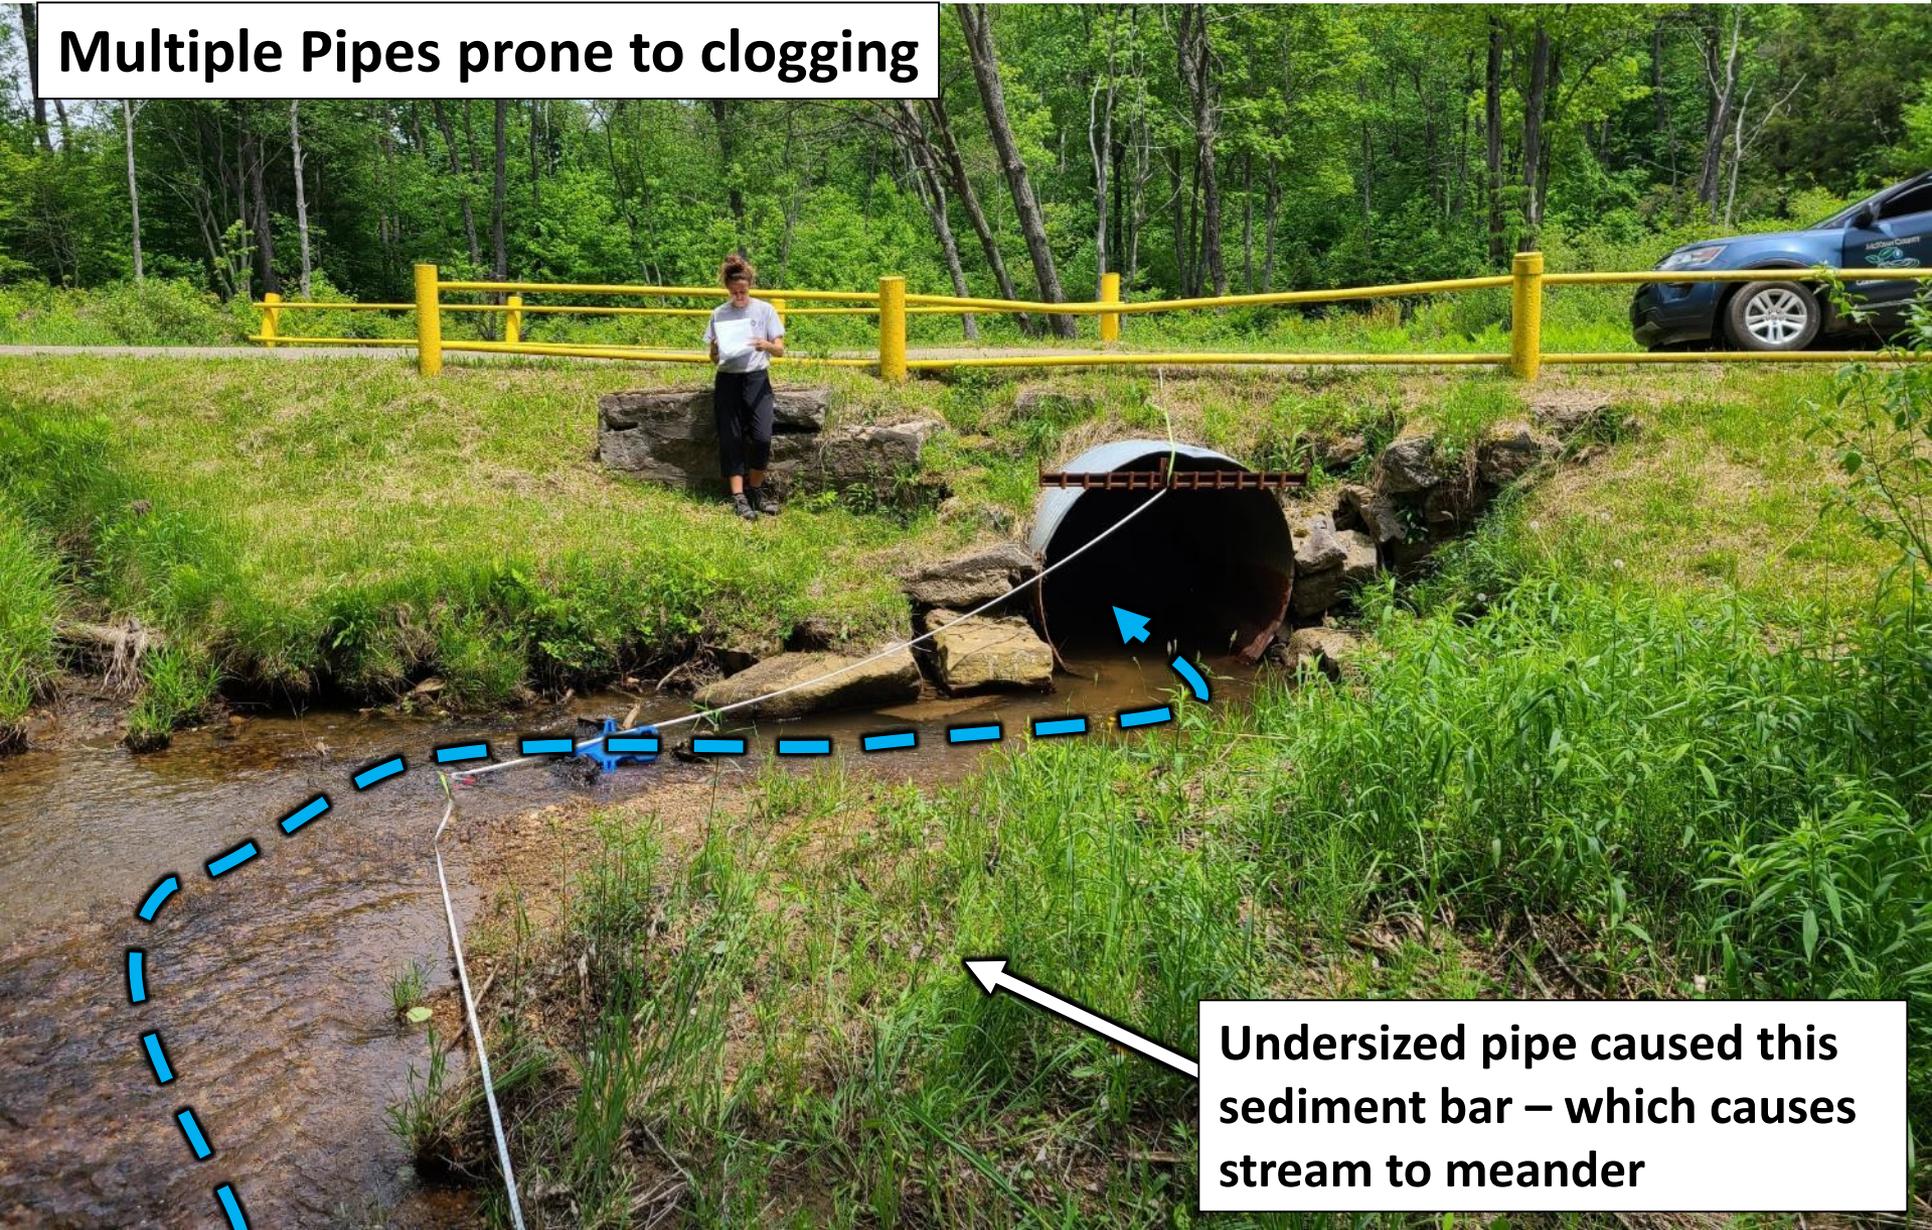
Multiple Pipes prone to clogging

Undersized pipe caused this sediment bar – which causes stream to meander

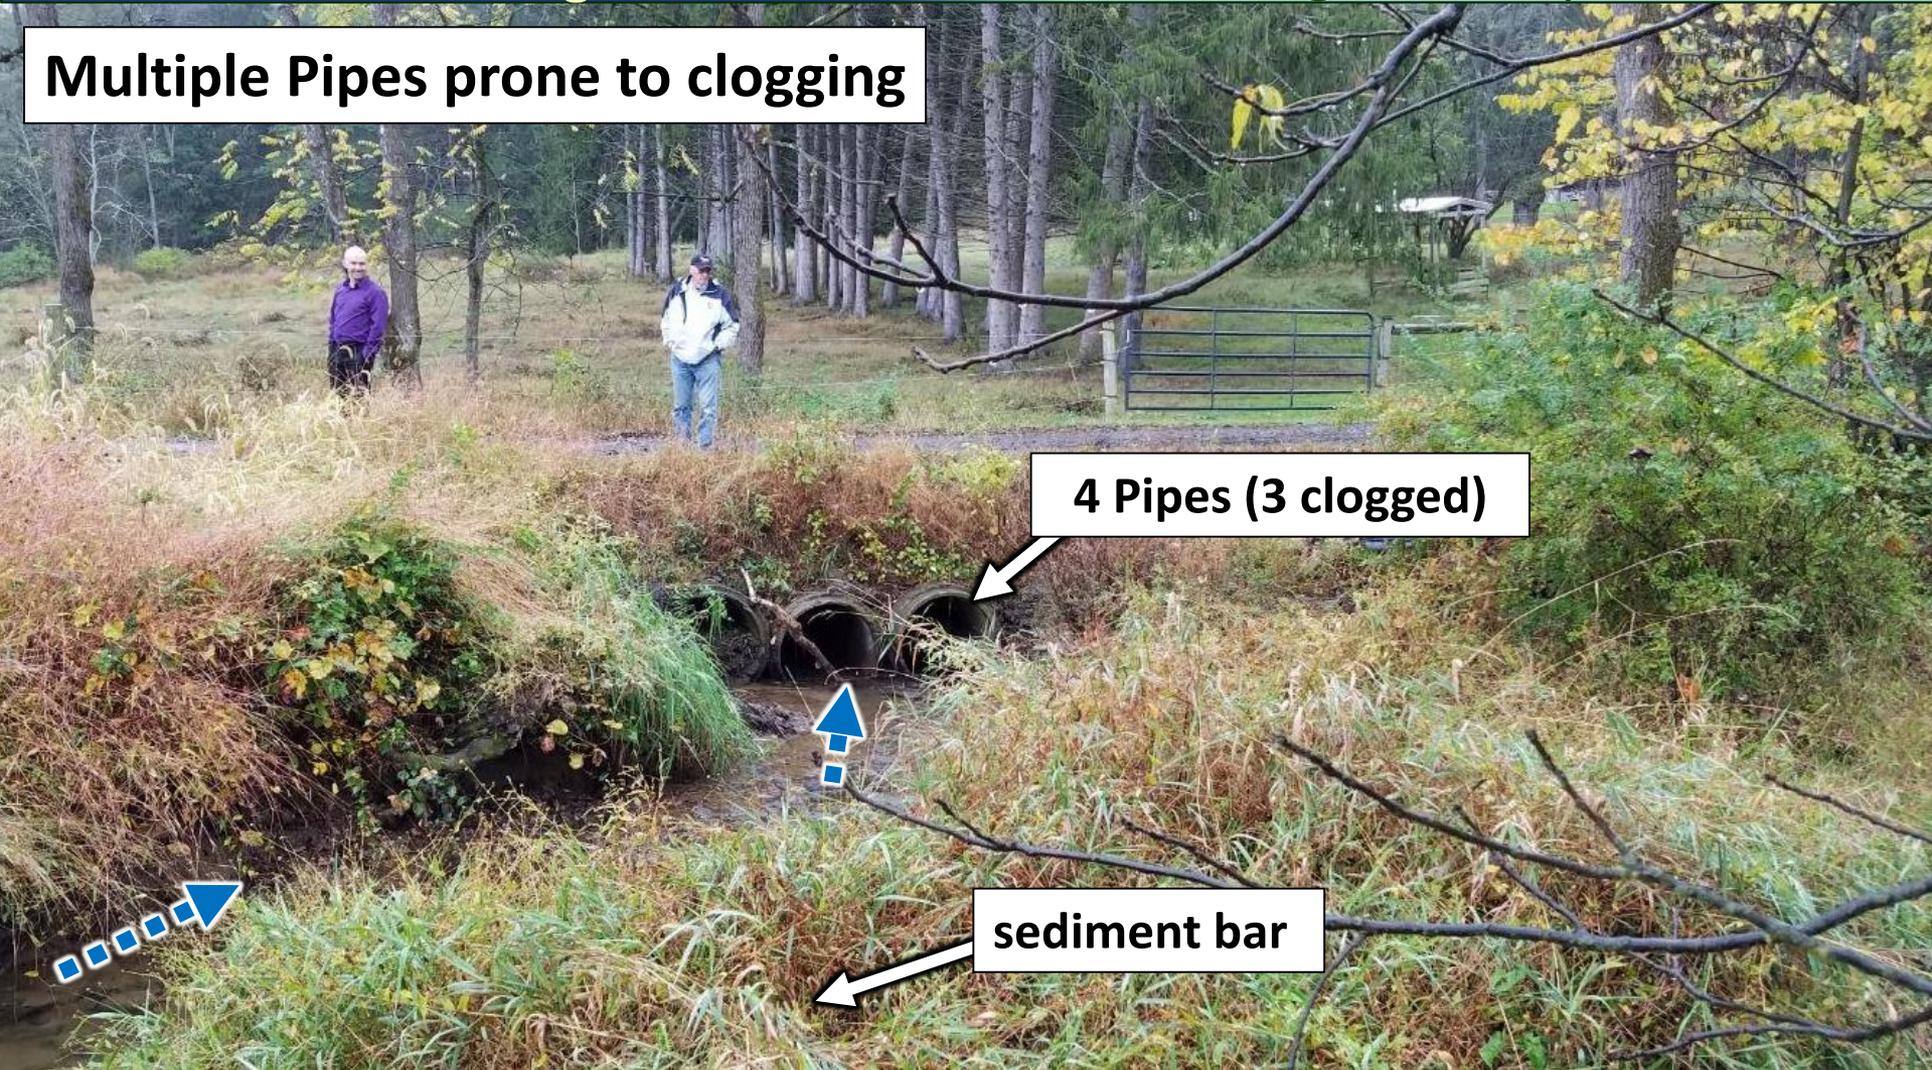
Multiple Pipes prone to clogging

- Not enough conveyance
- **Sediment deposits upstream**
- Stream moves sideways => Erosion => Flooding

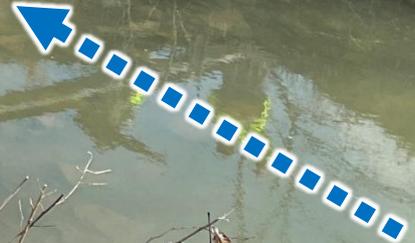
Debris Jam

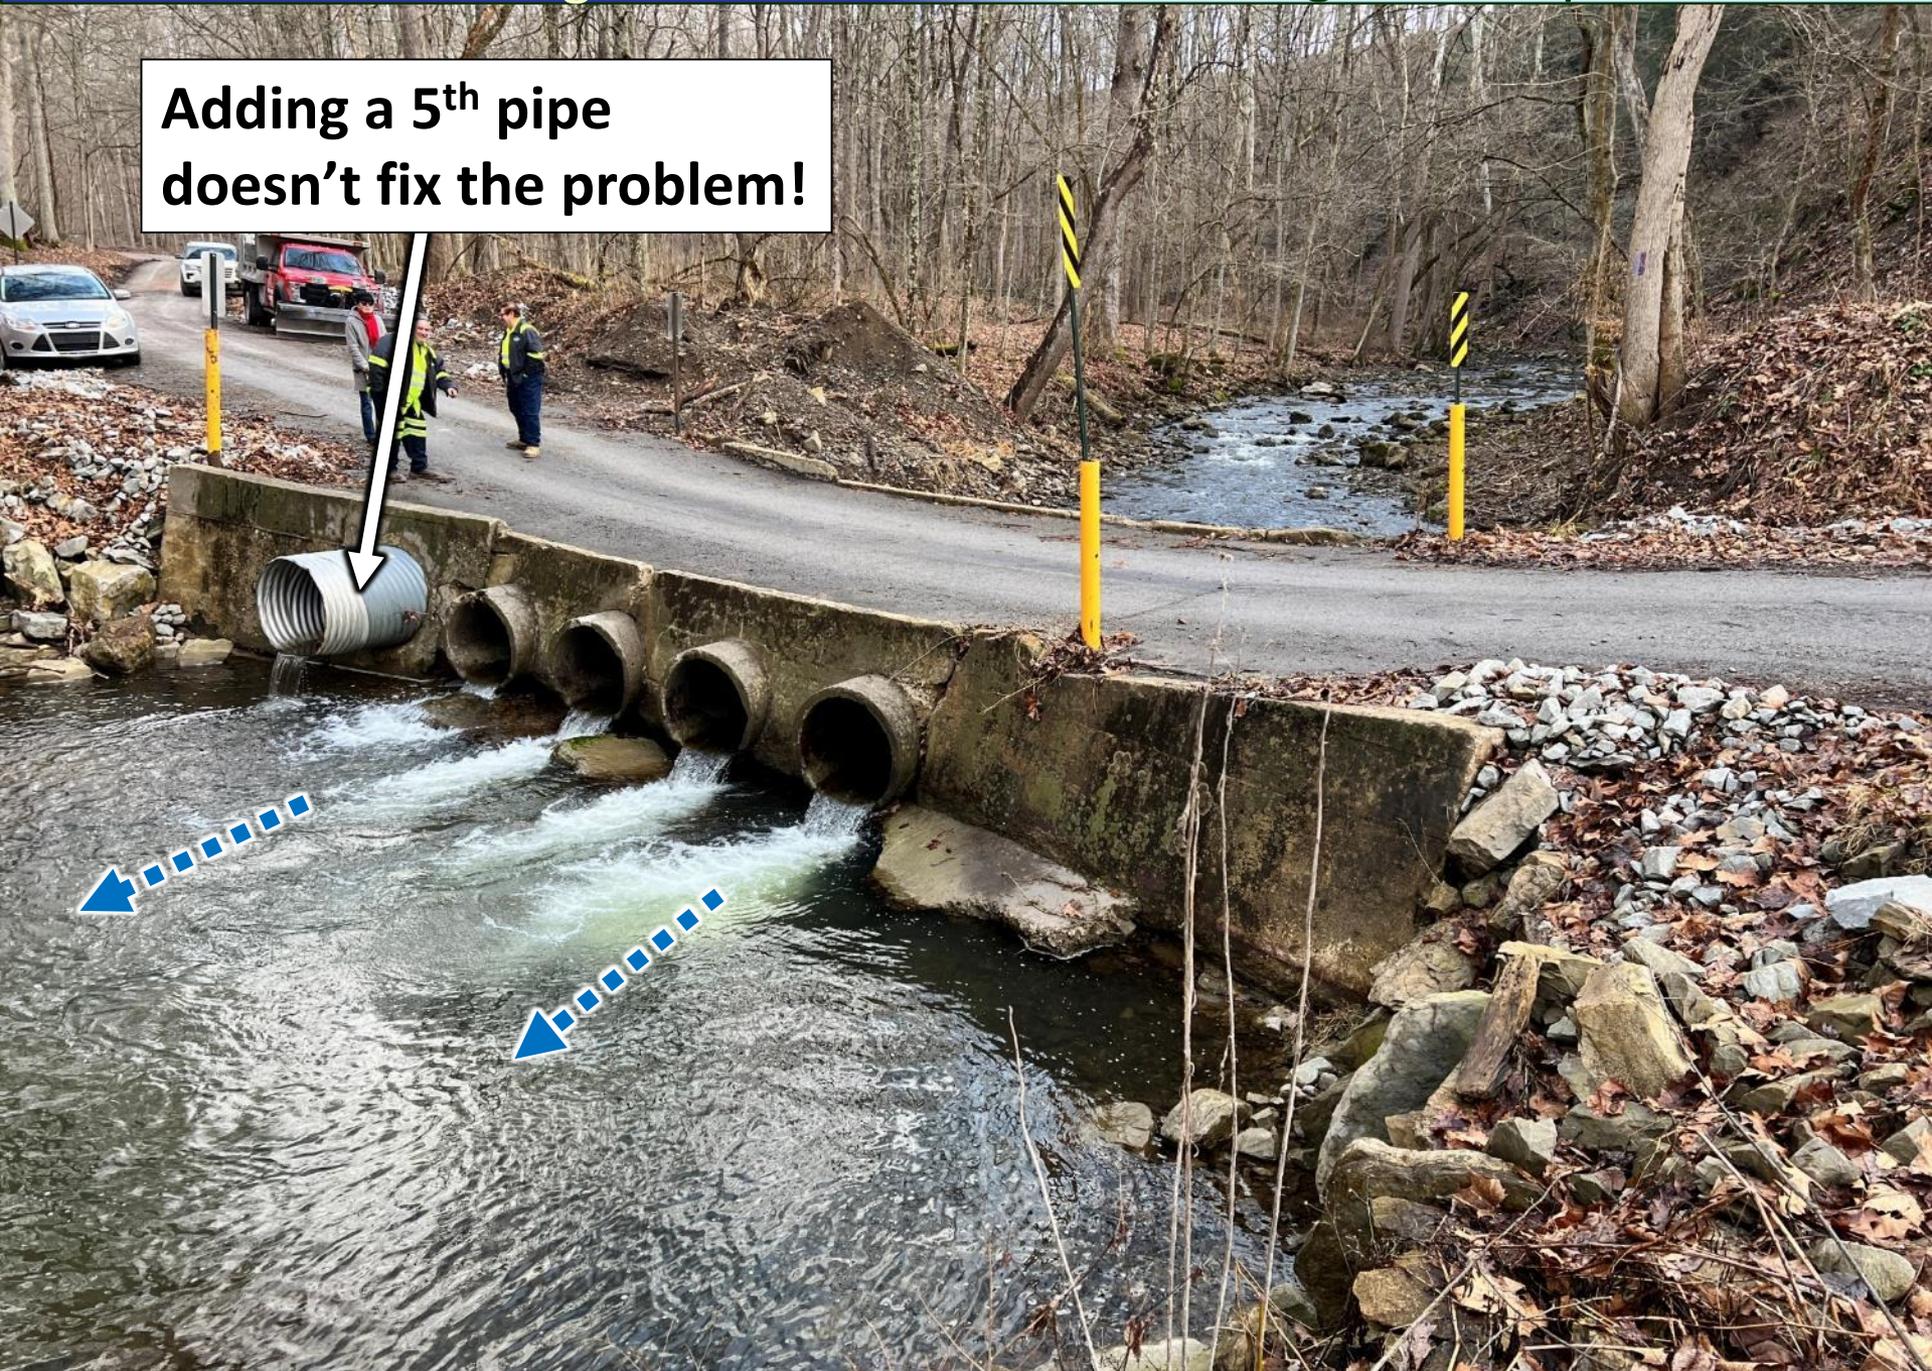
Three 7' pipes in a 27' bankfull channel.

**Adding a 5th pipe
doesn't fix the problem!**

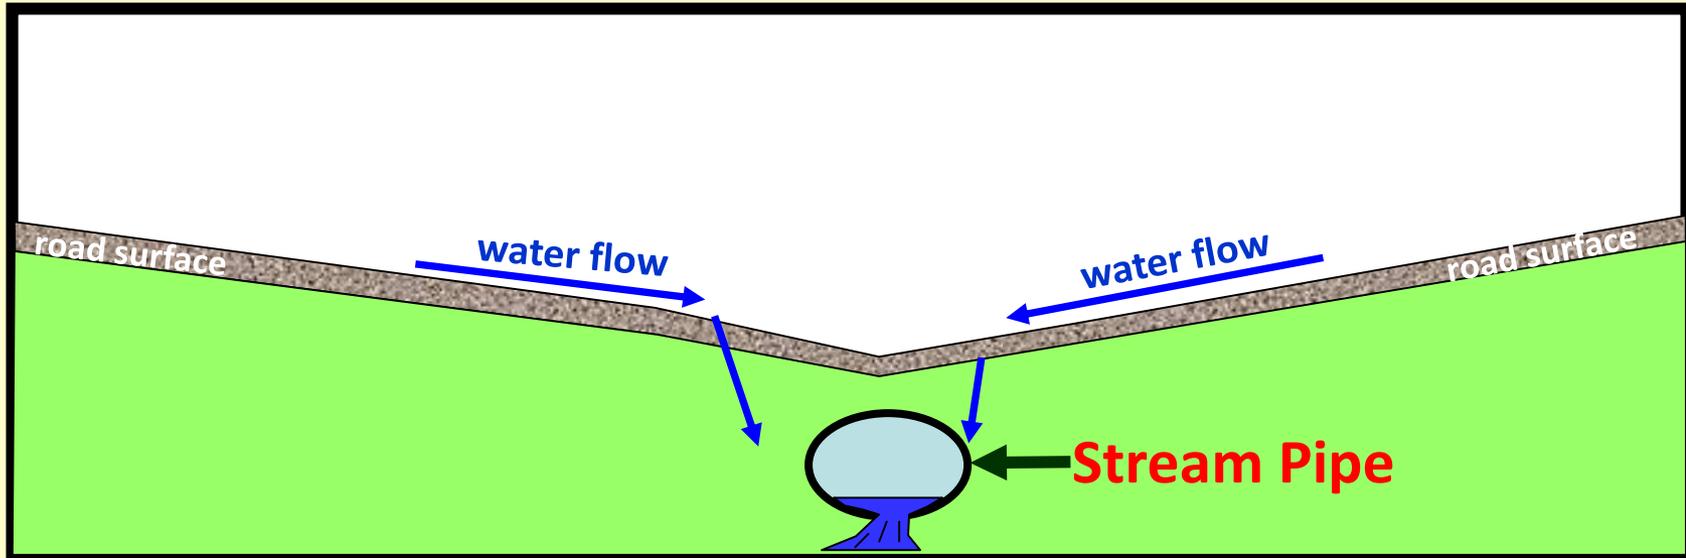
Common Practices: The low point in the road is over the stream pipe.

- Minimal road cover over pipe.
- Pipe is too small => disrupts stream shape
- Runoff from road concentrates at the crossing
