Environmentally Sensitive Maintenance for Dirt, Gravel, and Low-Volume Roads

Stream Crossings

Road/Stream Crossings

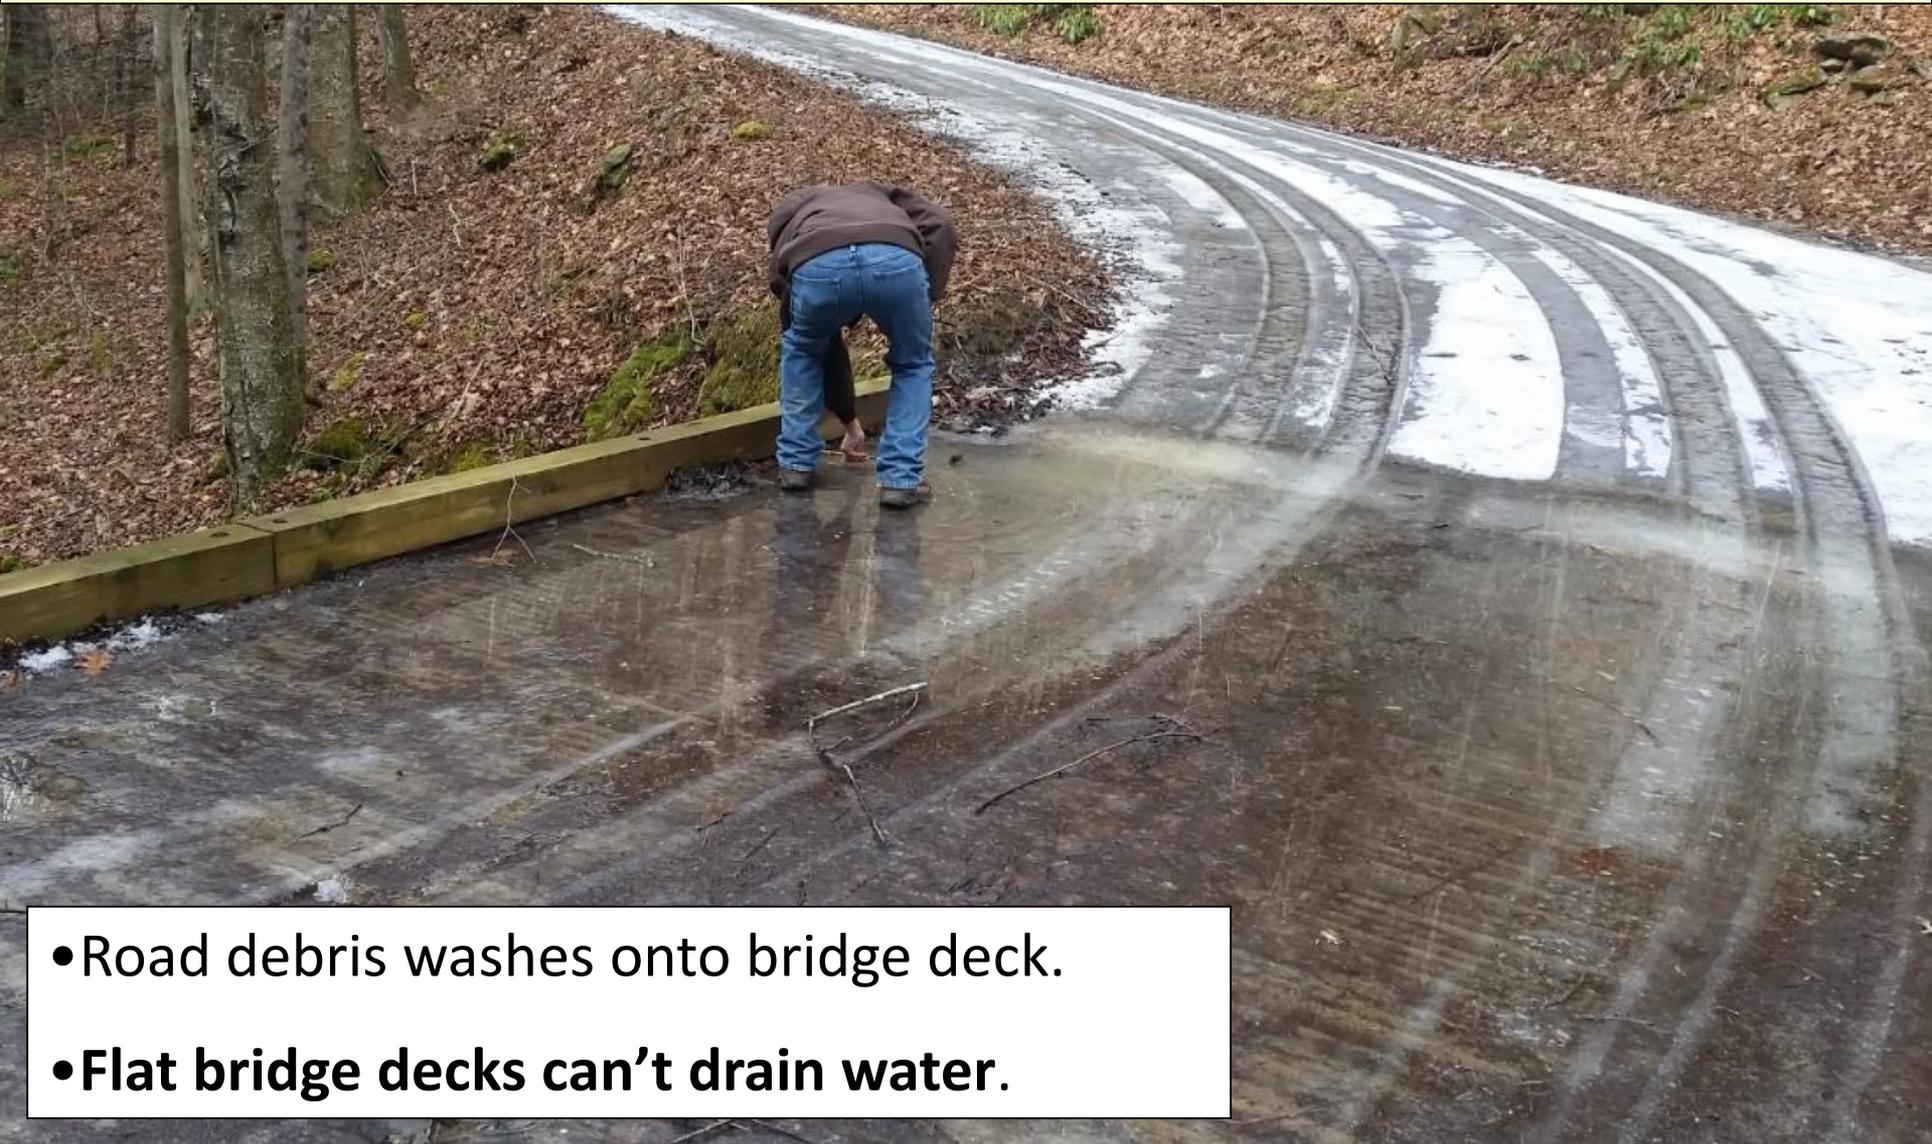
Common Practices: Bridge deck or road surface at low point in road.

- Road debris washes onto bridge deck.
- **Flat bridge decks can't drain water.**

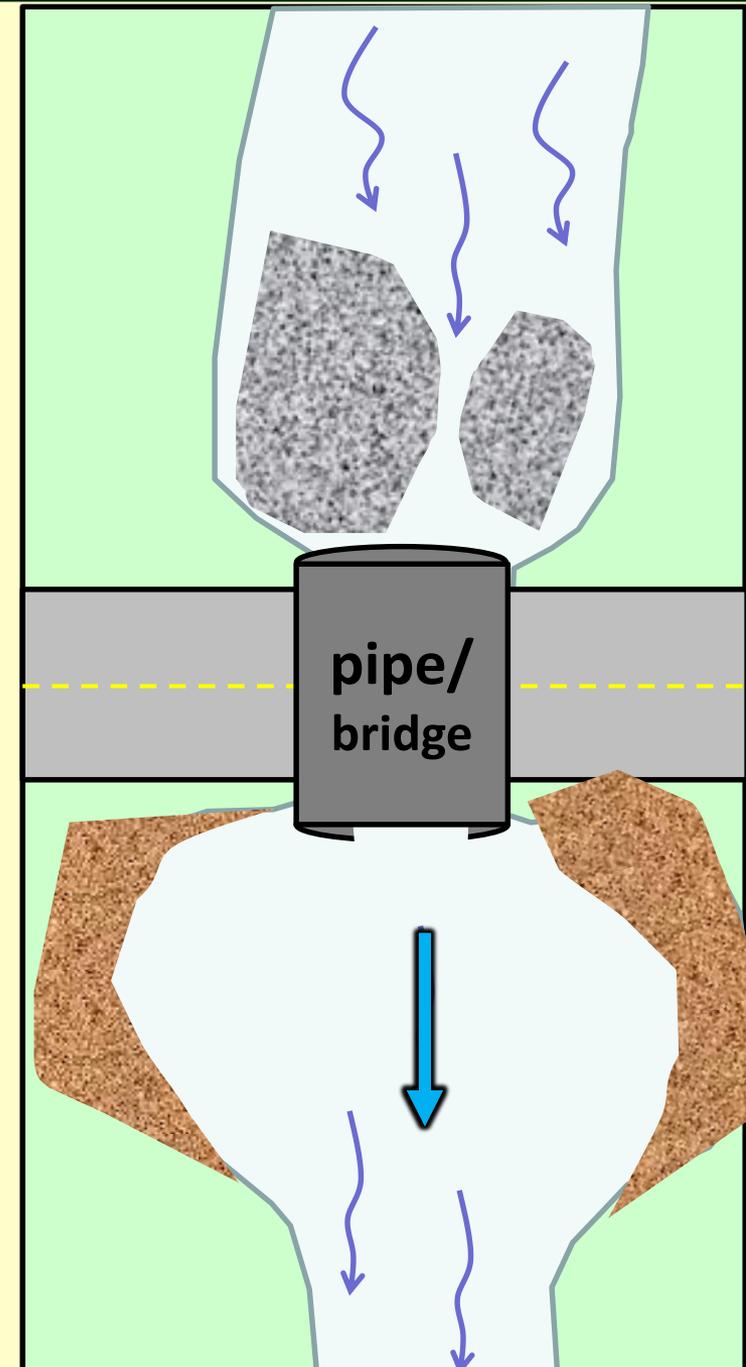
Remember undersized pipe issues

- Gravel bar formation upstream
- Erosion downstream

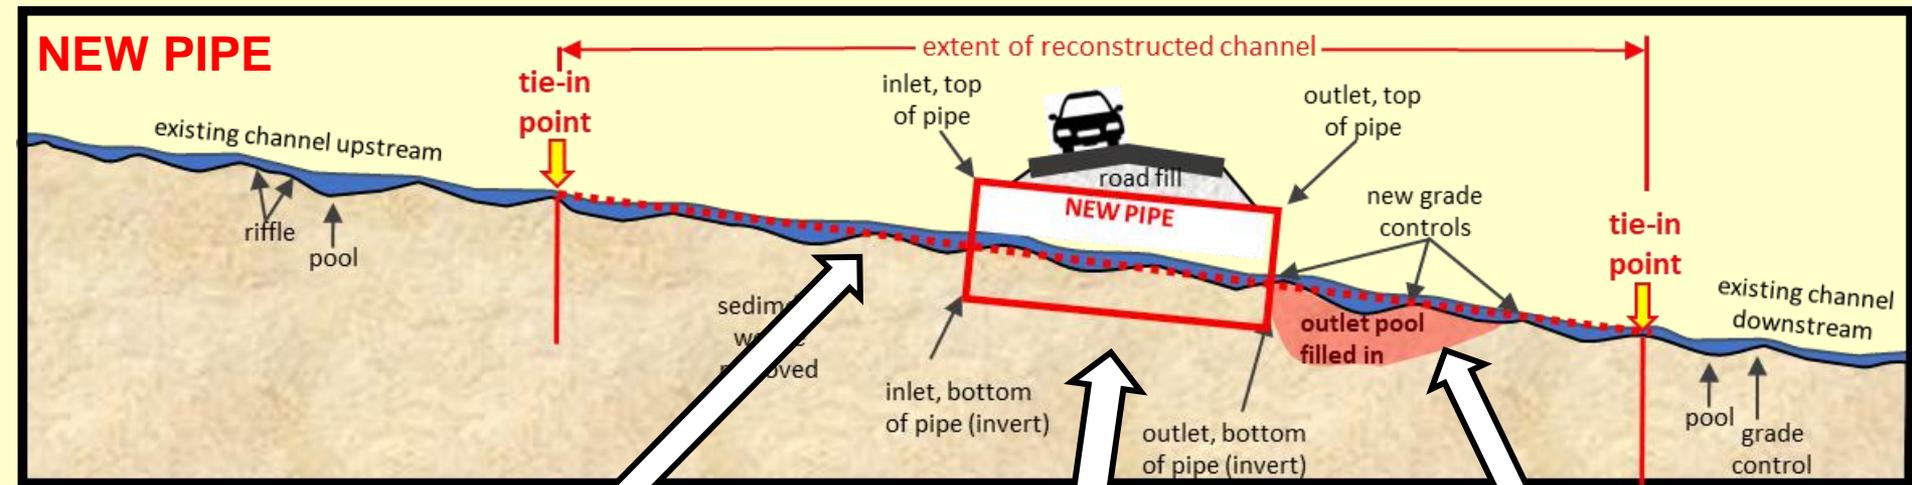
NEW PIPE

- Sediment wedge removed
- Streambed reconstructed

- Larger pipe installed
- Sufficient material in pipe

- Scour hole filled in
- Streambed/banks reconstructed

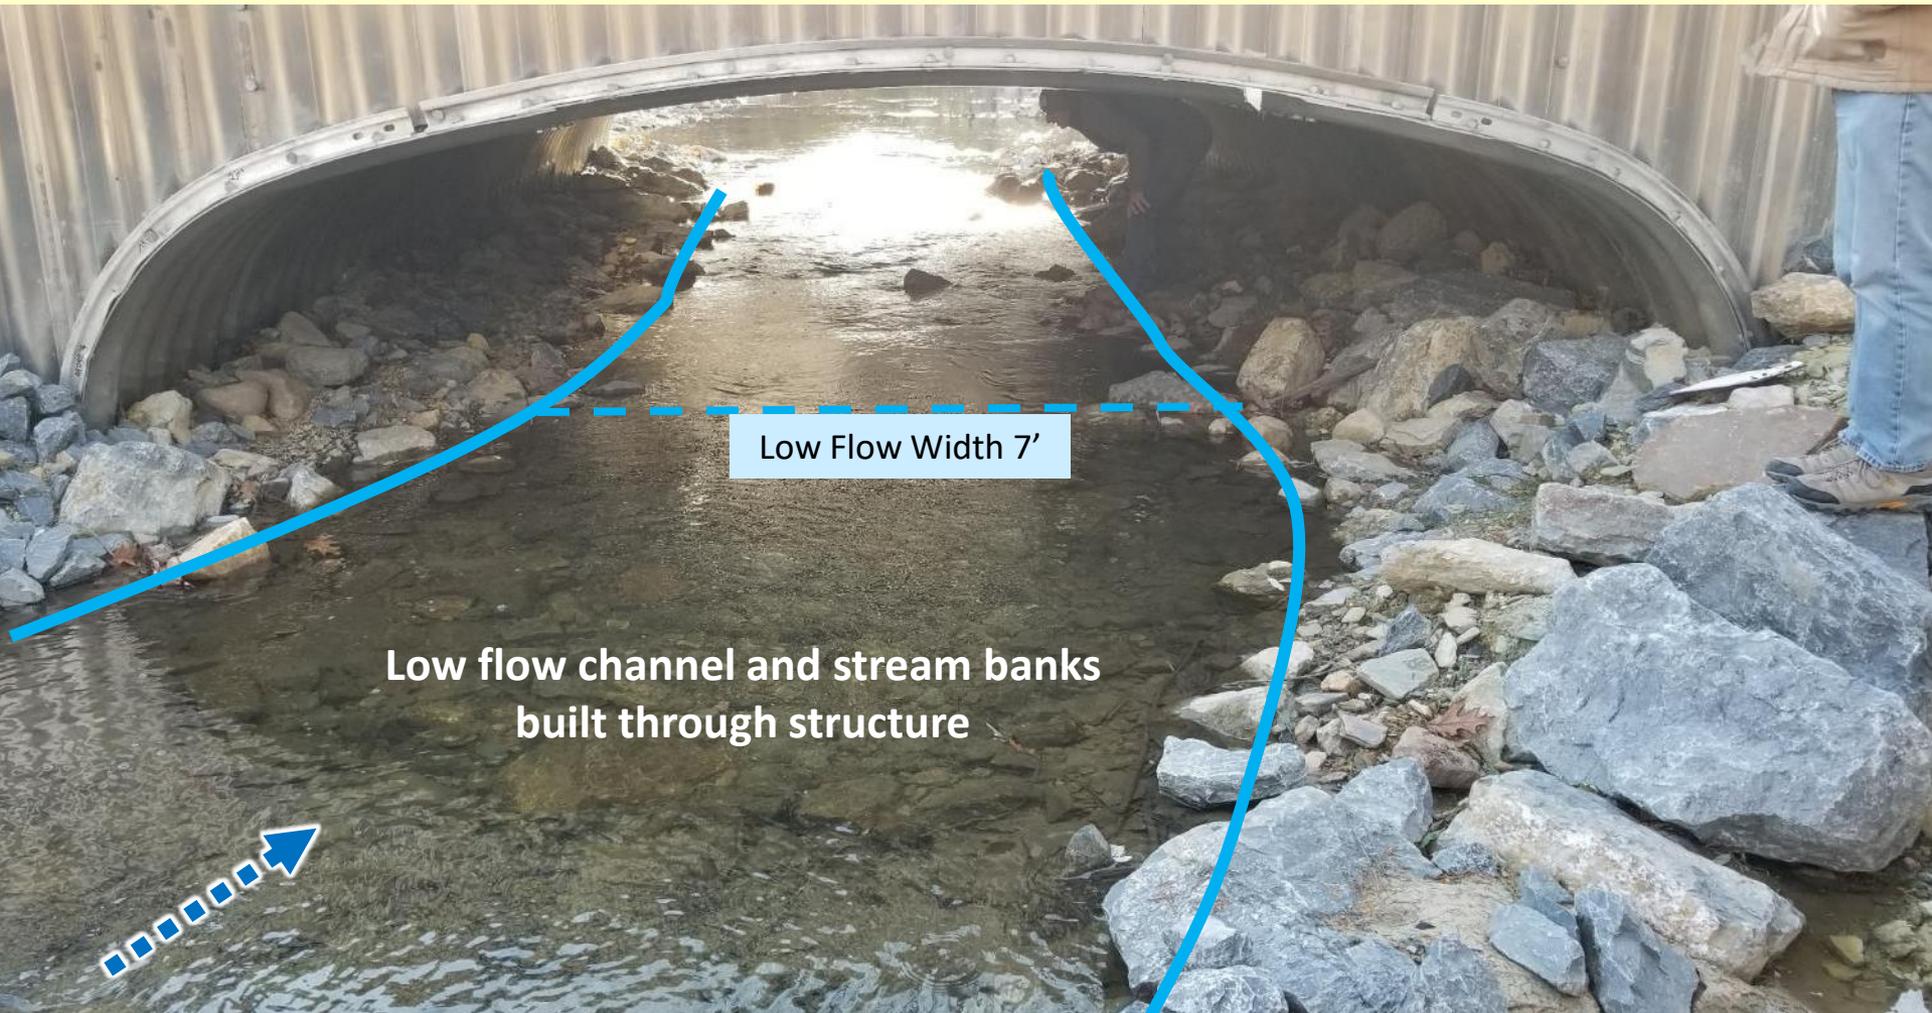
A Better Approach: “Build the stream like the road isn’t even there”

Low Flow Width 7'

Low flow channel and stream banks
built through structure

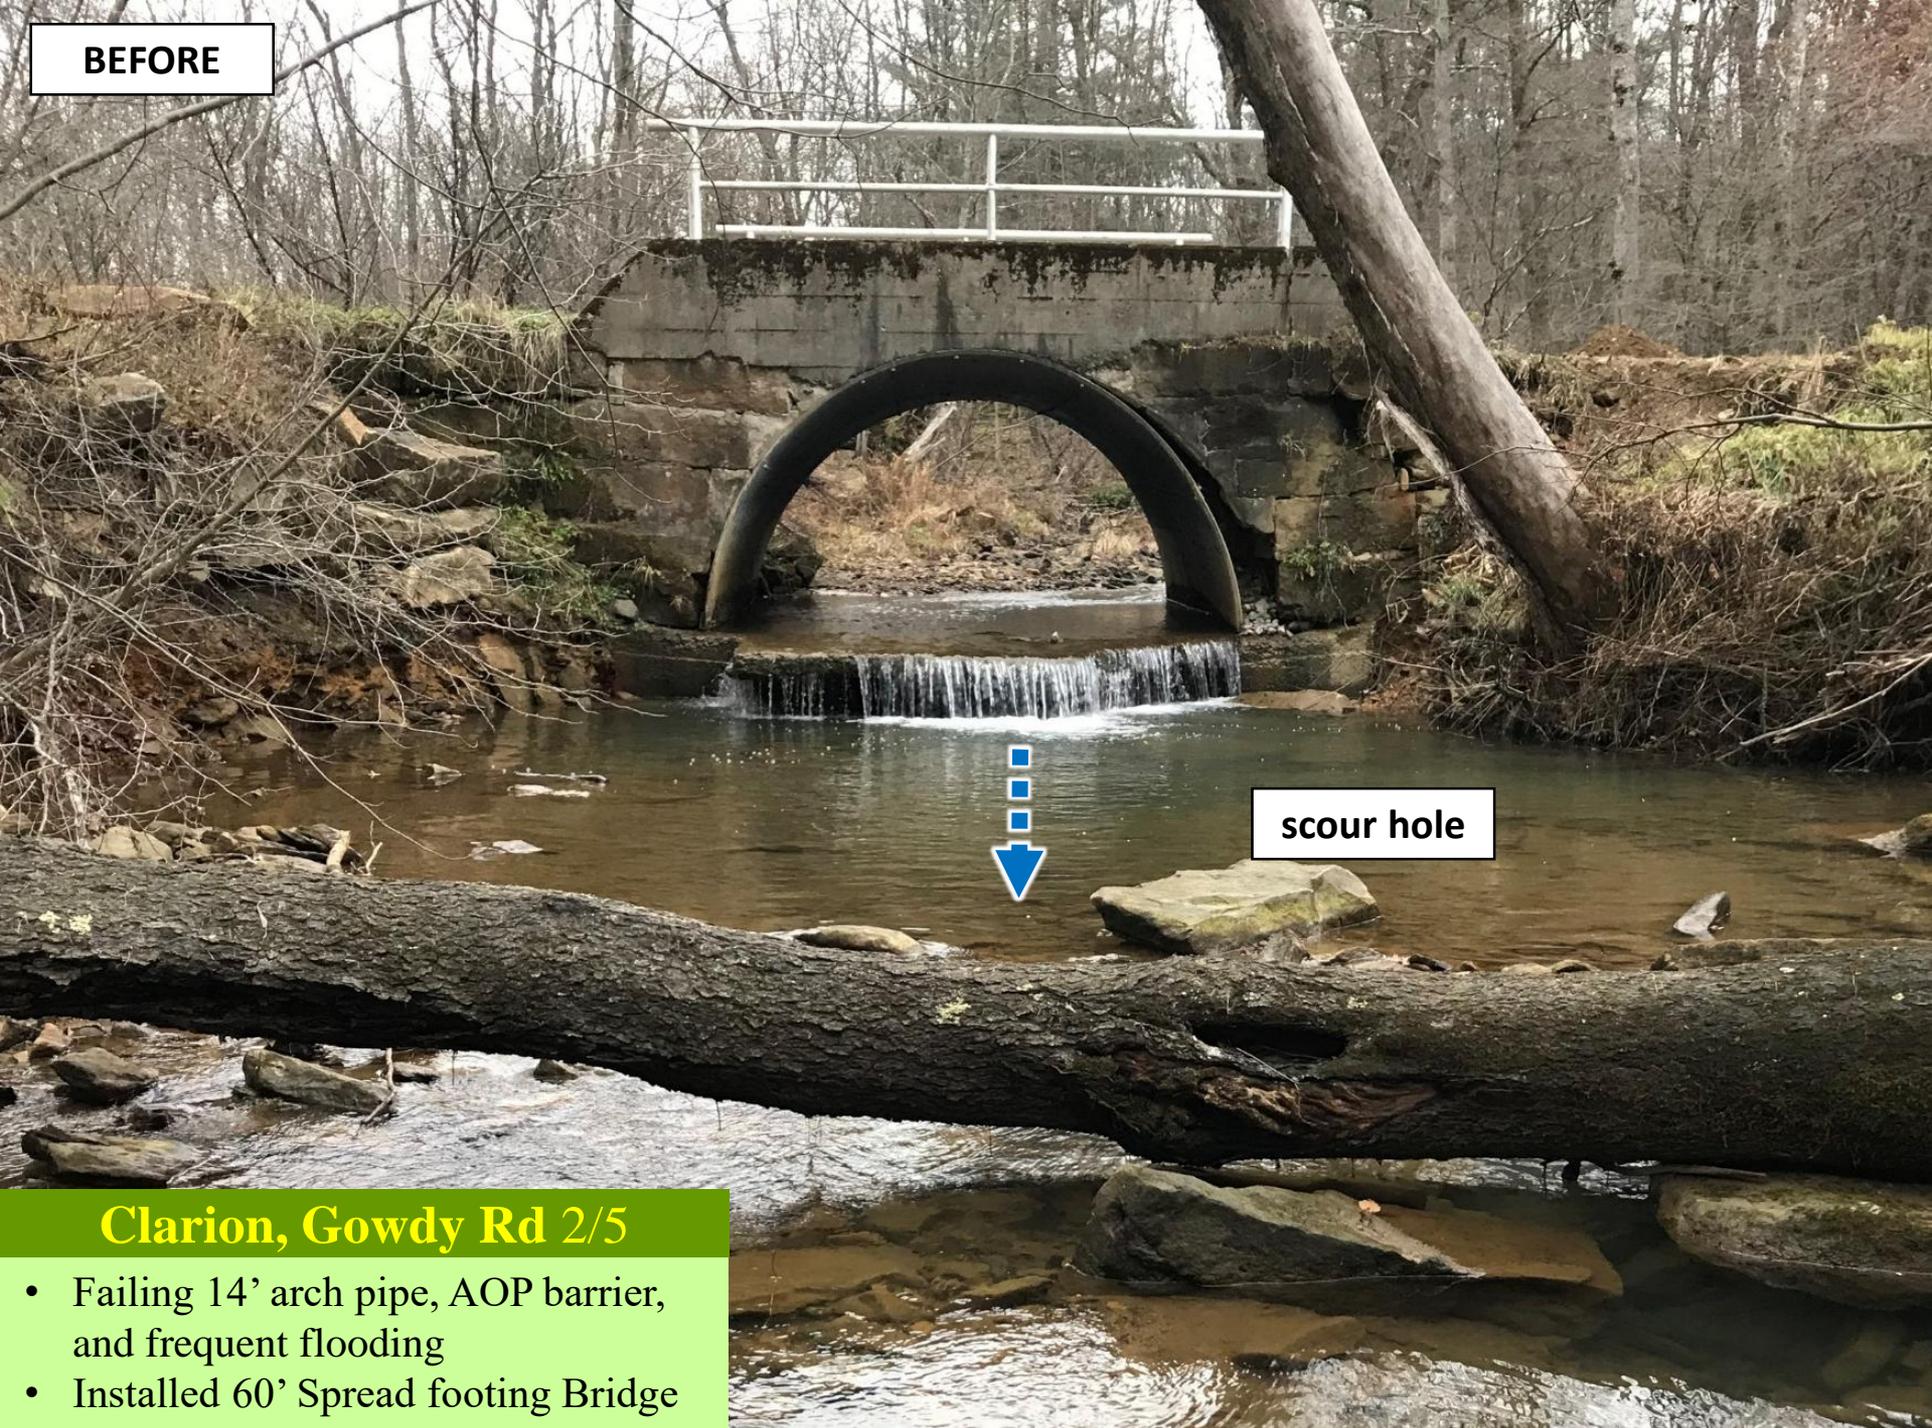
BEFORE

scour hole

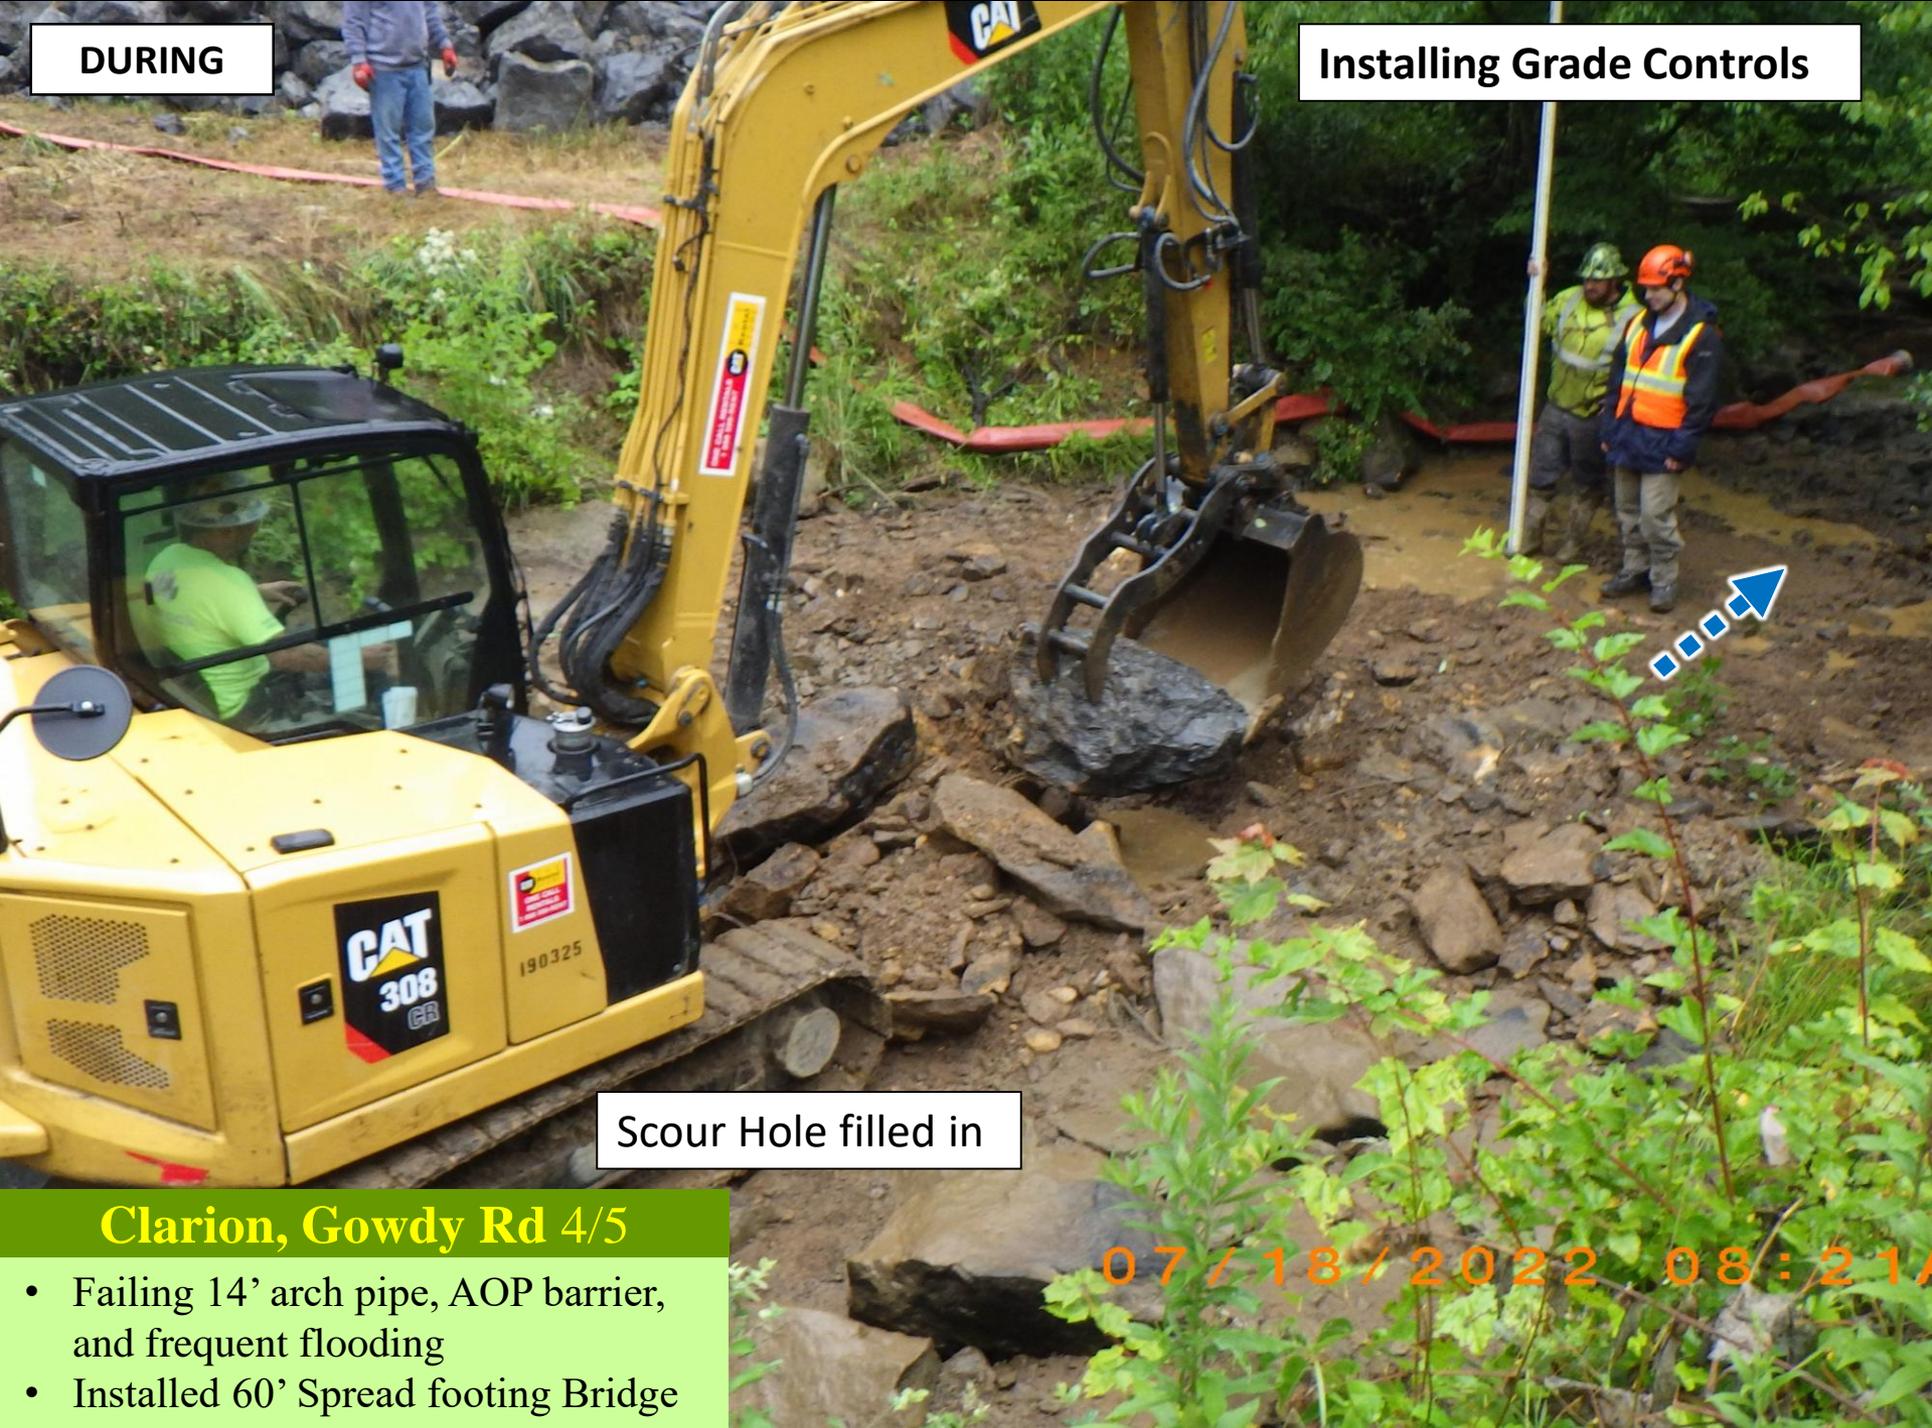
Installing Grade Controls

Scour Hole filled in

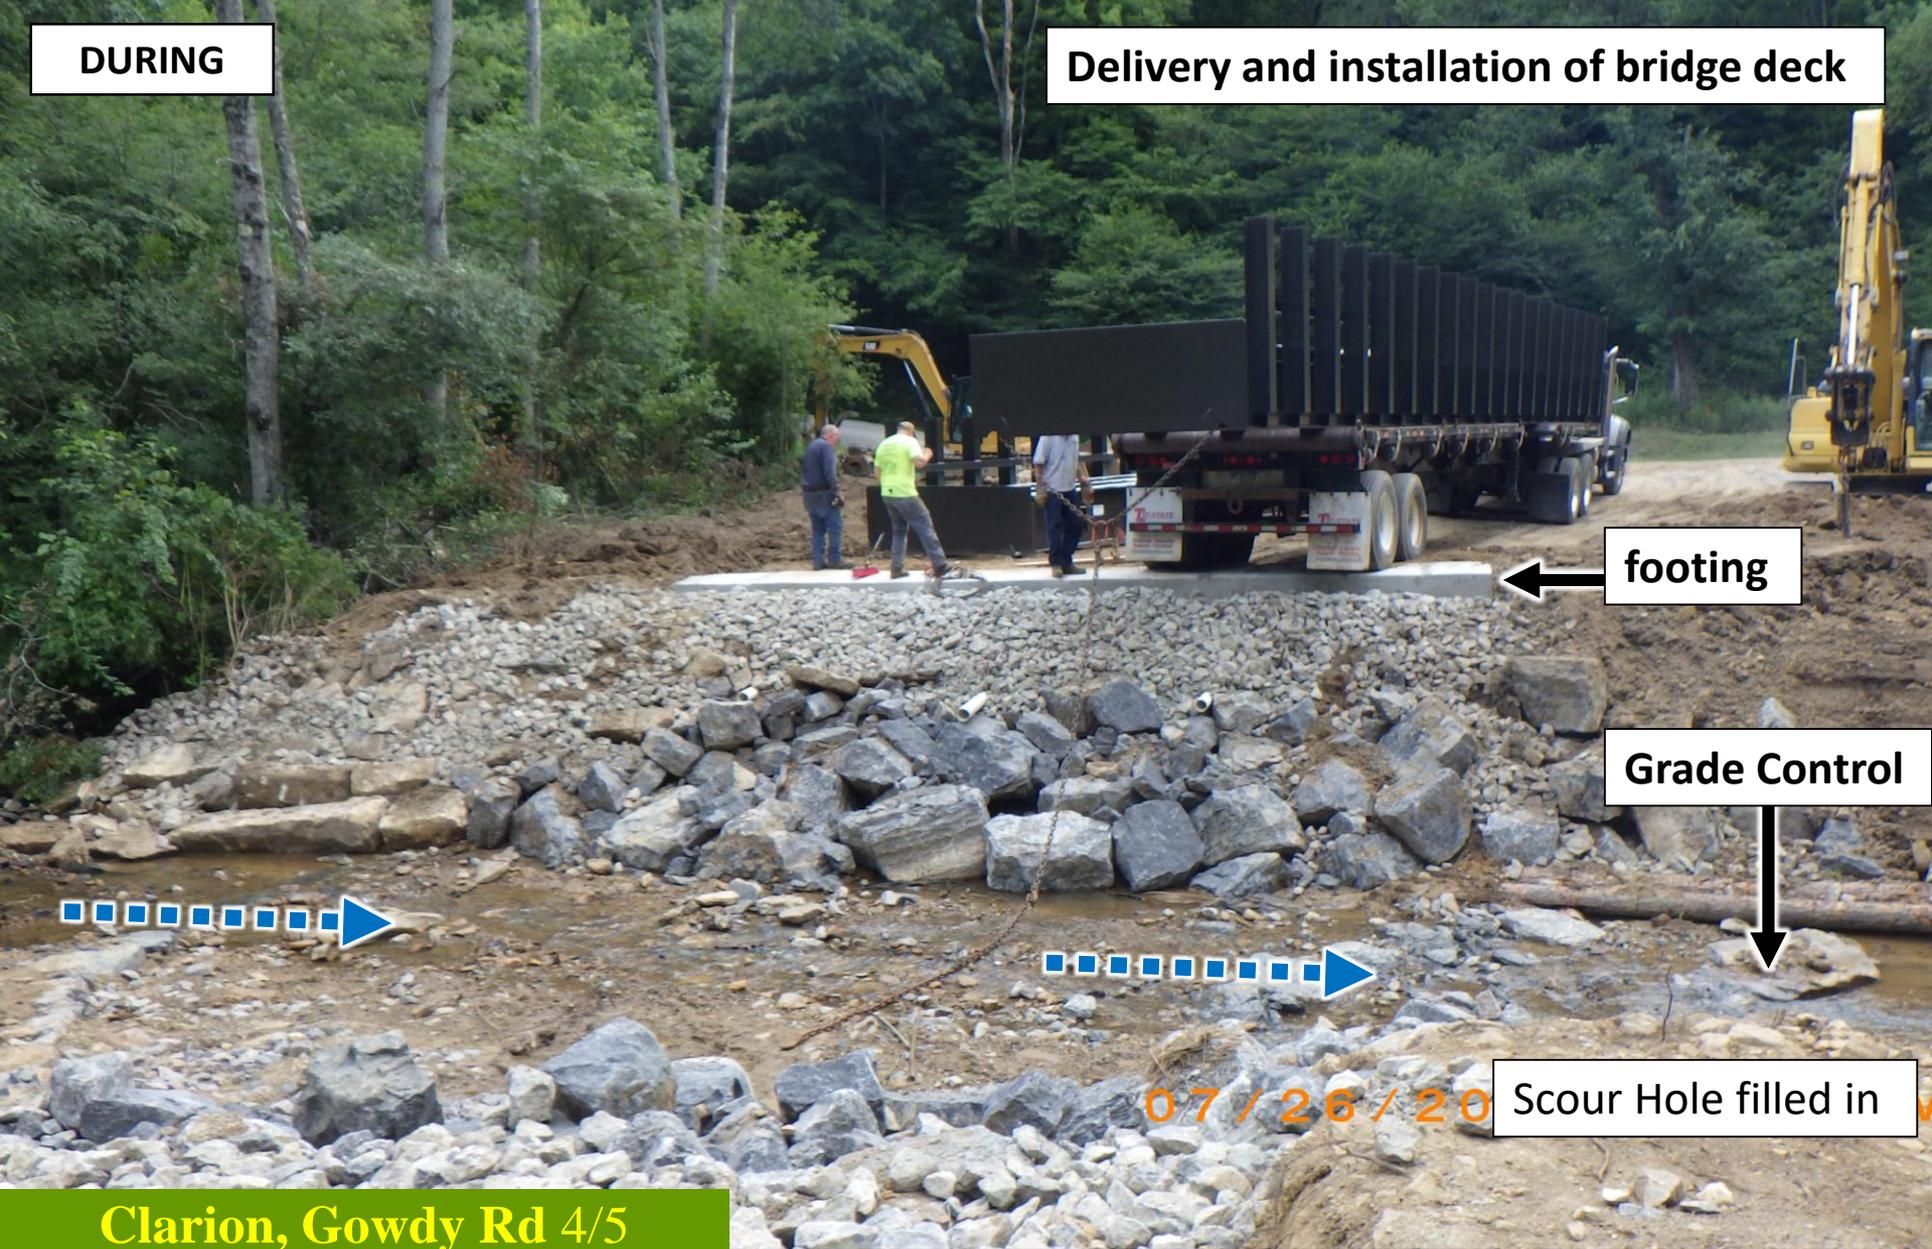
Delivery and installation of bridge deck

footing

Grade Control

Scour Hole filled in

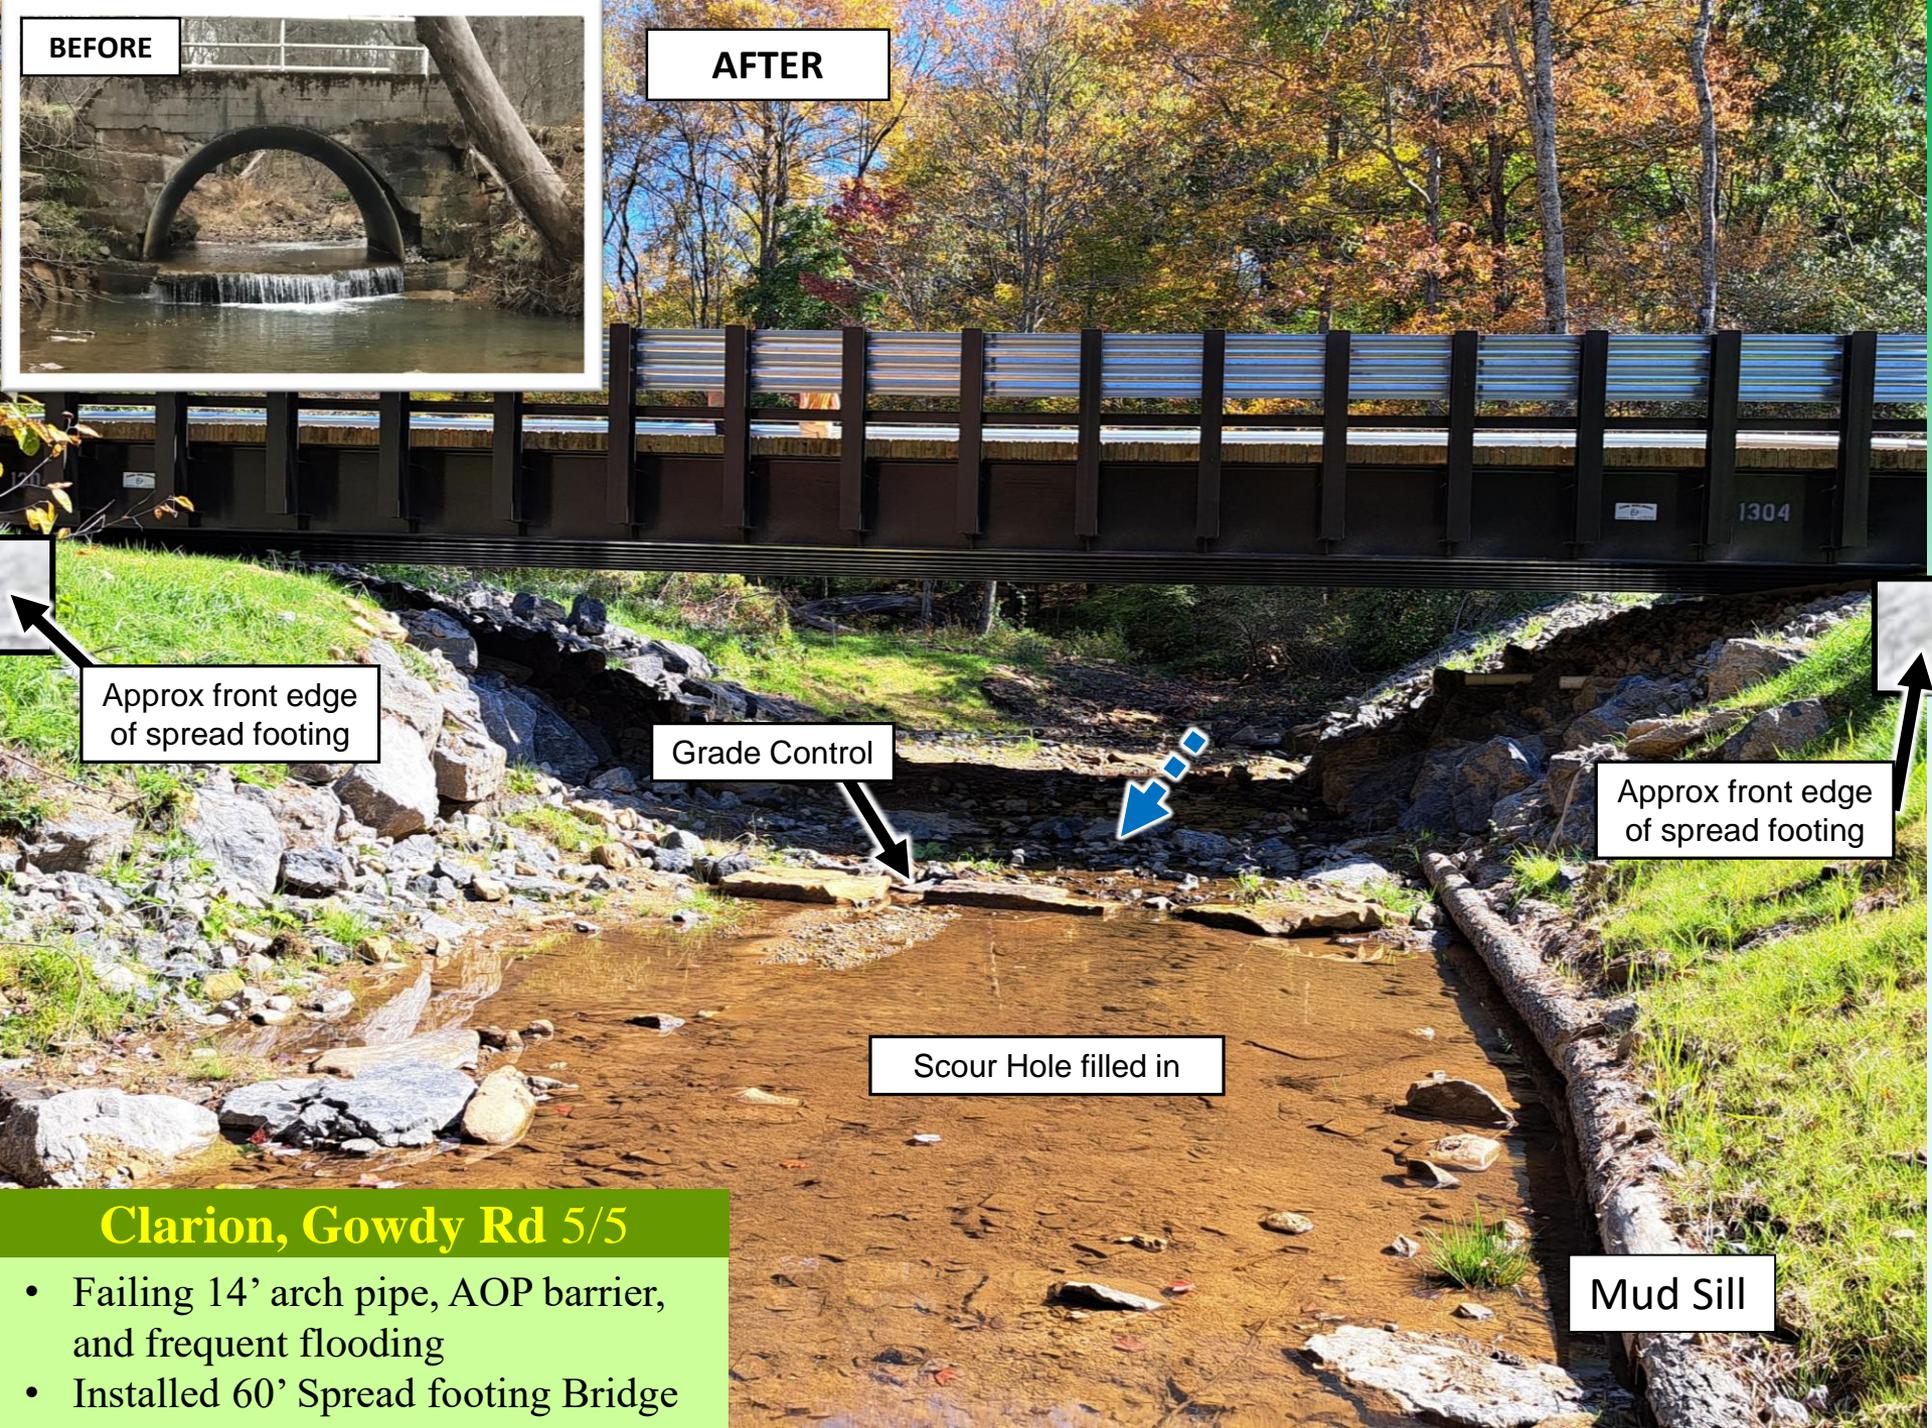
AFTER

Approx front edge of spread footing

Grade Control

Scour Hole filled in

Mud Sill

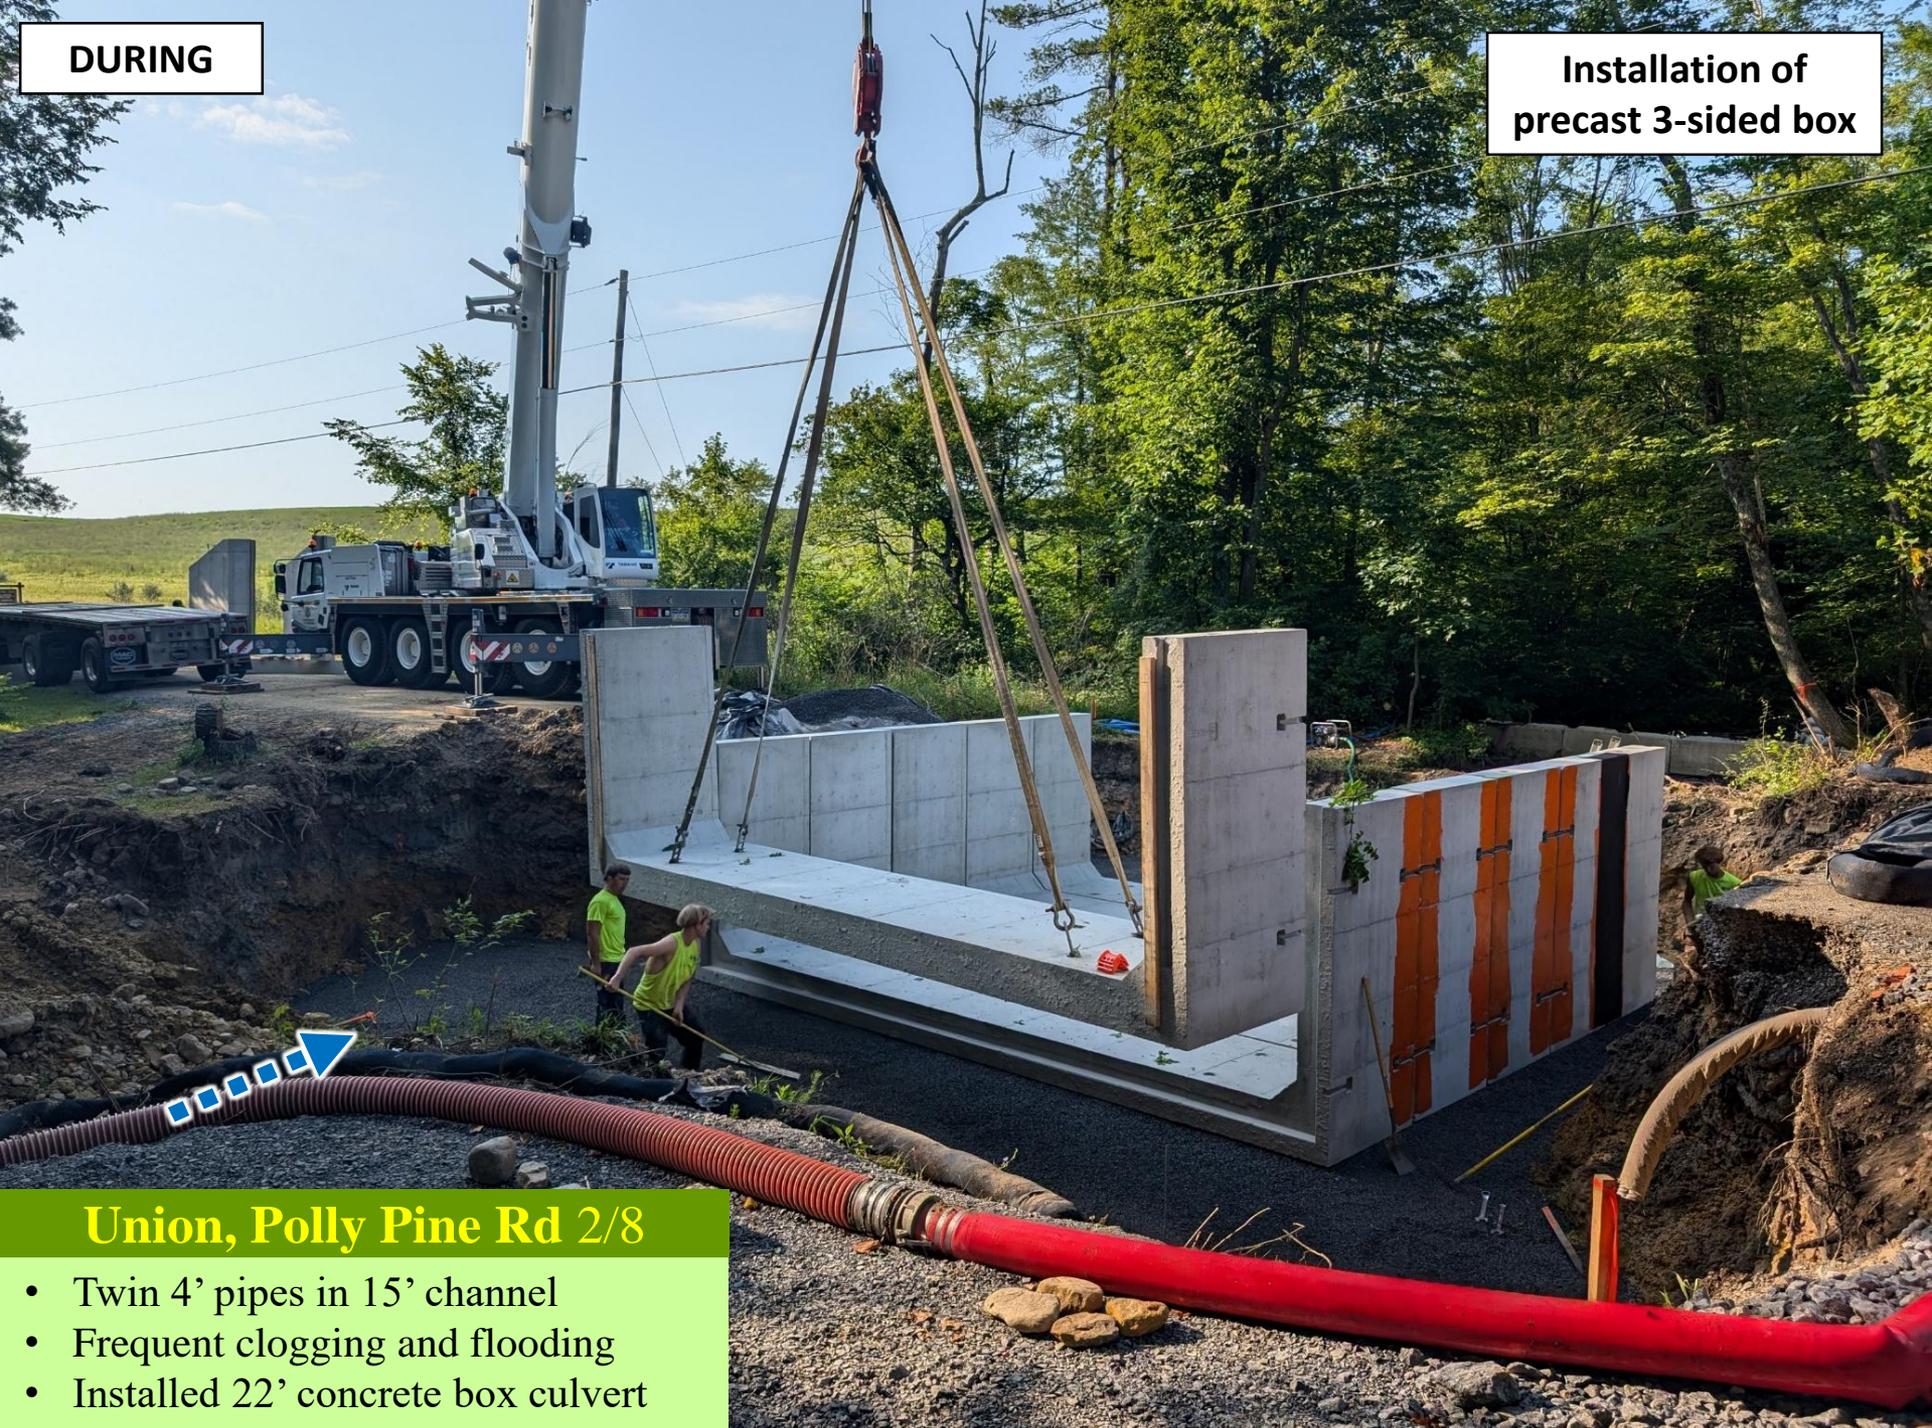
**Installation of
precast 3-sided box**

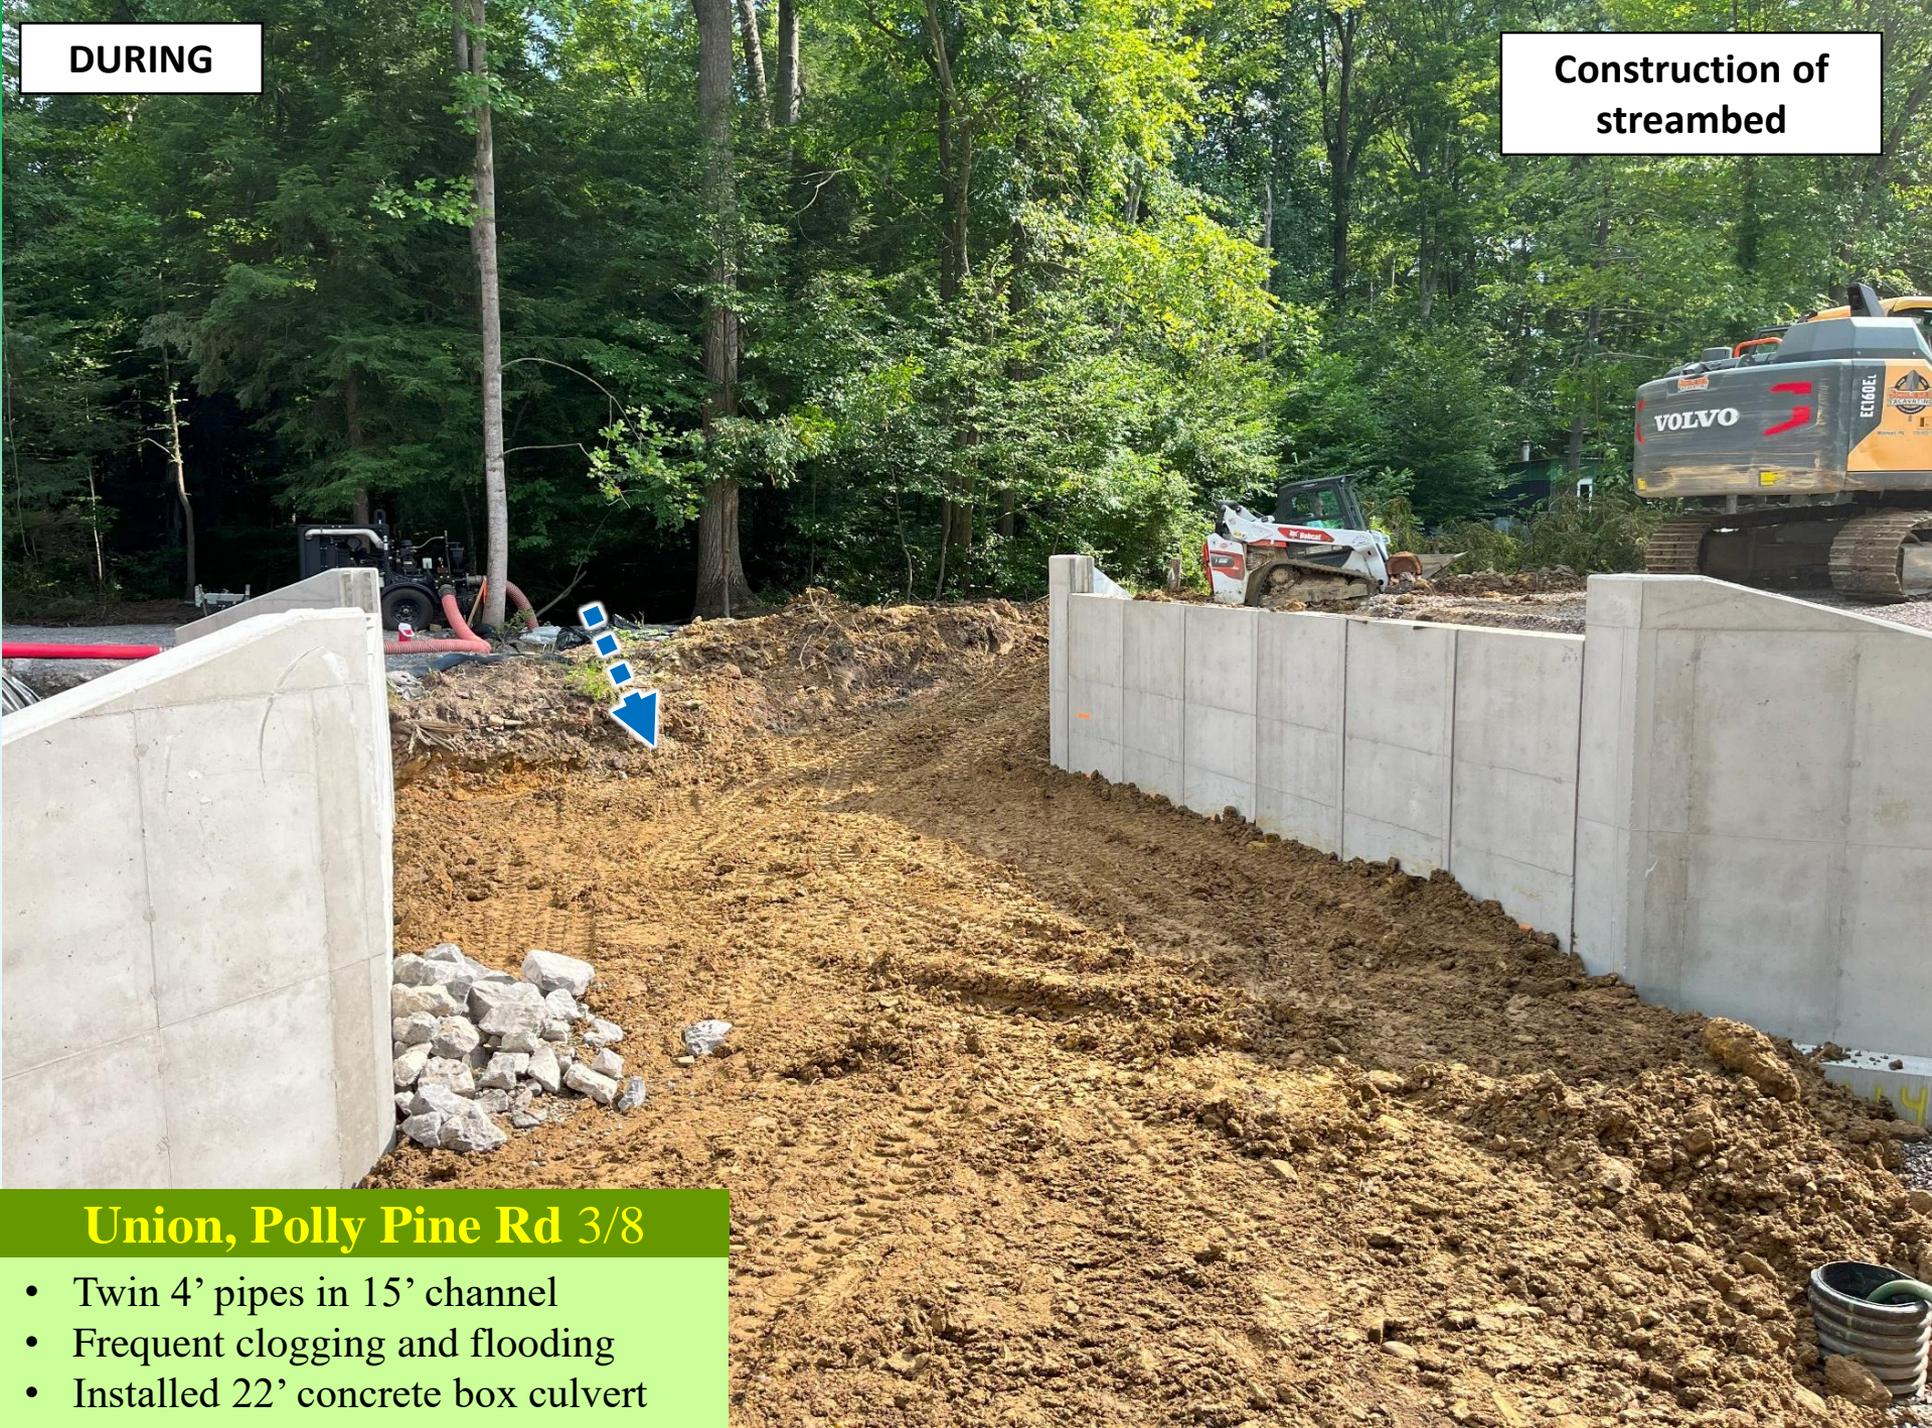
Construction of
streambed
