Environmentally Sensitive Maintenance for Dirt, Gravel, and Low-Volume Roads

Stream Crossings

Road/Stream Crossings

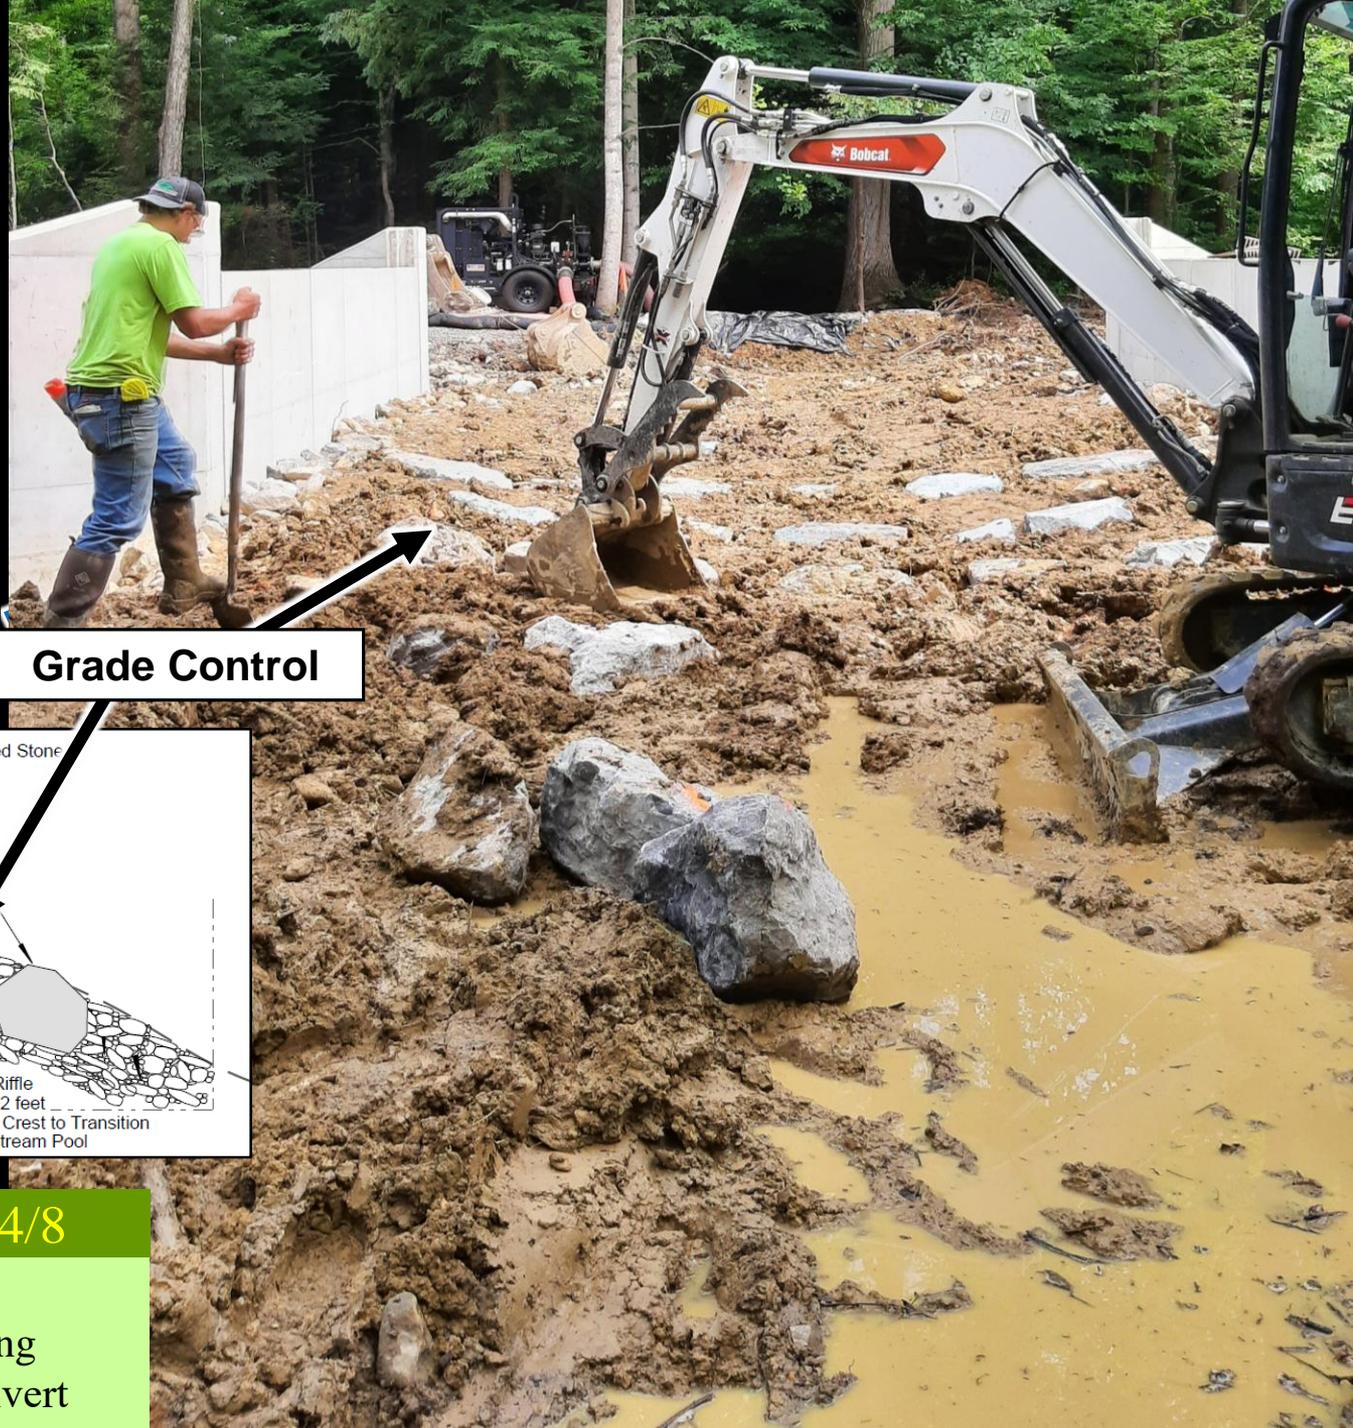
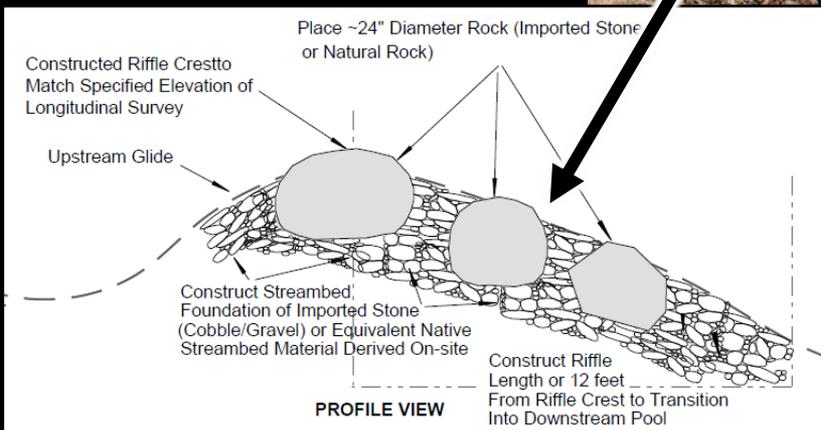
**Placement of
grade controls**

Grade Control

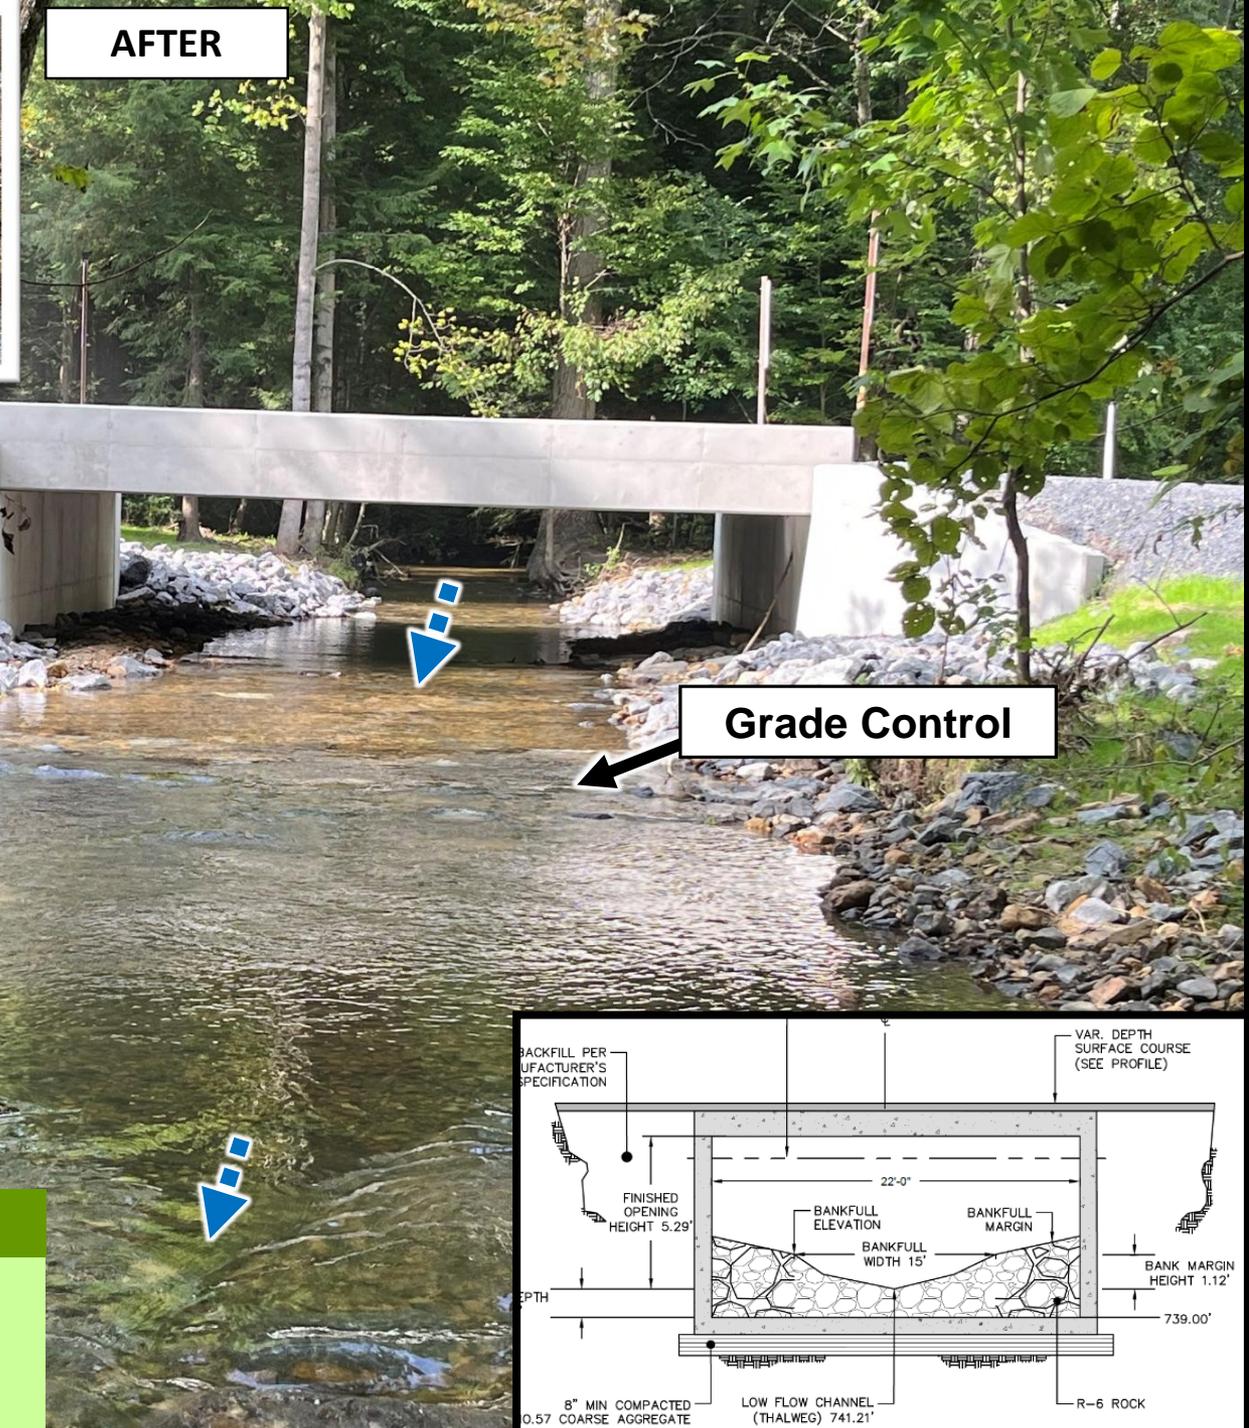
AFTER

Grade Control

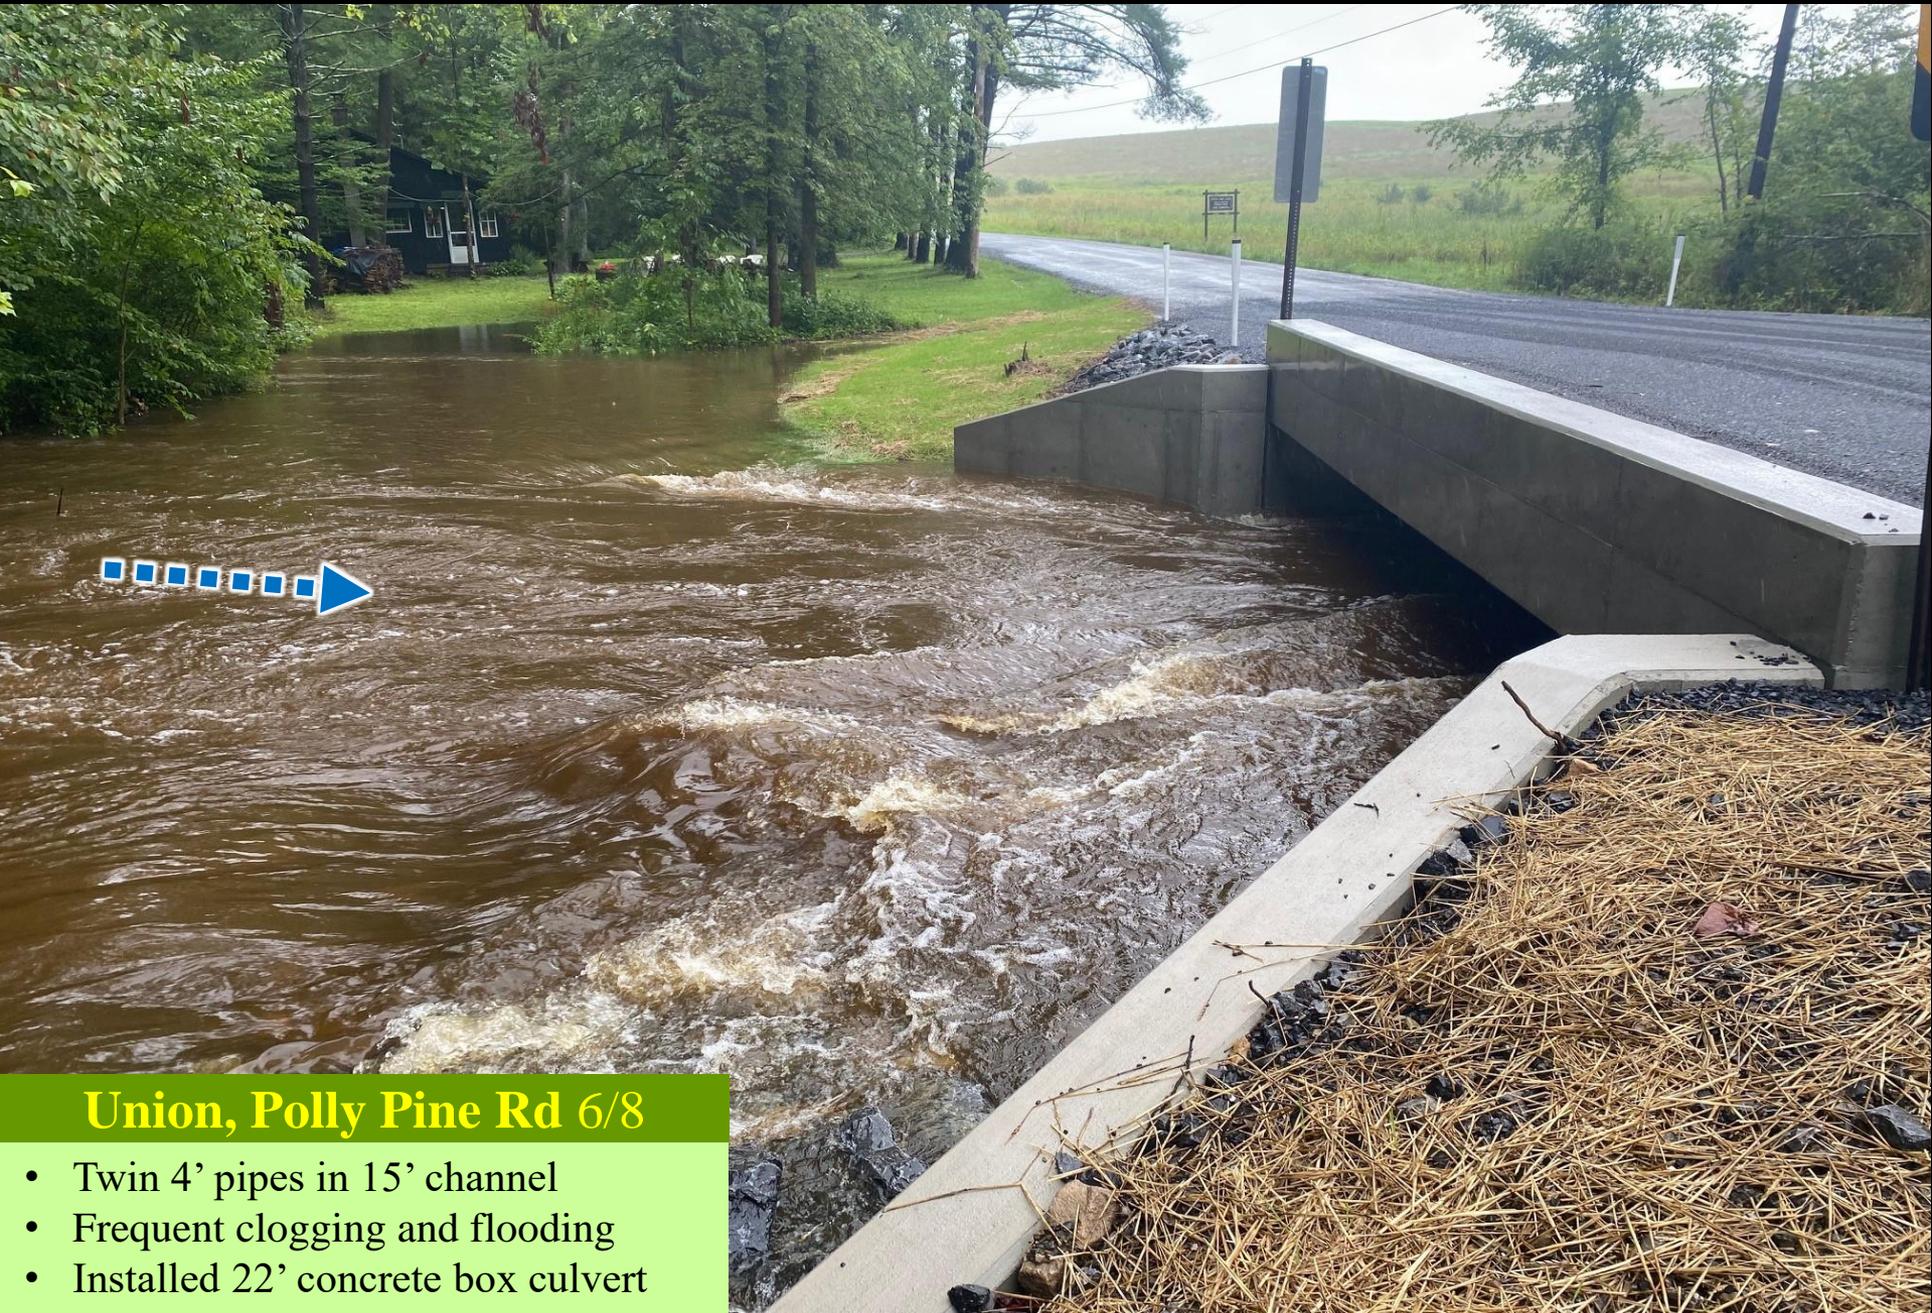
Union, Polly Pine Rd 6/8

- Twin 4' pipes in 15' channel
- Frequent clogging and flooding
- Installed 22' concrete box culvert

Hurricane Debbie, ~7" of rain, 3 weeks post construction

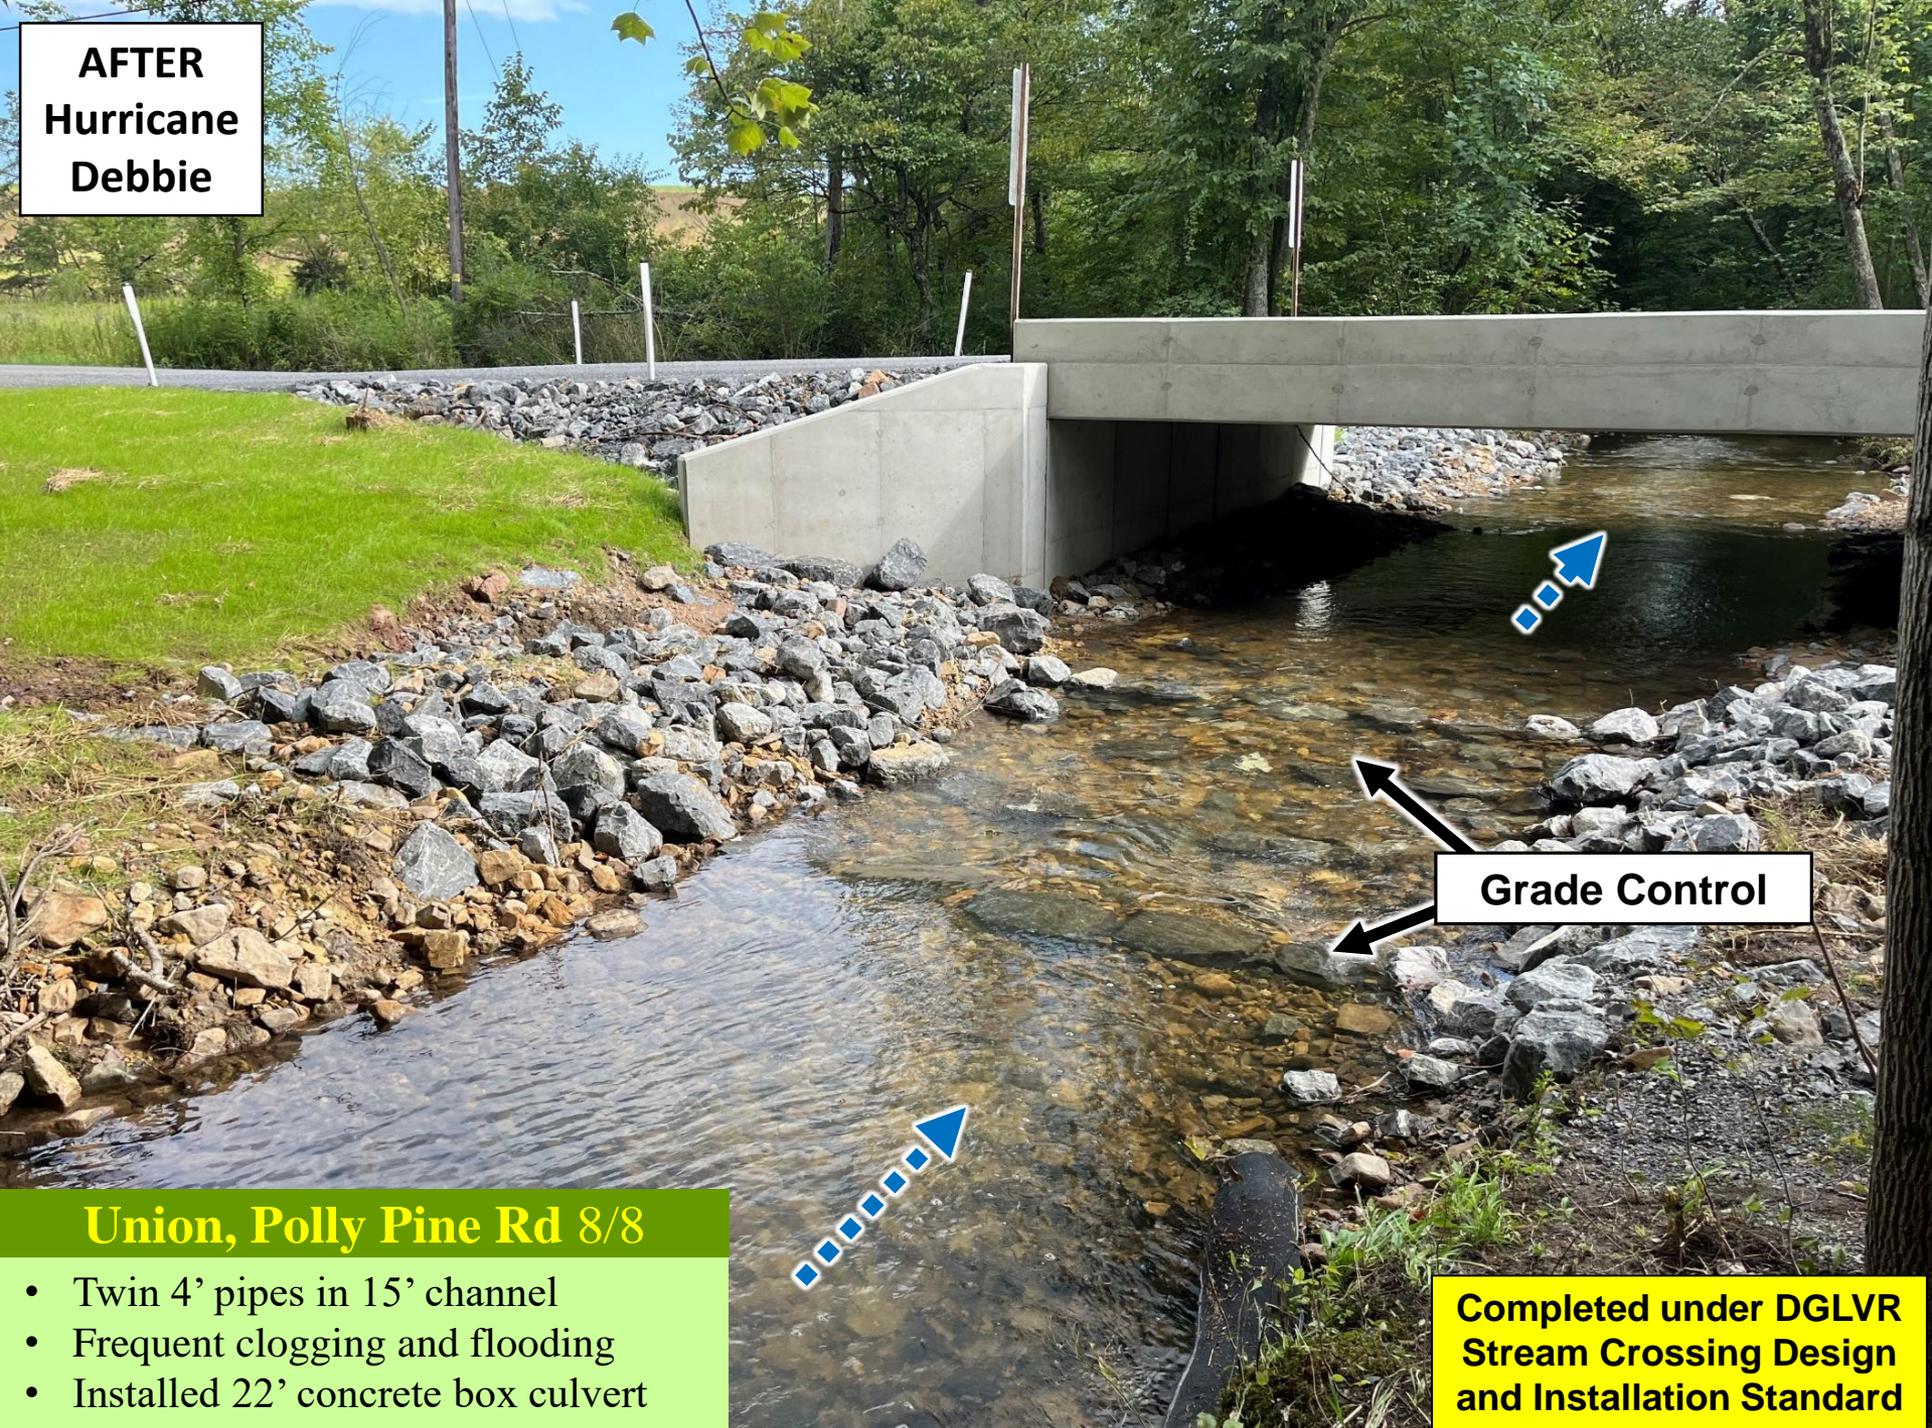
Union, Polly Pine Rd 8/8

Grade Control

- Twin 4' pipes in 15' channel
- Frequent clogging and flooding
- Installed 22' concrete box culvert

**Completed under DGLVR
Stream Crossing Design
and Installation Standard**

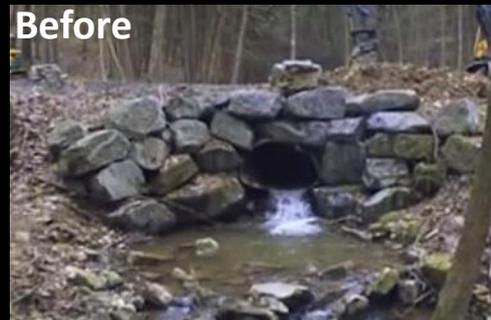
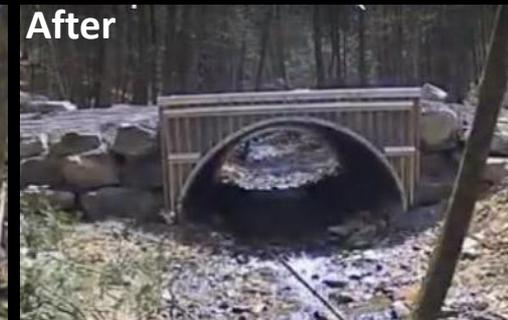
Huntingdon: Shaver's Creek Time Lapse

Problem: Failing 6' squash pipe in a headwater stream with a 14' bankfull channel. Undersized crossing had created a significant upstream sediment wedge and downstream scour hole with a ~3' outlet drop.

Fix: A 15' x 10' structural plate pipe arch was assembled and installed with headwall/endwall. Streambed was re-established in the pipe and three log cross vanes were installed upstream to control the grade and return the stream to its natural condition.

- Existing 6' Squash Pipe
- 13' Bankfull Channel
- Installed 15' Structural Plate Arch

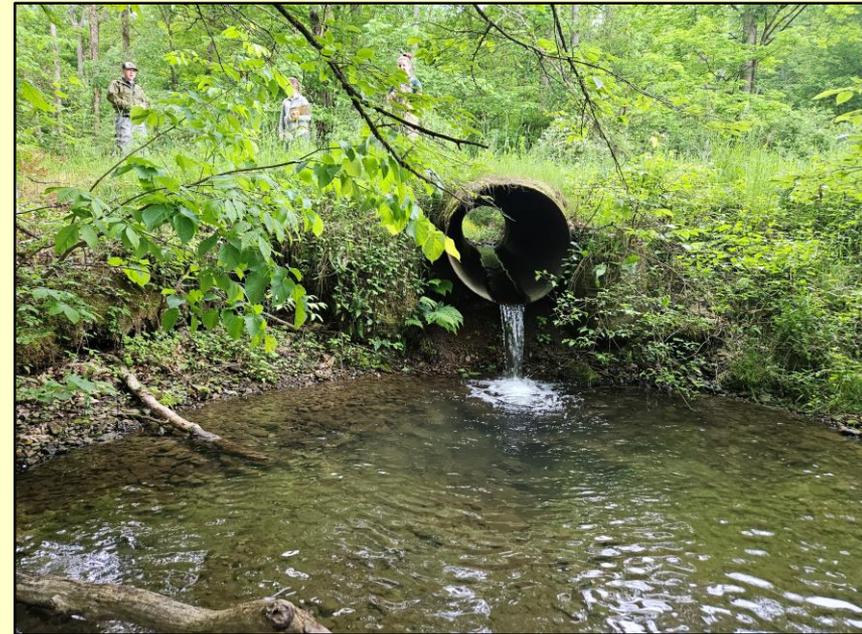
Ex. 4' pipe in a stream with 10' bankfull width

- $4/10 = 40\%$ - **ELIGIBLE**

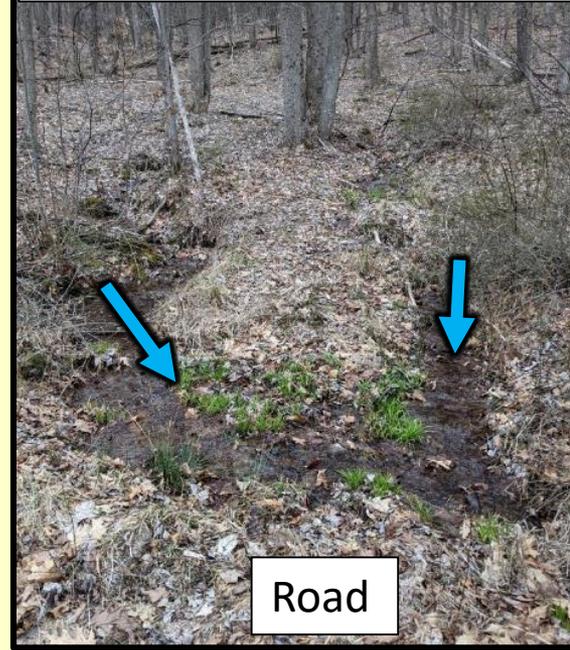
Stream is a small spring

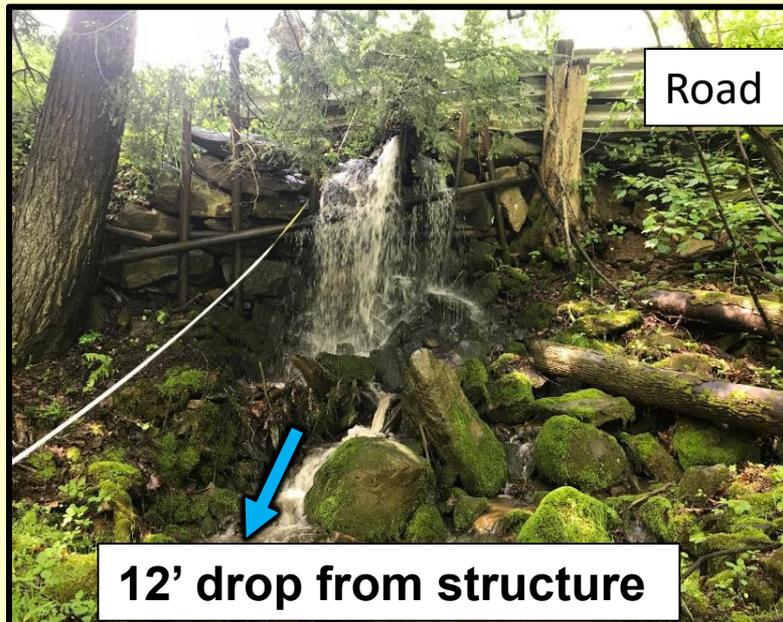
Where Connectivity is Impossible

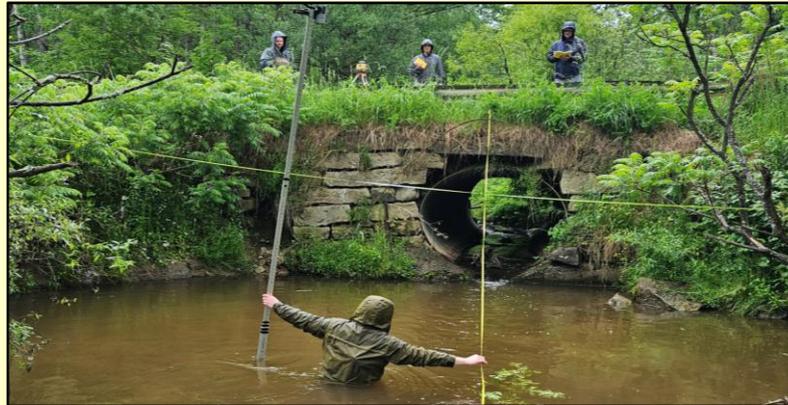
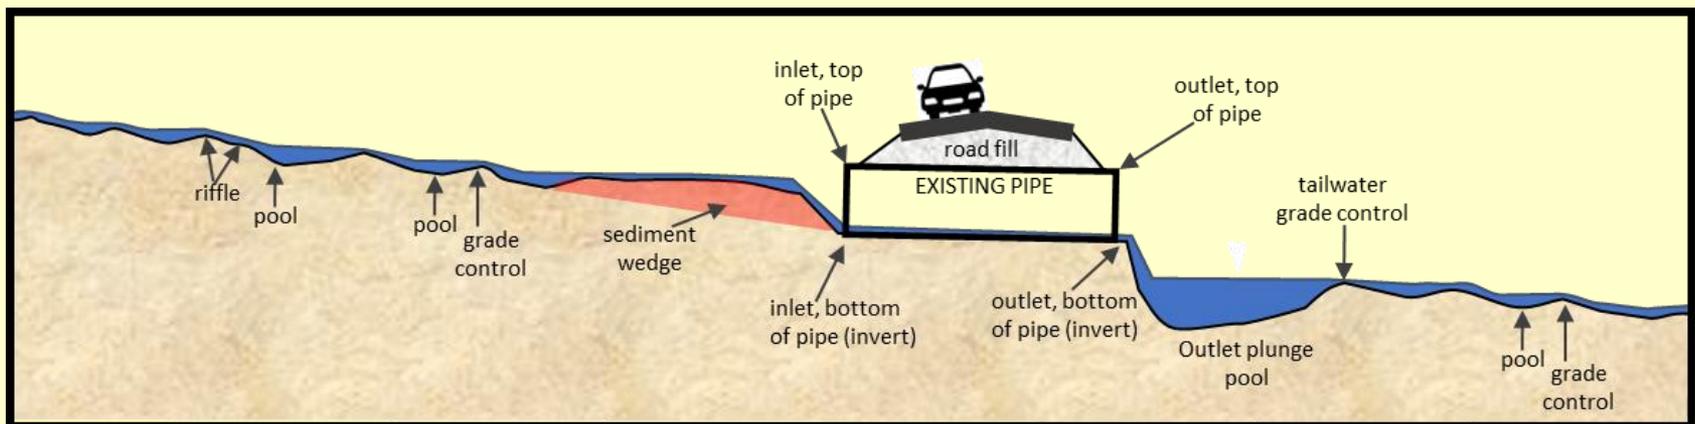
Site Survey: Survey done by CD

- Guides project estimates and budgets
- Informs structure selection and channel reconstruction

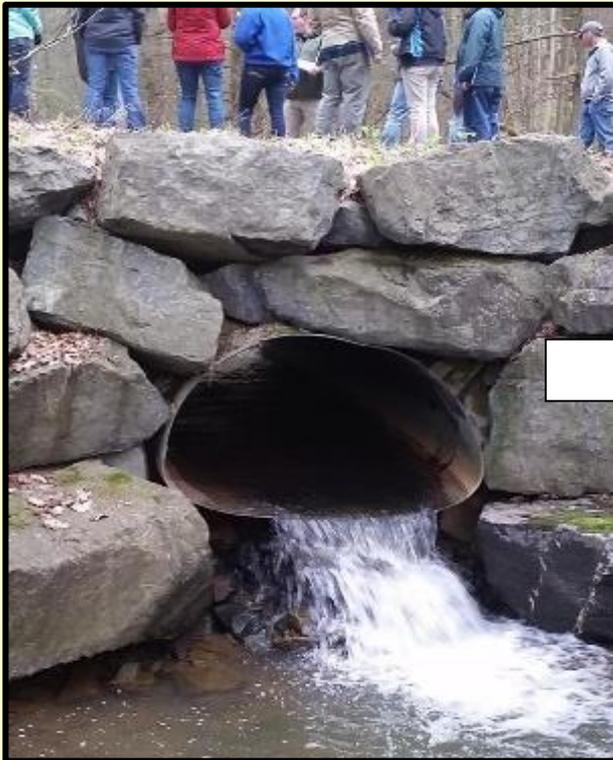
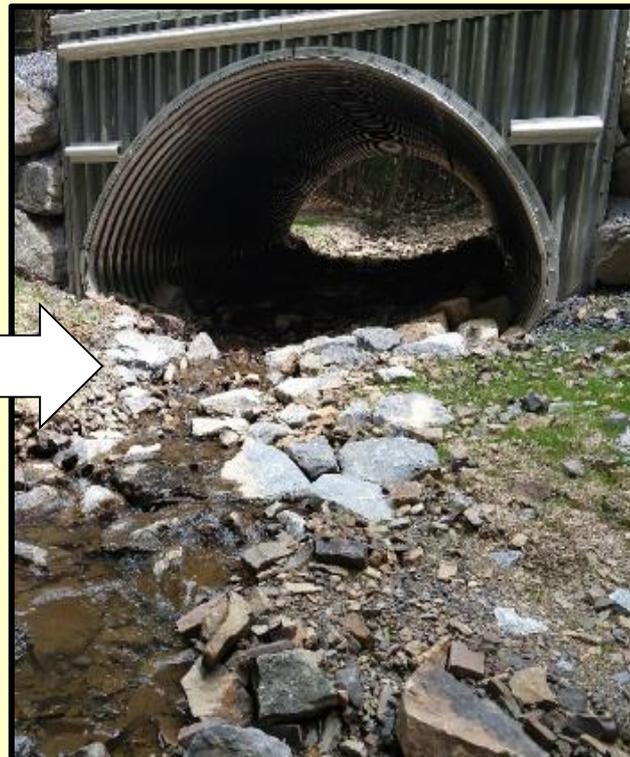
Structure sizing and selection: CD & Engineer

- Engineer will select a structure to pass 100-year storm at 80% capacity
- New structures will be significantly larger than existing structures (minimum of 125% of bankfull)

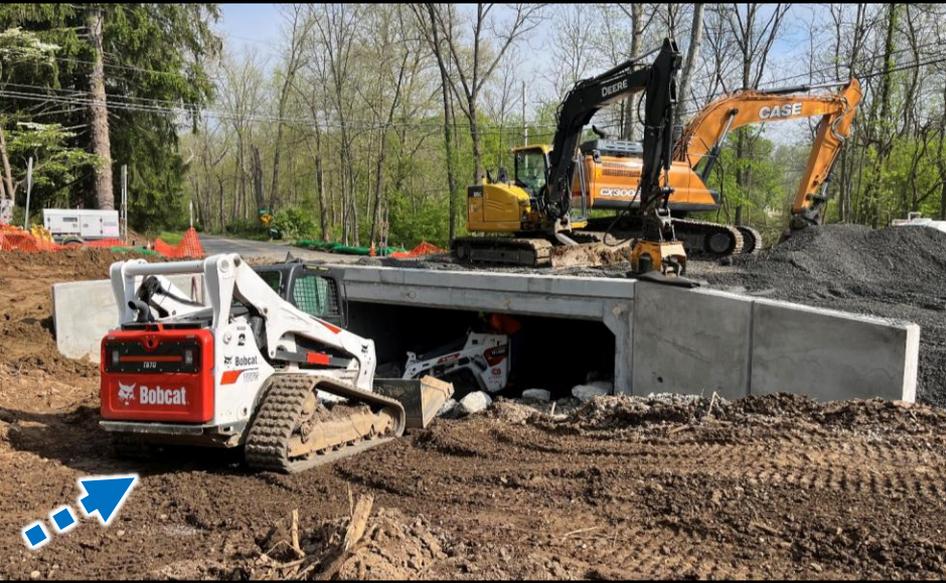
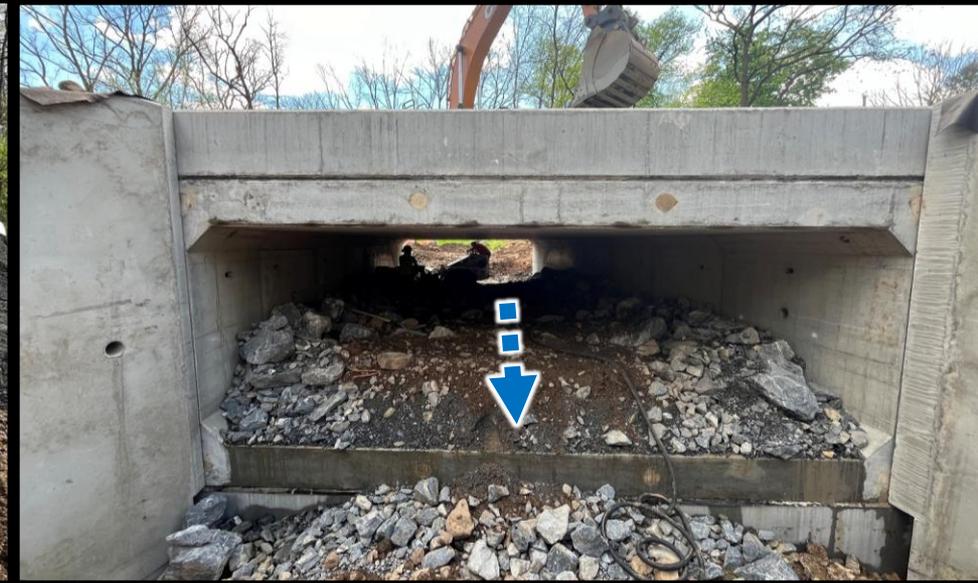
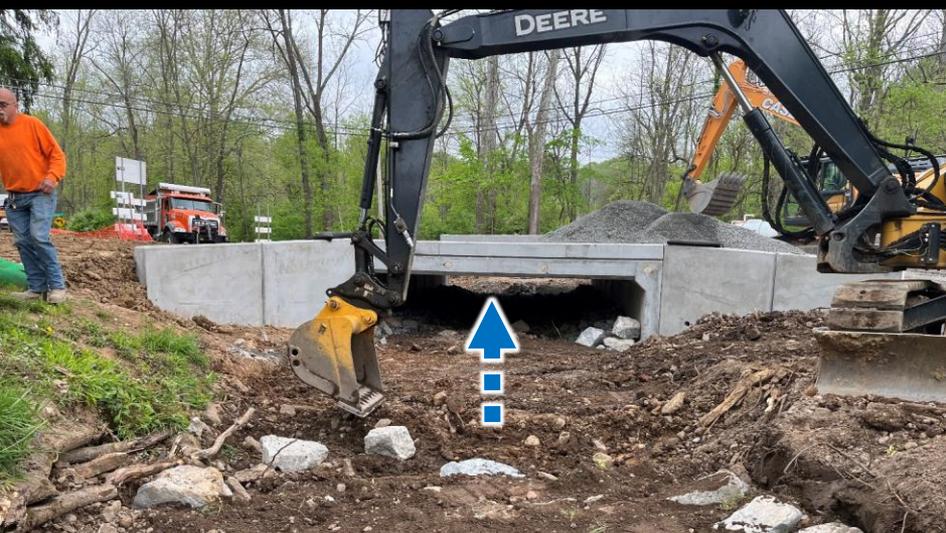
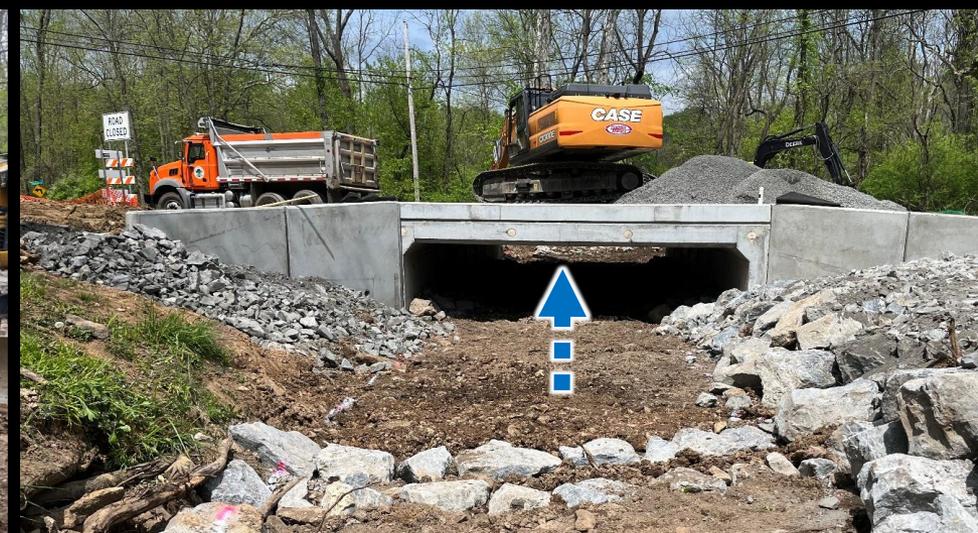
Stream Restoration: CD & Engineer

Requires more channel design, work, and reconstruction

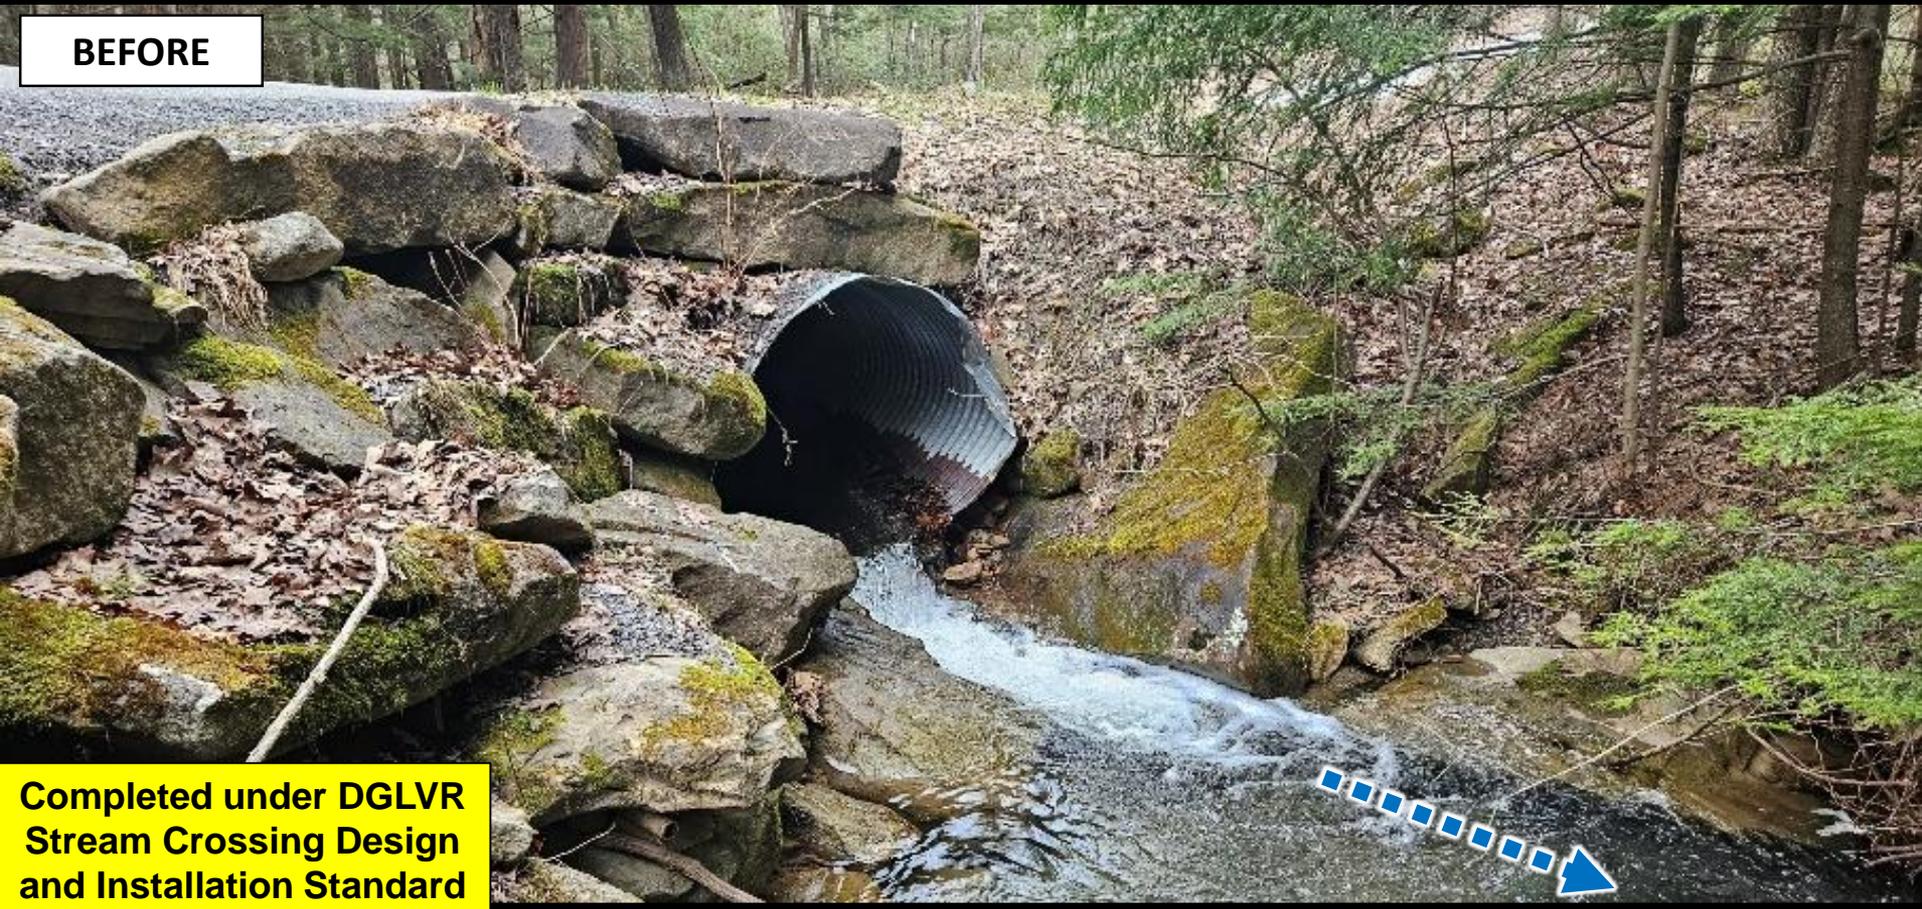
BEFORE

- **2024: \$130K Grant, \$45K in-kind**
- 4' pipe in 12' channel caused outlet drop and AOP barrier in trout stream
- Installed 18' bottomless arch pipe on poured concrete footings

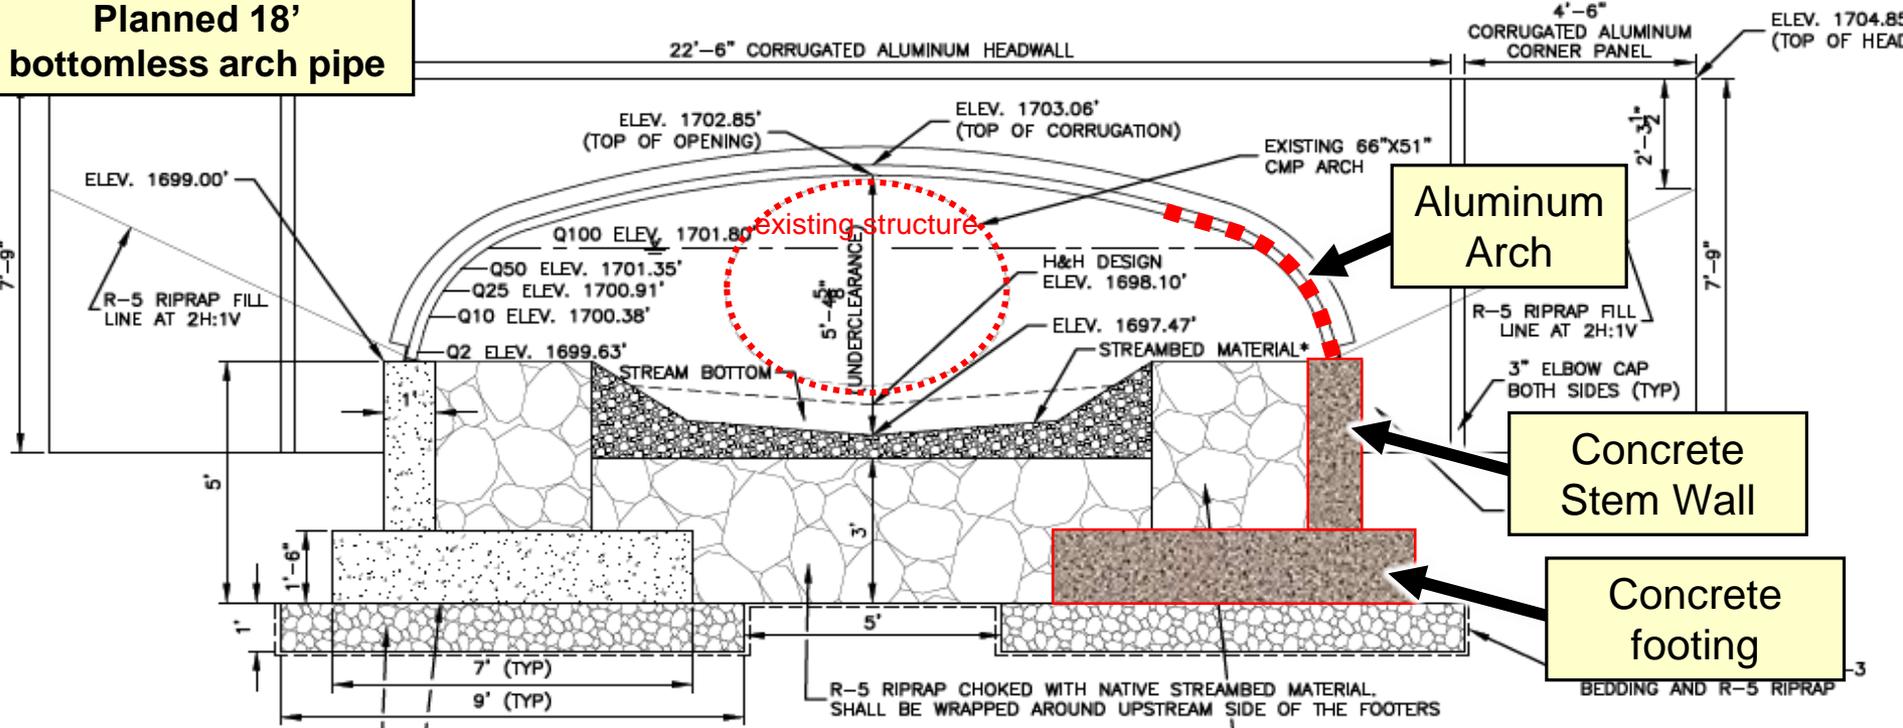
Planned 18' bottomless arch pipe

NOTE: FOR THIS PROJECT, CONSTRUCTED RIFFLE LENGTH (UPSTREAM TO DOWNSTREAM) IS 15.8'

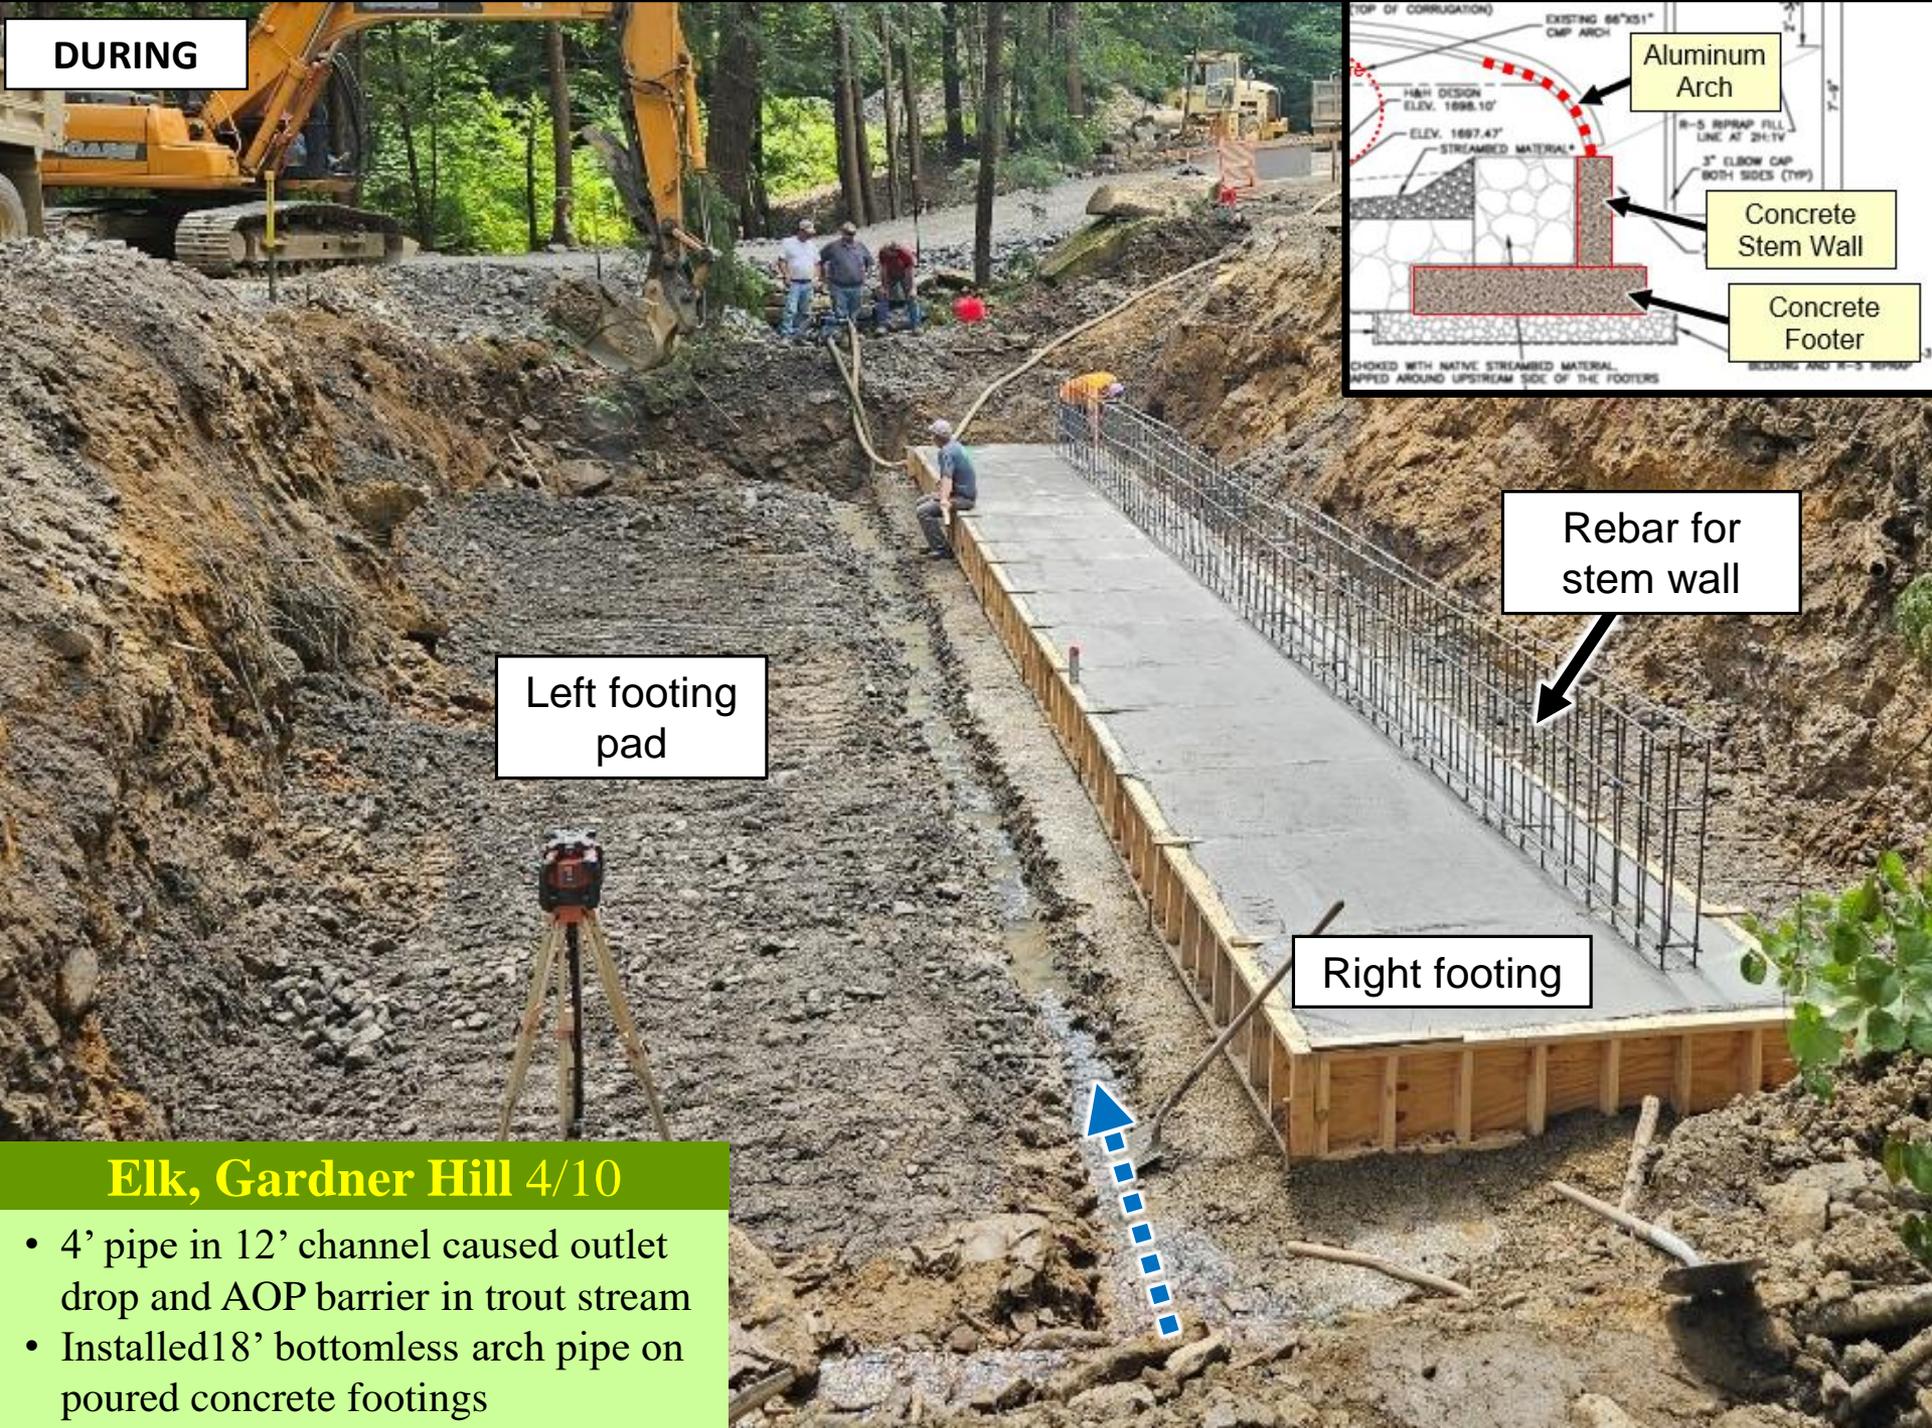
DURING

Left footing pad

Rebar for stem wall
