Environmentally Sensitive Maintenance for Dirt, Gravel, and Low-Volume Roads

Stream Crossings

Road/Stream Crossings

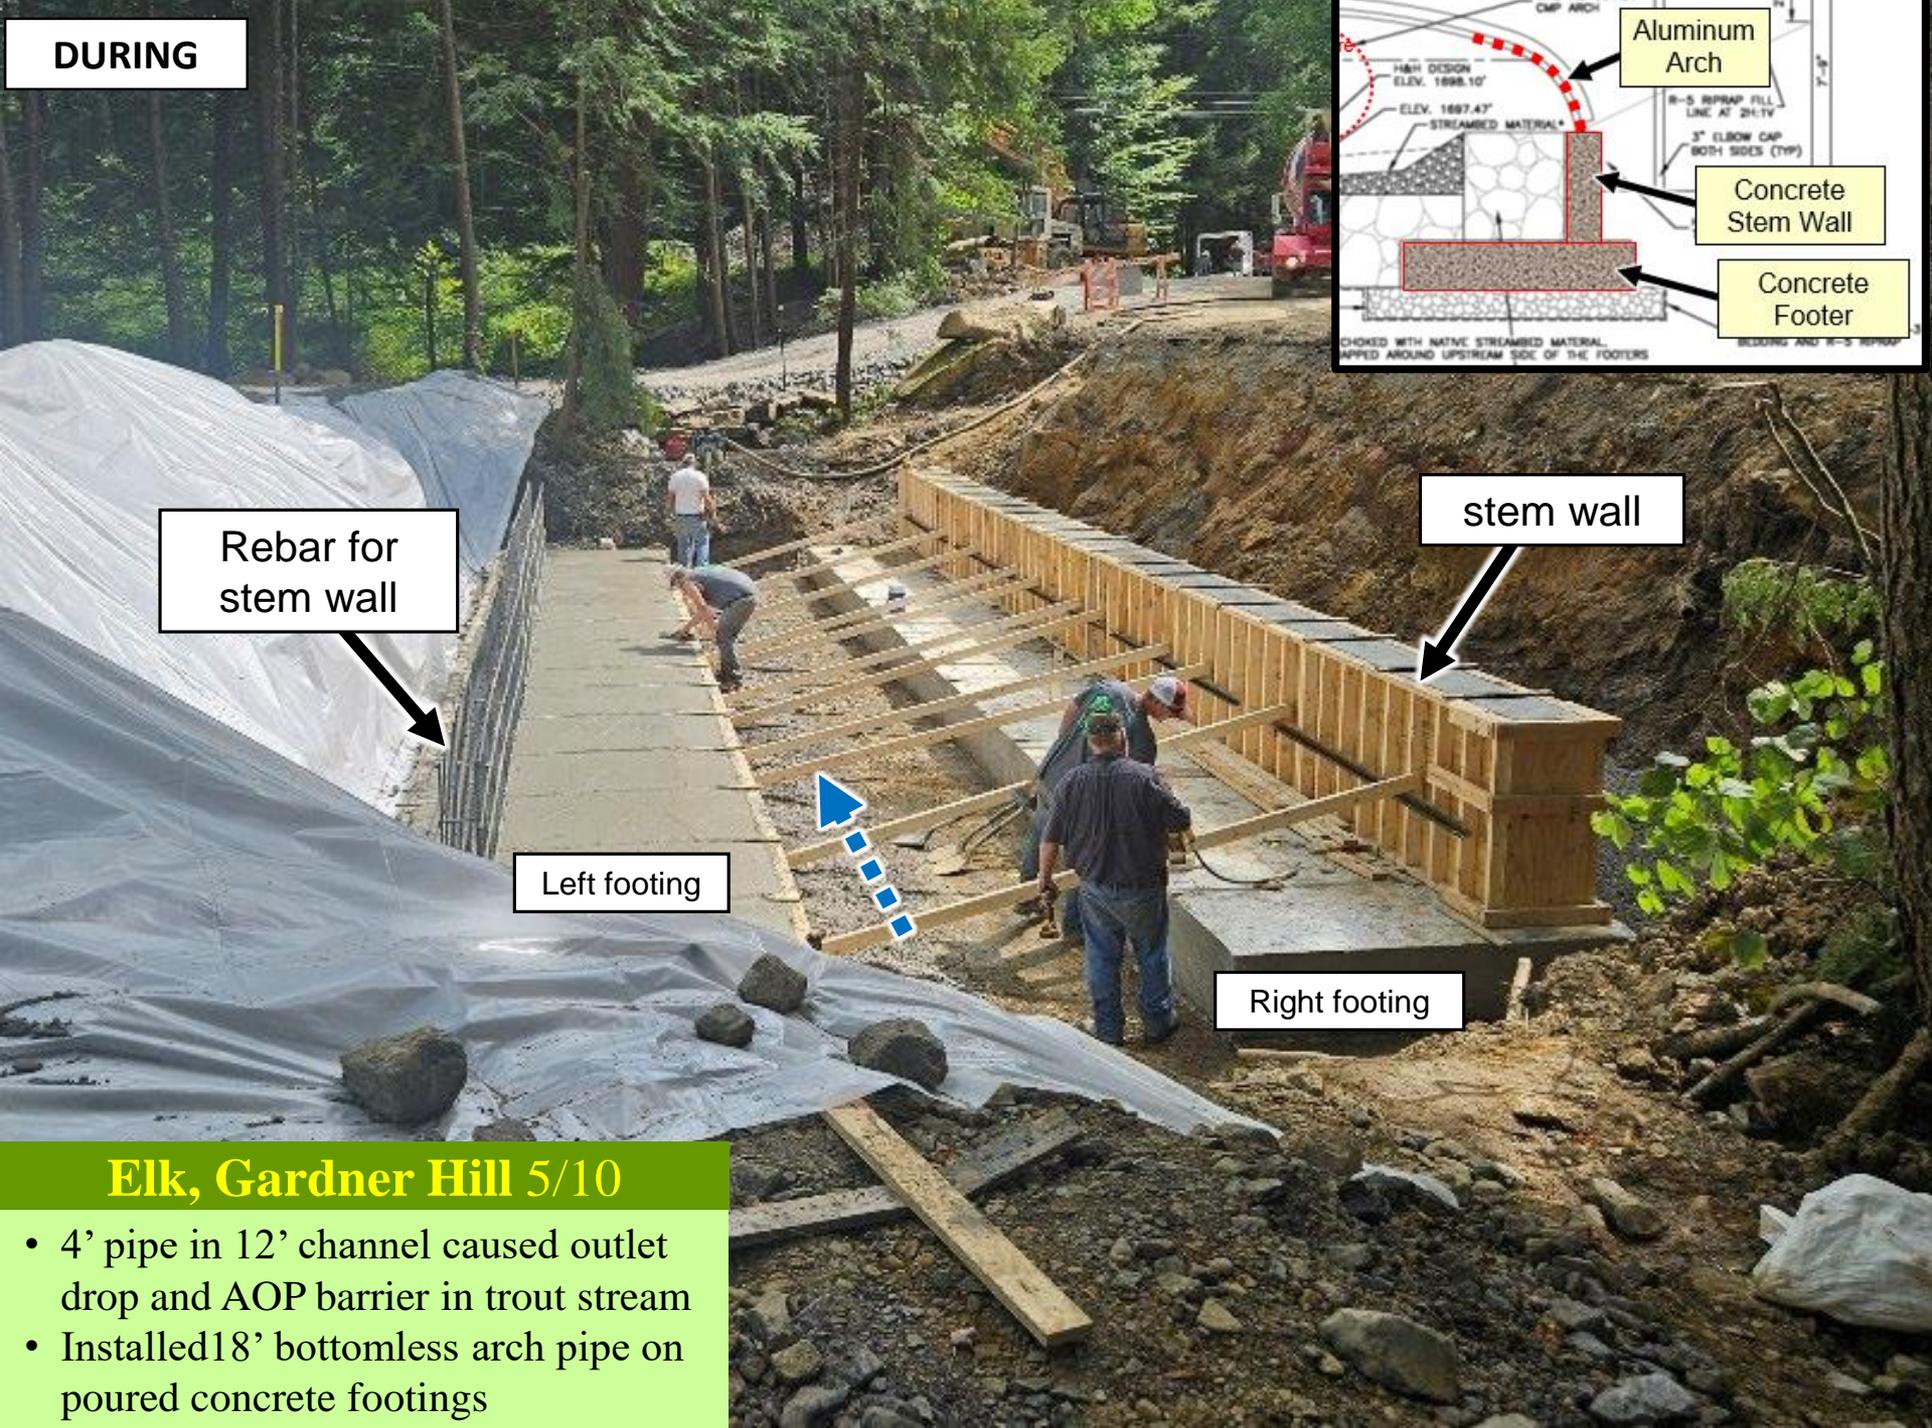
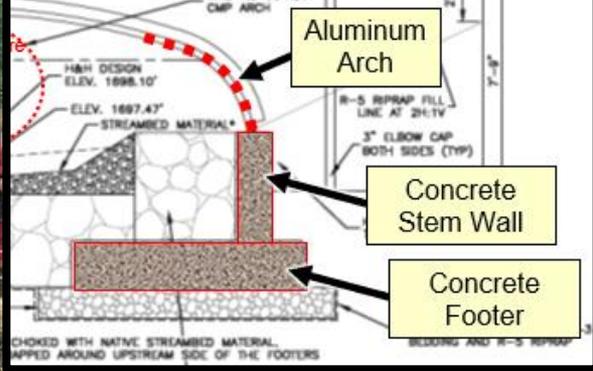
DURING

Rebar for stem wall

Left footing

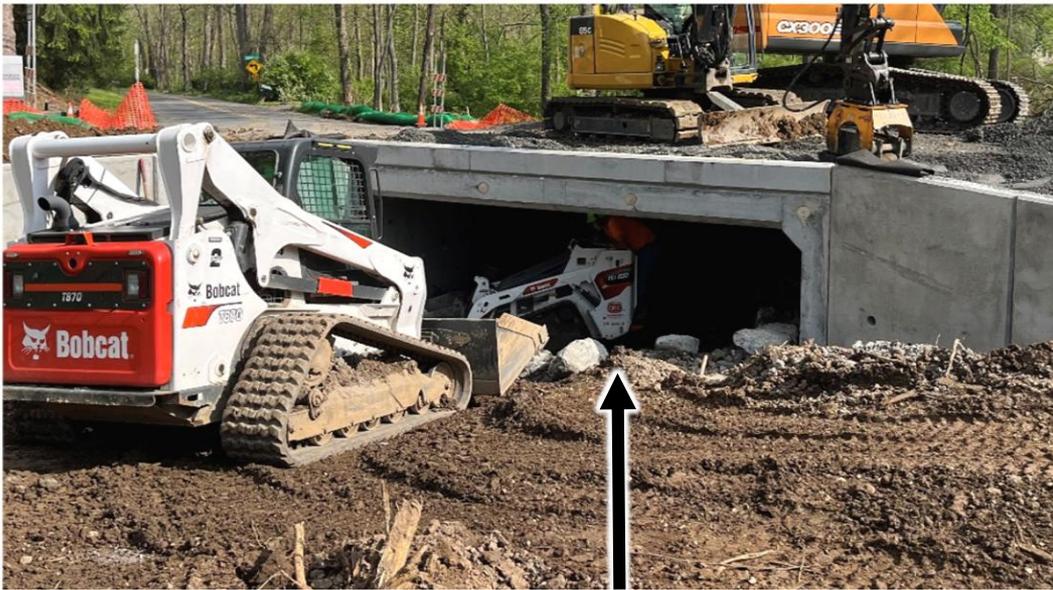
Stem walls allow streambed construction before installing top

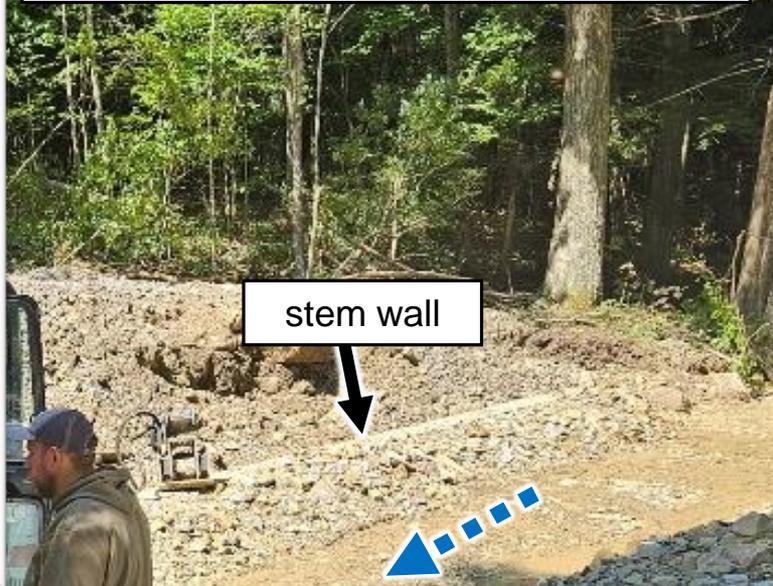
stem wall

Easier than building the streambed with top on!

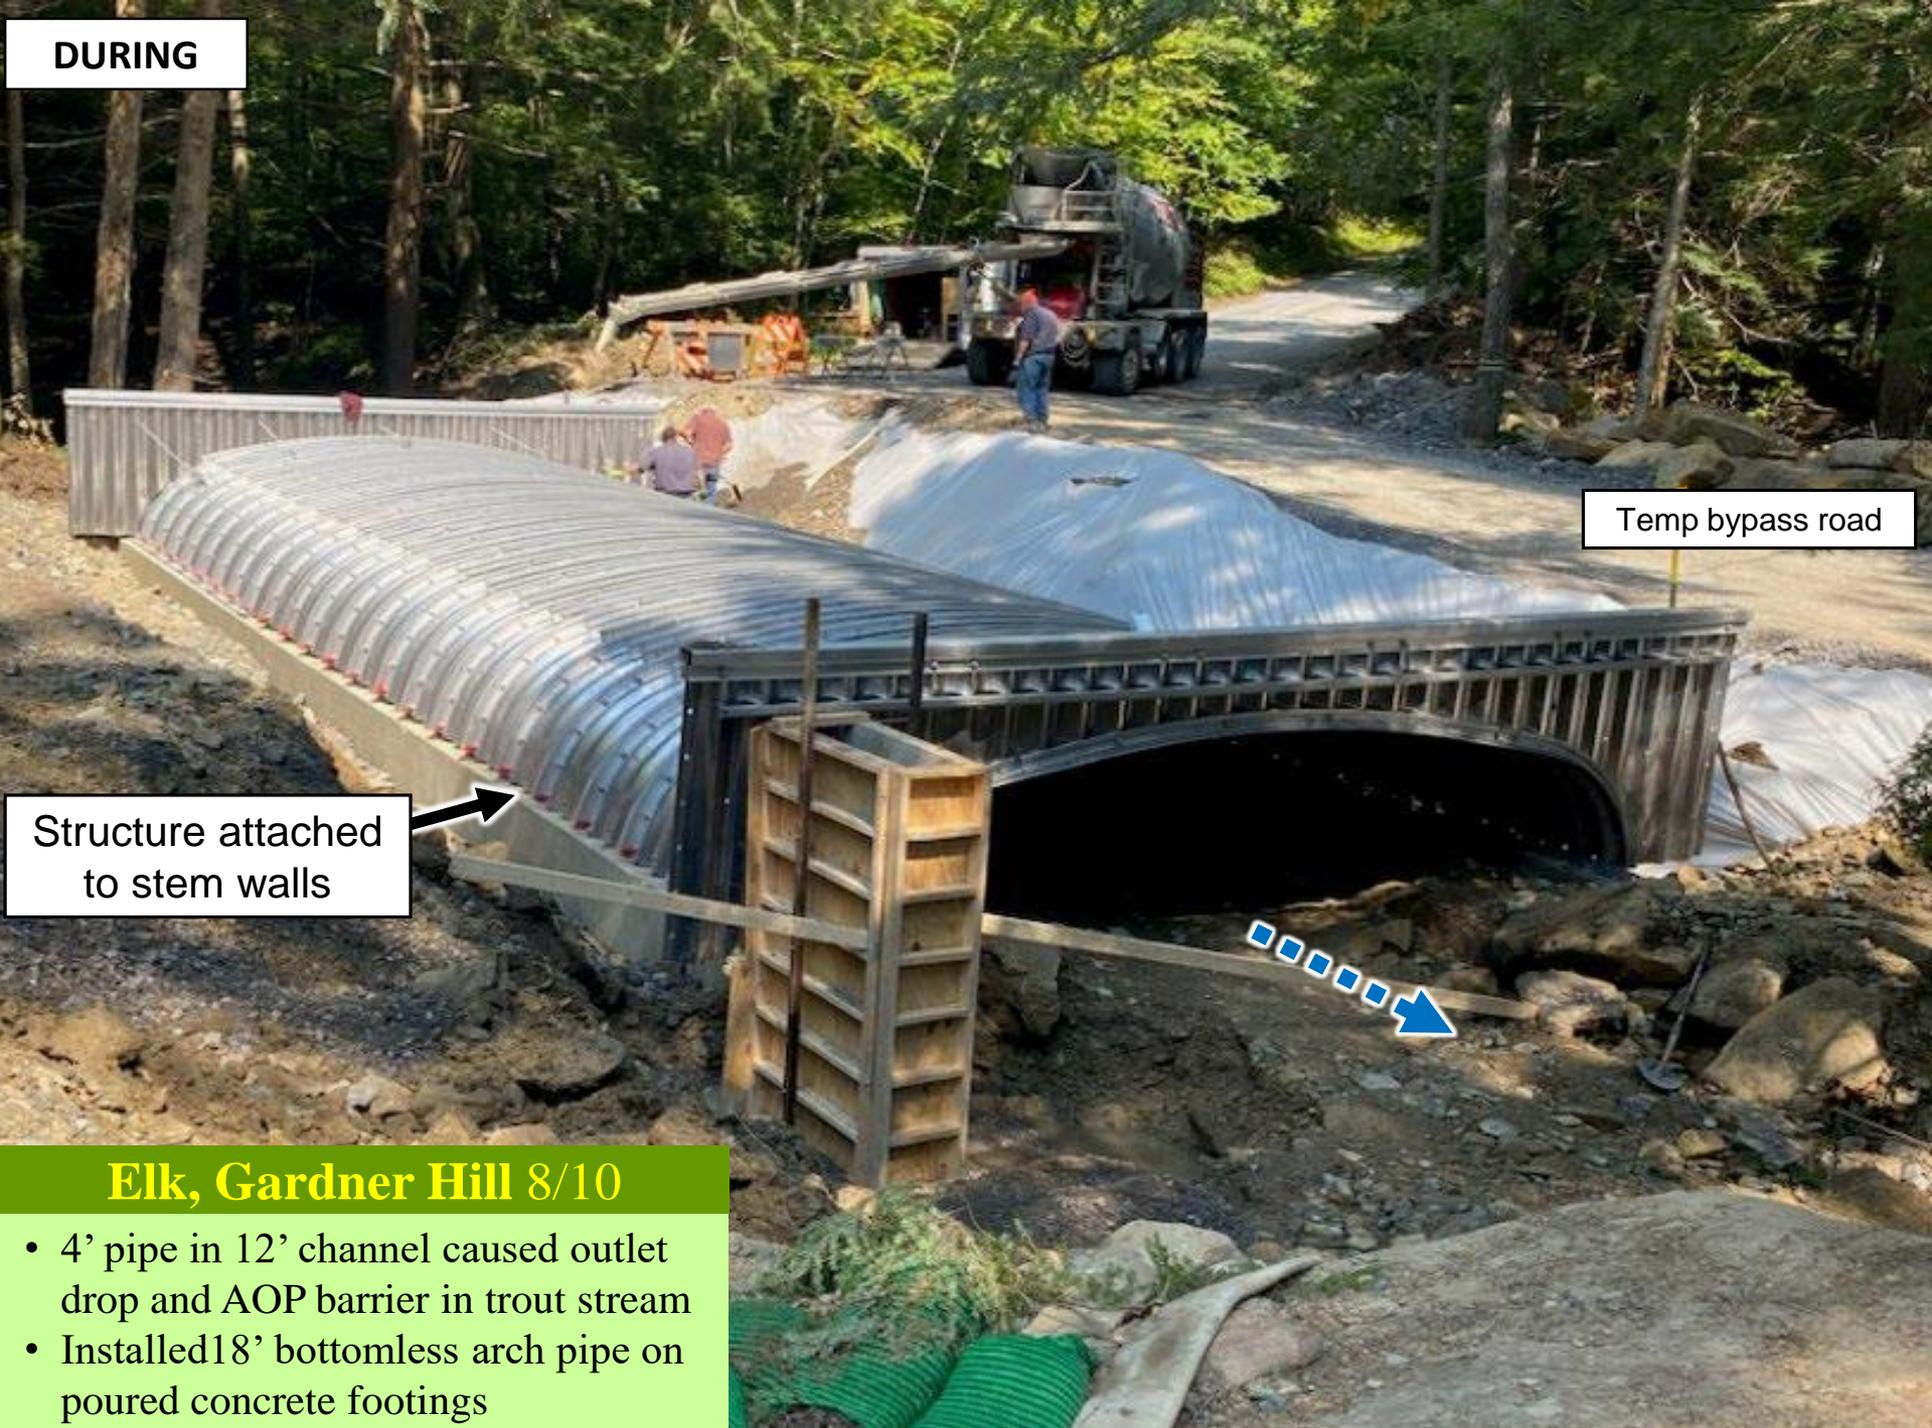
DURING

Temp bypass road

Structure attached
to stem walls

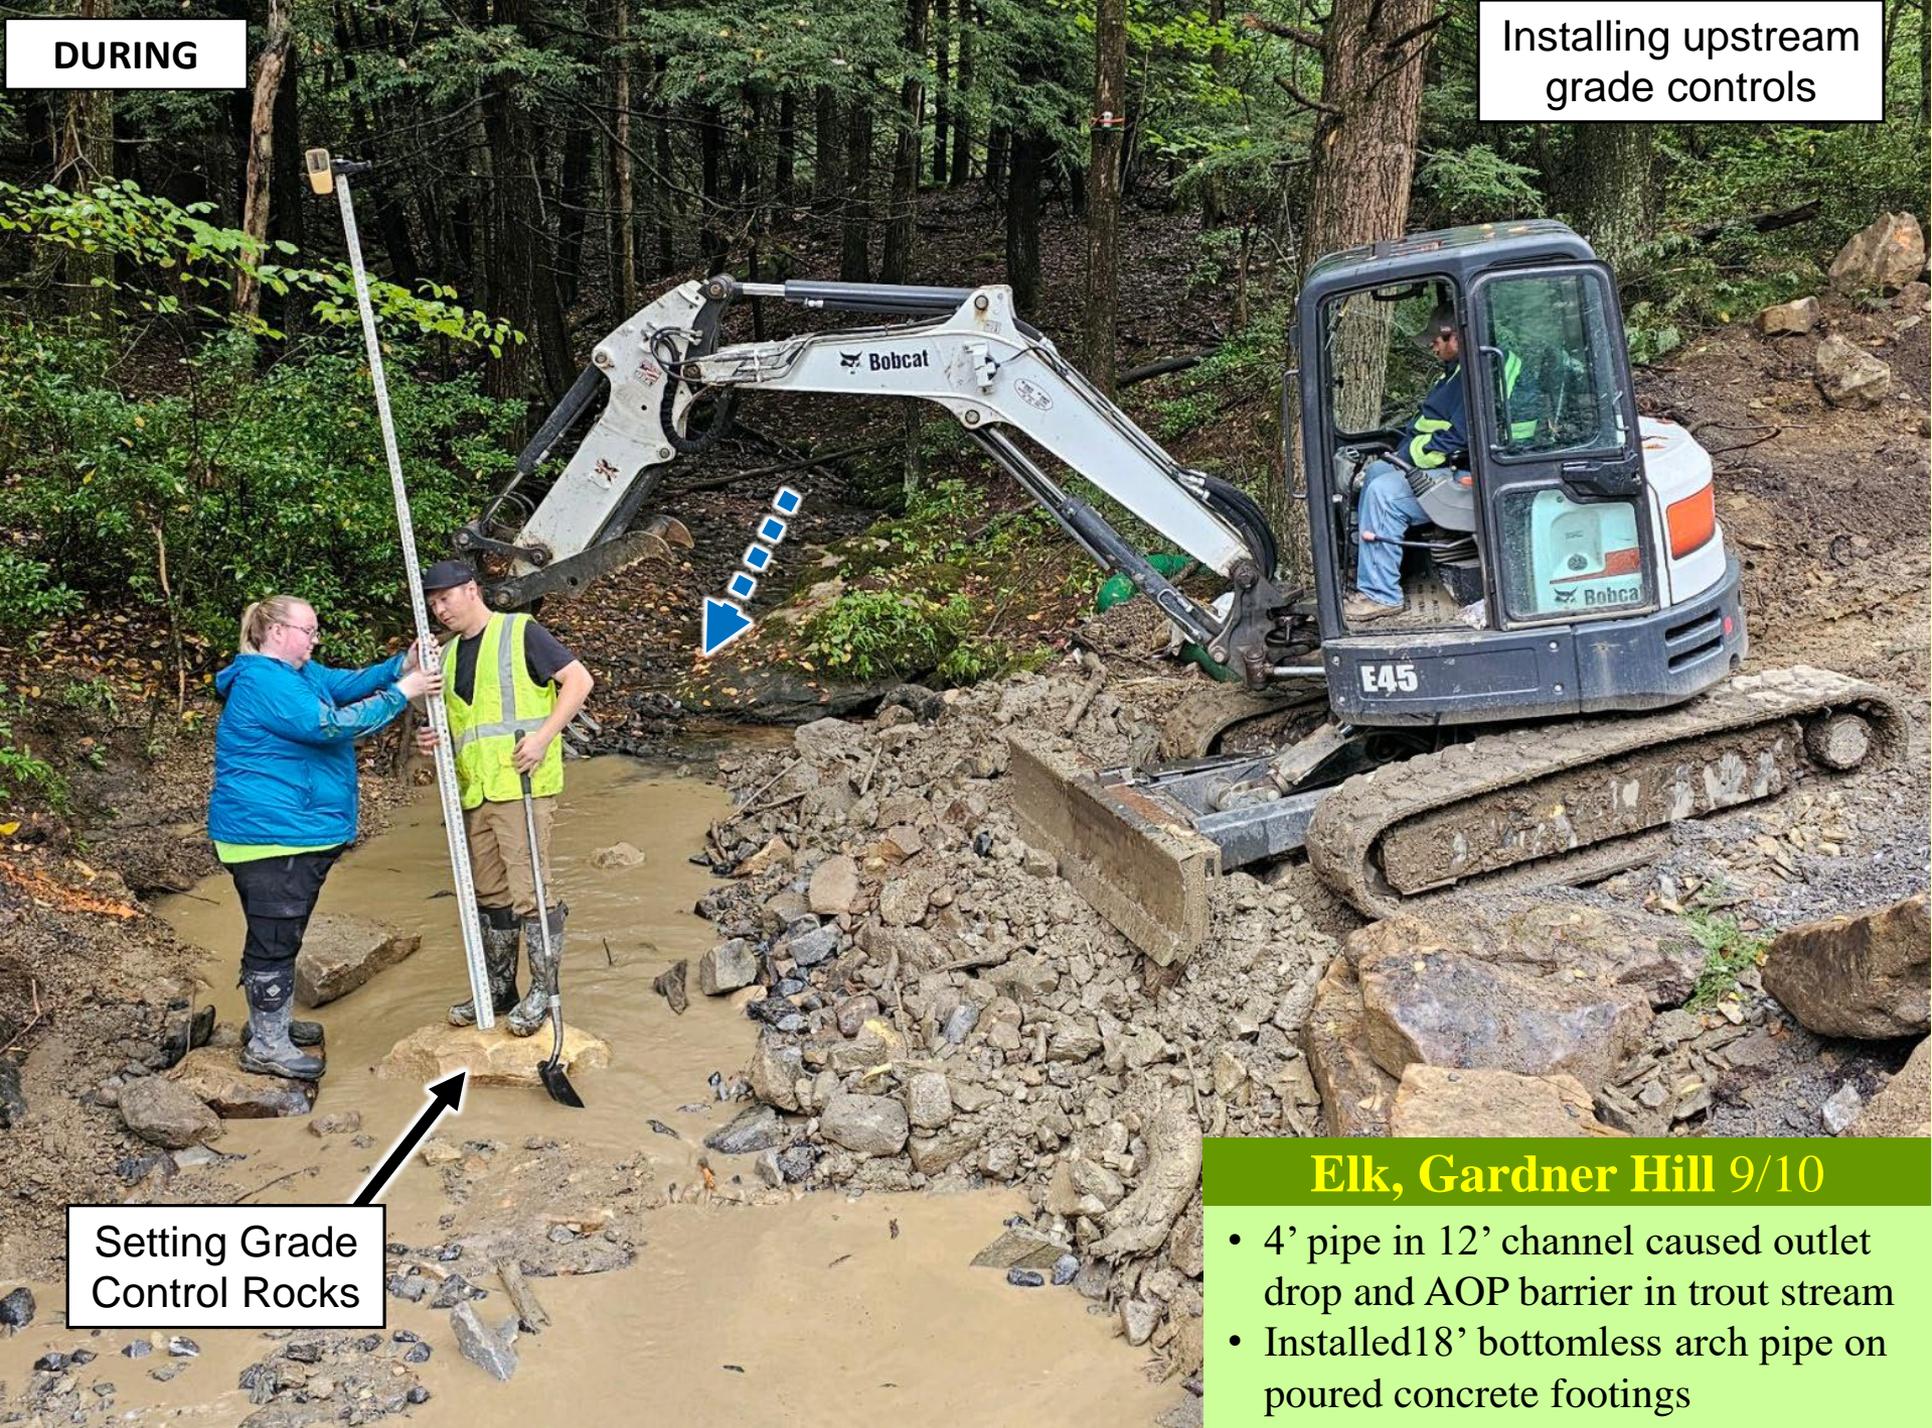
DURING

Installing upstream
grade controls

Setting Grade
Control Rocks

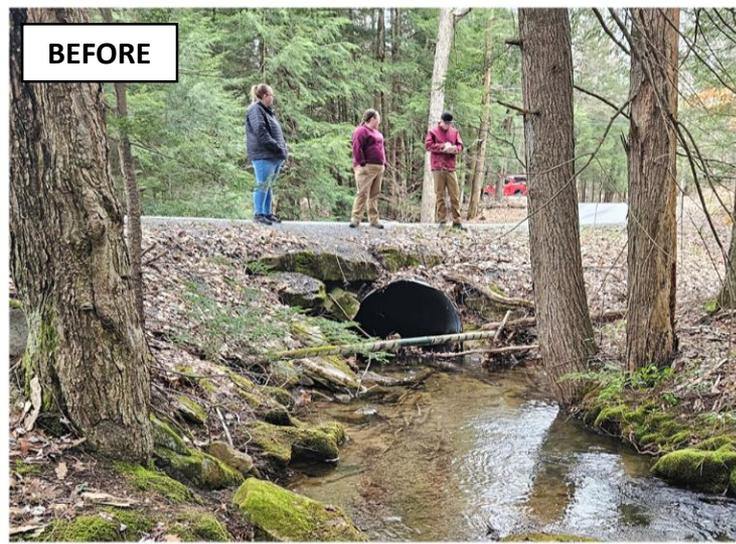
BEFORE

- 4' pipe in 12' channel caused outlet drop and AOP barrier in trout stream
- Installed 18' bottomless arch pipe on poured concrete footings

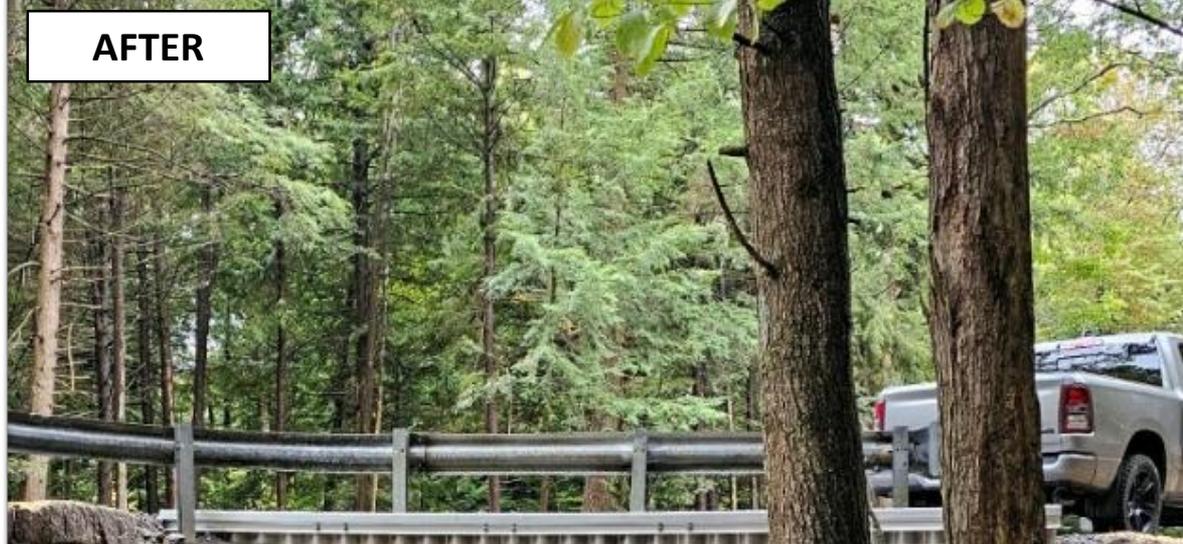
AFTER

Grade Control
Rocks
