Derry Community Pool – Infiltration Parking Lot

Design features: Porous pavement, rain garden, trees

Date of Installation: 2015

Location: Derry Area Community Pool, Derry Borough, Westmoreland County PA

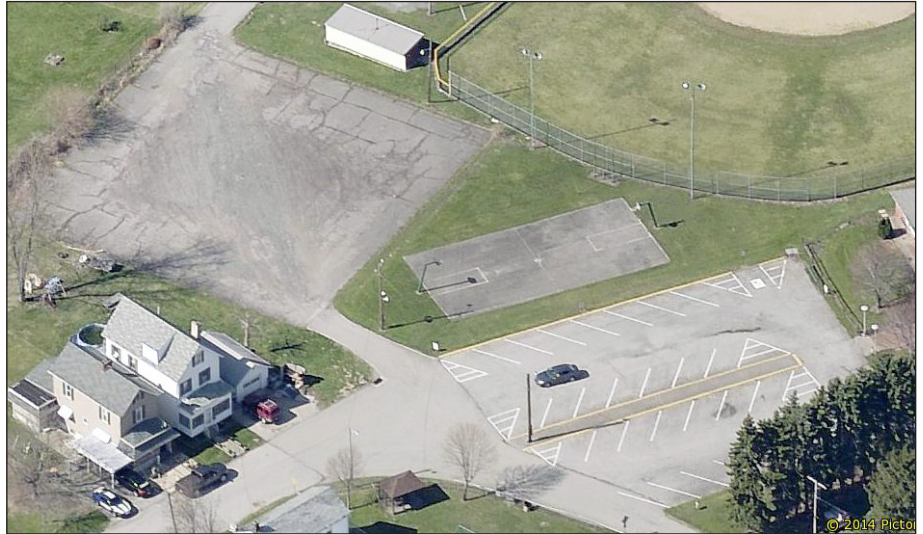
An aerial view of the project site before construction

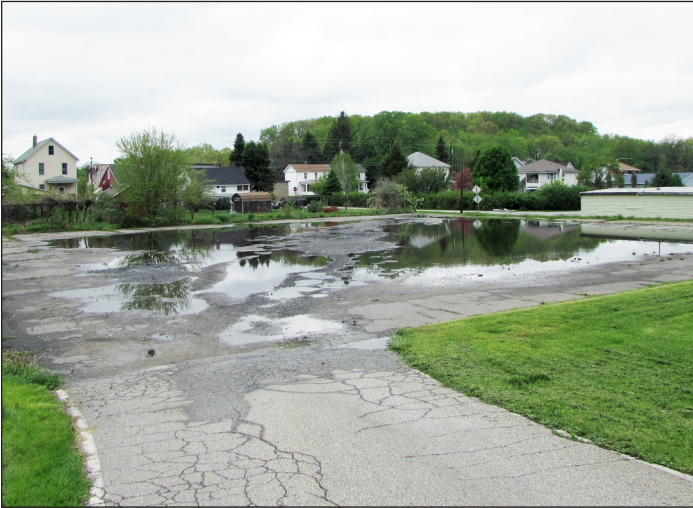
Unused tennis court at the Derry Area Community Pool before construction

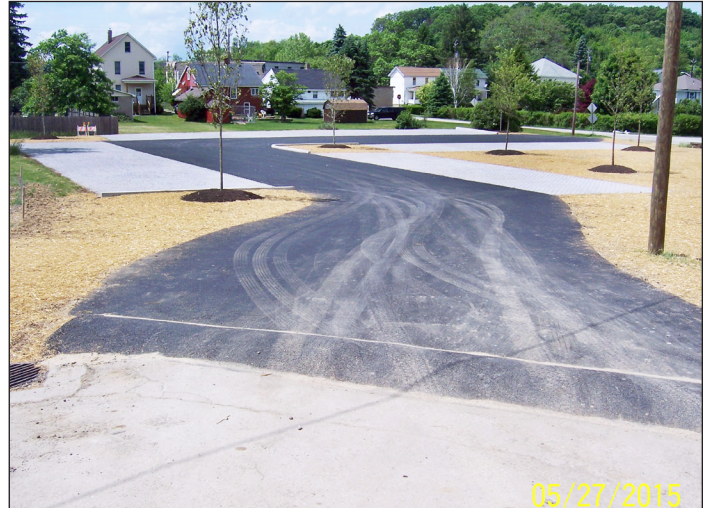
The tennis court area after the permeable parking lot with an asphalt driving lane and turfstone parking spaces was installed

Stormwater reduction performance analysis: Runoff from a 1/2" storm event on the new 30 car parking lot is fully managed by 5,400 square foot permeable

paving which captures 333 cu/ft total runoff. And approximately half of the existing 32 car lot is managed by a 700 square foot rain garden.

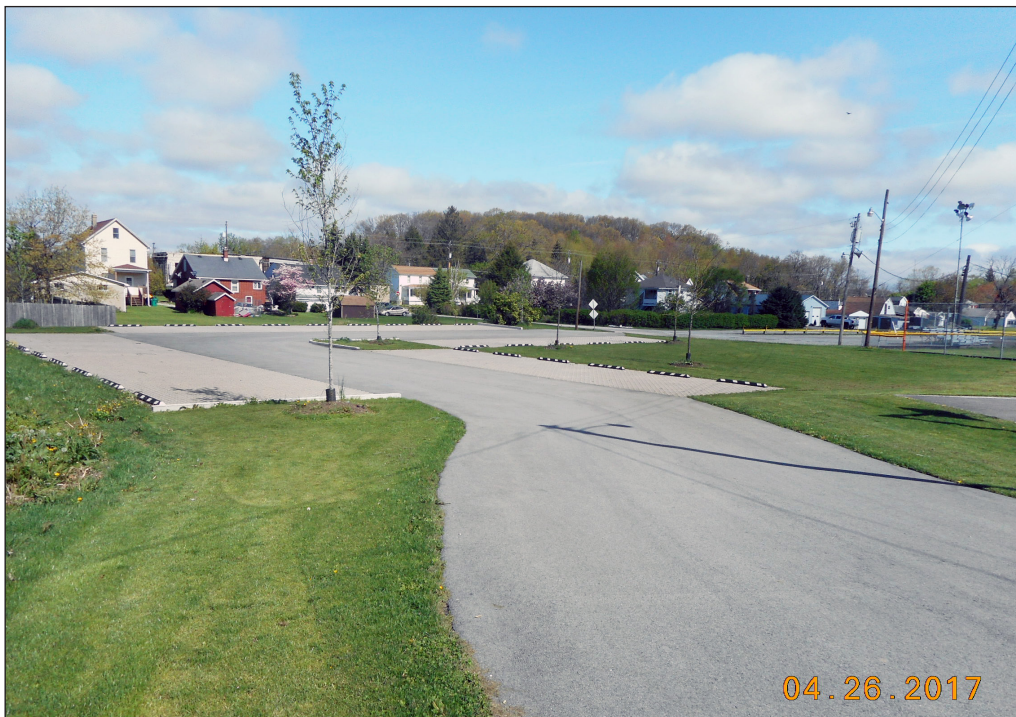
The new parking lot two years after the retrofit

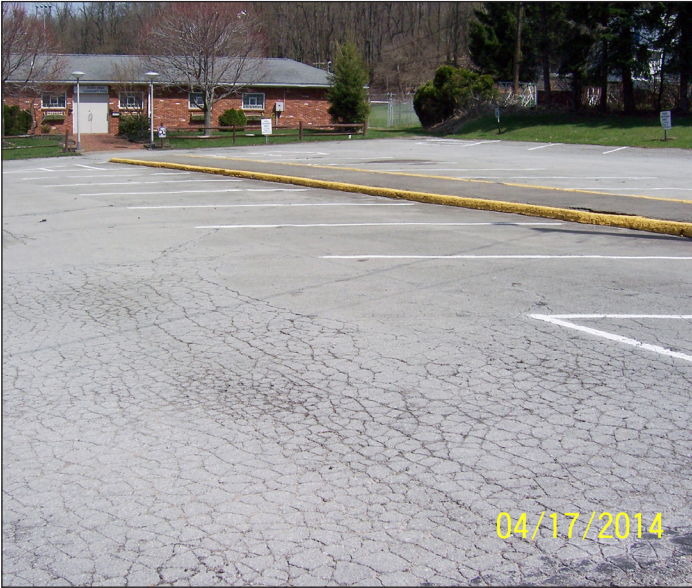
The traffic control island in the parking lot before construction

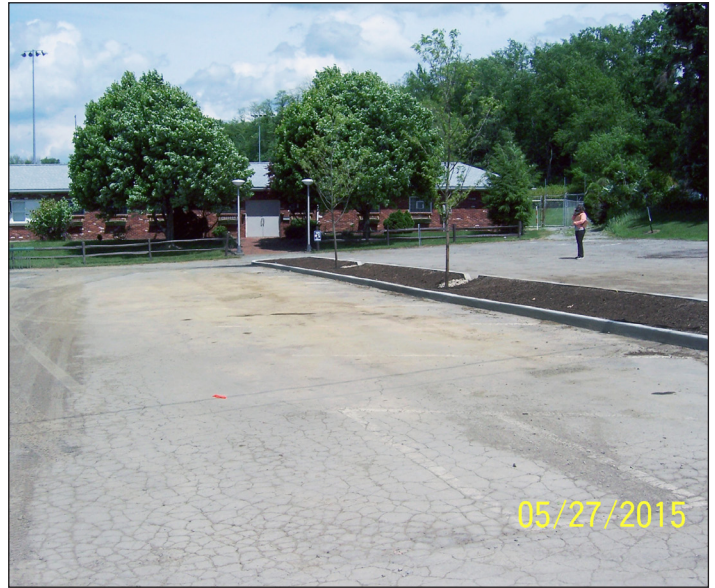
The new curbed rain garden with curb cuts, trees, and native seed mix

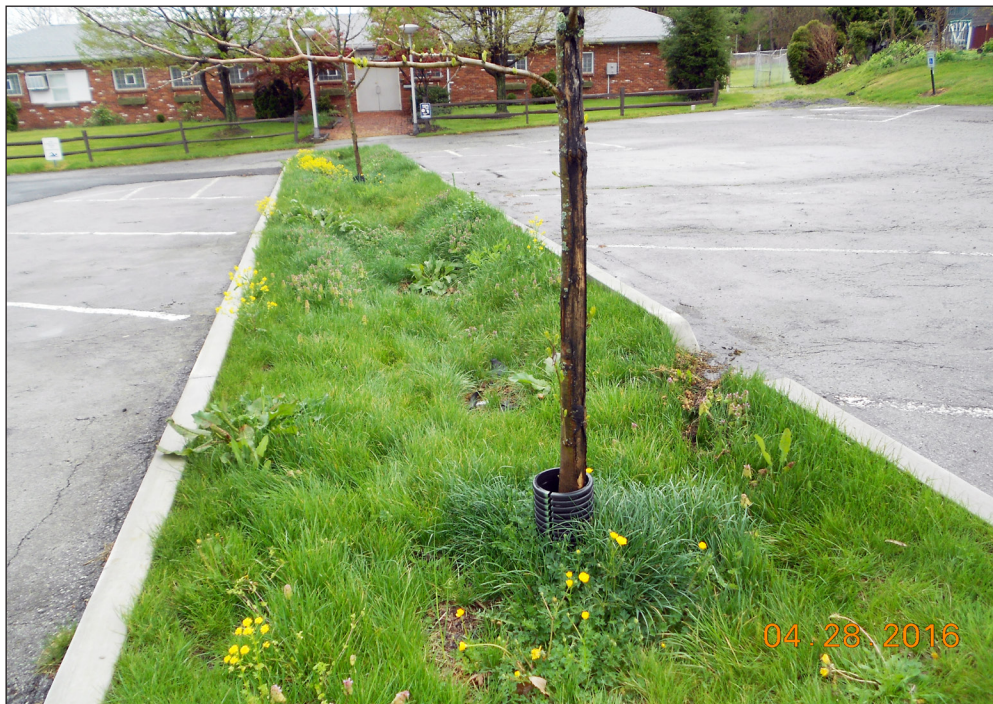
The new traffic control island a year after installation
