Stormwater Program

St. James Evangelical Lutheran Church Parking Lot Rain Gardens

Design features: Rain gardens **Date of installation:** Fall 2015

Location: St. James Evangelical Lutheran Church, Ligonier, Westmoreland County, PA

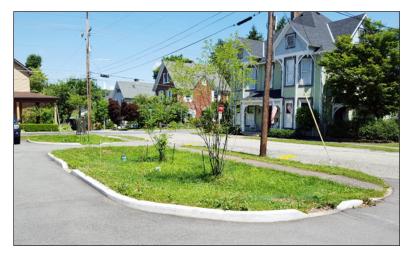
Two rain gardens at the low end of the parking lot capture much of the surface runoff through curb cuts before it runs out to the nearby street. Small ornamental trees accent the meadow cover to provide shade.

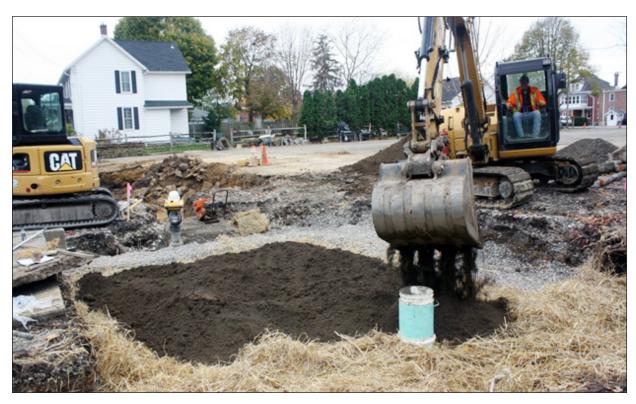
Straw is used to separate soil layers from stone layers from the engineered (topsoil-sand-compost) soil mix layers. A pipe riser with a basket grate connected to an underdrain provides a safe overflow outlet for larger storms.

The rain garden locations were excavated to a three to four foot depth and backfilled with layers of straw (for separation), clean angular stone, more straw, engineered soil mix of topsoil, sand, and compost, and then stabilized with vegetation.

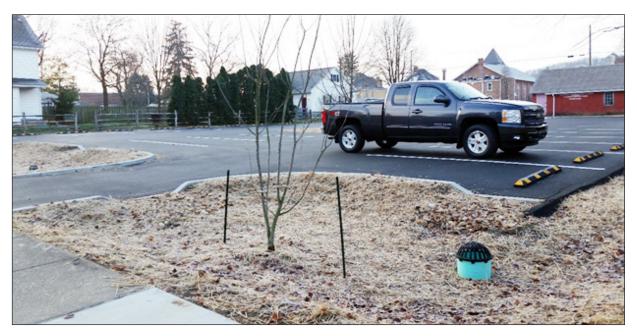
Freshly seeded and mulched, the rain gardens include rock aprons at the curb cuts to slow and spread out the runoff into the rain garden.

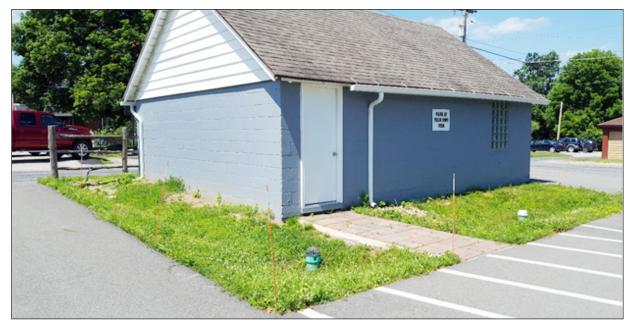
A rain garden, connected by pipe beneath the access path to the storage building, controls a portion of the parking lot as well as the storage building roof runoff. A dense meadow mix covers the surface of the garden.
