Nature Park-Donohue Creek Protection and Restoration

Design Features: stormwater retention basins, bioretention swales, porous pavement

Location: Ann Rudd Saxman Nature Park (Greenforge Office Building, Bureau of Parks and Recreation, Donohue Basin)

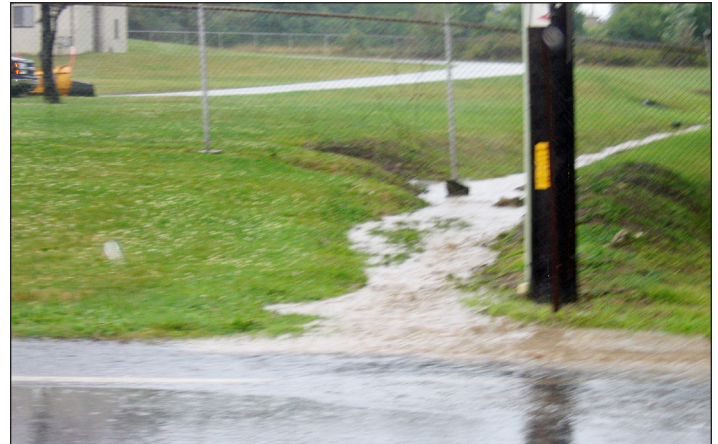
Unmanaged stormwater runoff from the Bureau of Parks and Recreation site before construction flowing onto Donohue Road

A new stormwater basin was constructed at the Greenforge building along with the installation of porous pavement in the surrounding parking lot. The existing BMPs at the Bureau of Park and Recreation site were retrofitted with three new bioretention swales. The first is a forebay to pretreat any large sediment being carried in the stormwater with the following two swales increasing detention time and restricting the amount of water leaving the site

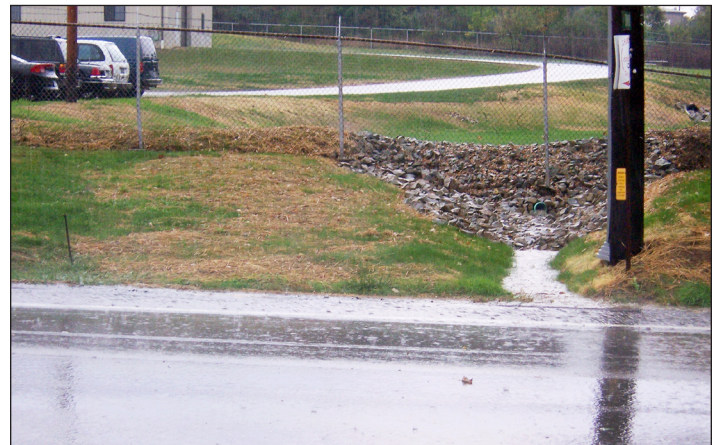
Bureau of Parks and Recreation site after construction with retention basin in place

The Parks retention basin retains approximately 40,000 gallons of runoff from the property after its retrofit, which reduces the volume and velocity of stormwater running onto Donohue Road. All of these projects ultimately reduced the erosion and sedimentation in Donohue Creek, improving the habitat and water quality downstream.

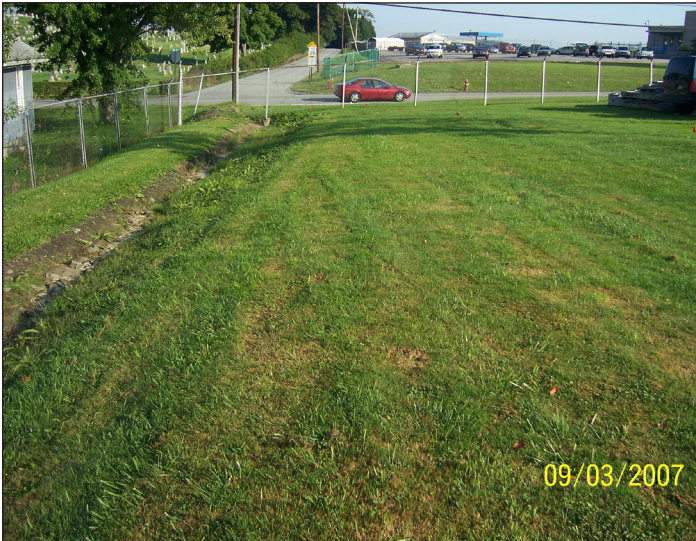
Area by the Bureau of Parks building before main retention pond is installed; uncontrolled stormwater flow directly onto Donohue Road

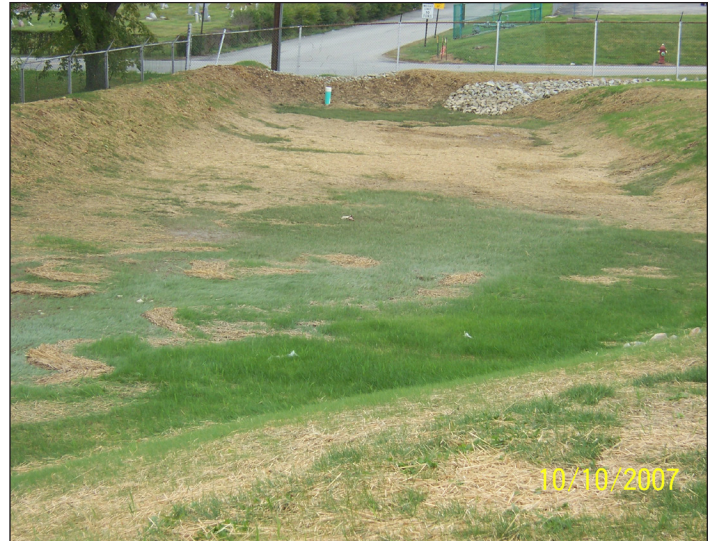
New stormwater retention basin constructed to control stormwater

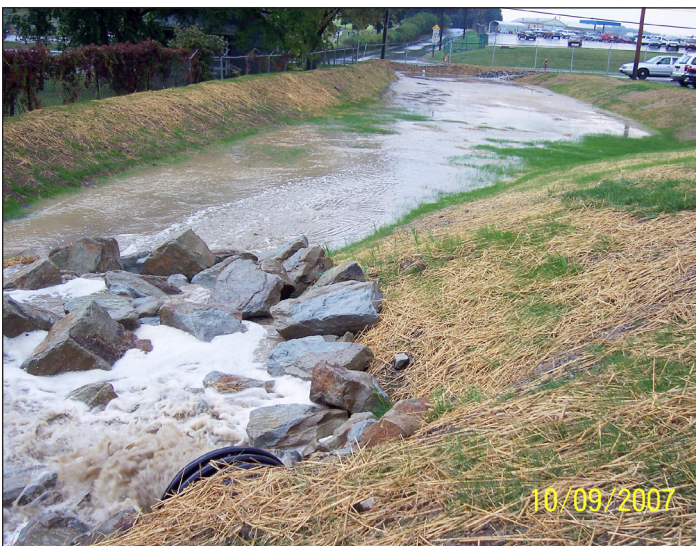
Retention basin at work after a rainstorm

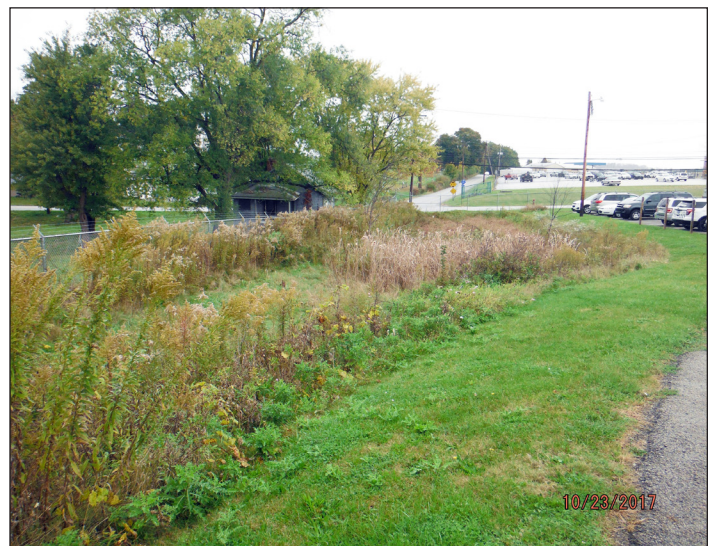
Bureau of Parks basin 10 years after construction

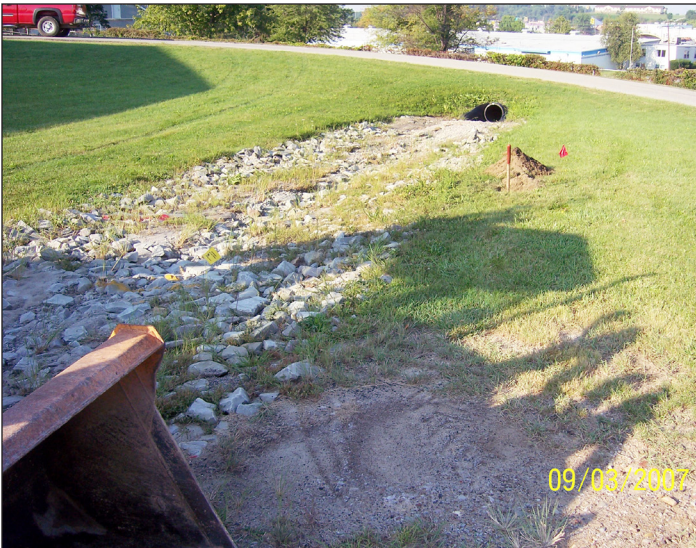
Forebay area of the Bureau of Parks basin before construction

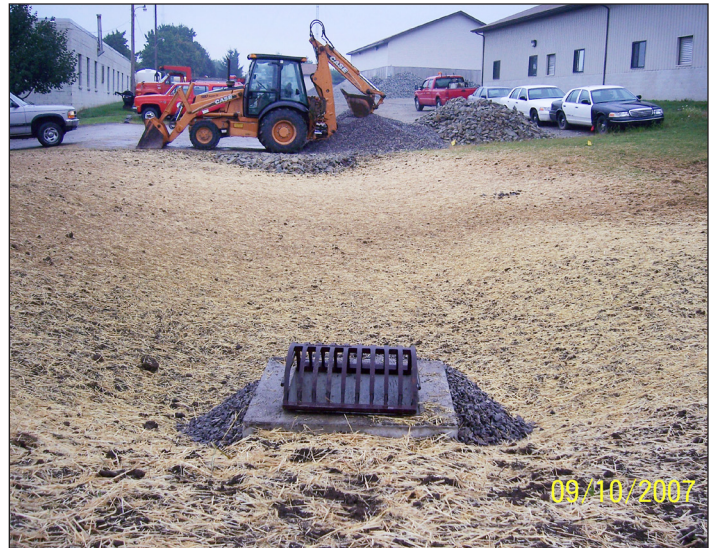
Forebay area after construction

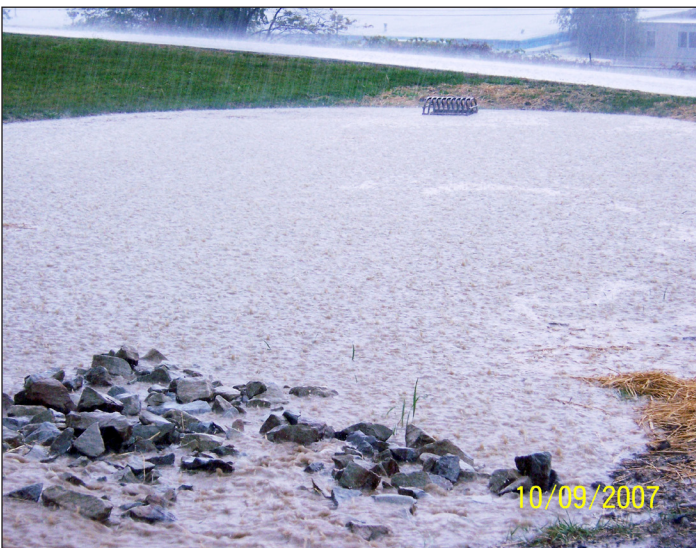
Forebay area managing a rainfall about a month after construction

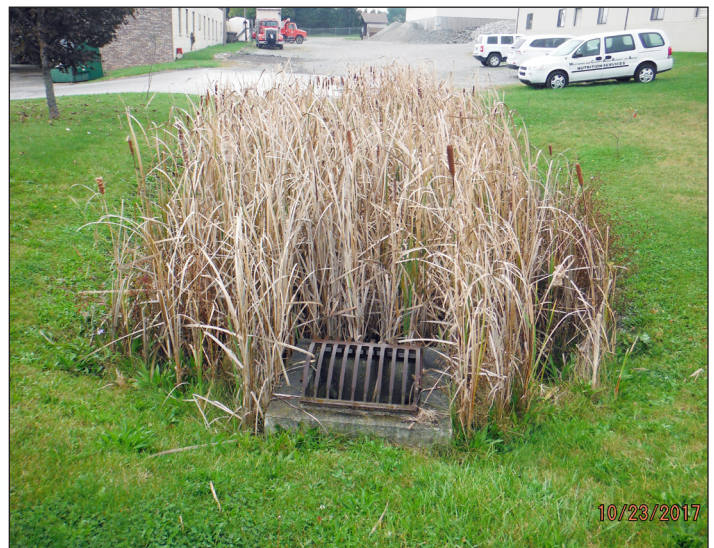
Forebay 10 years after construction

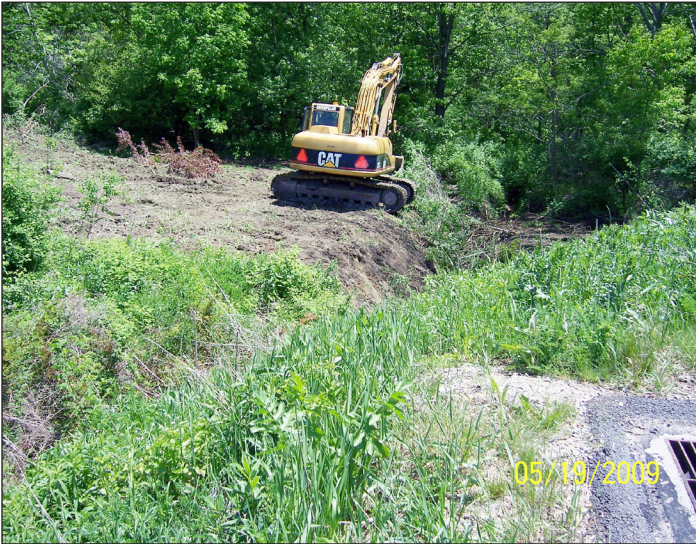
Area next to the Greenforge Office Building during construction of the stormwater retention basin

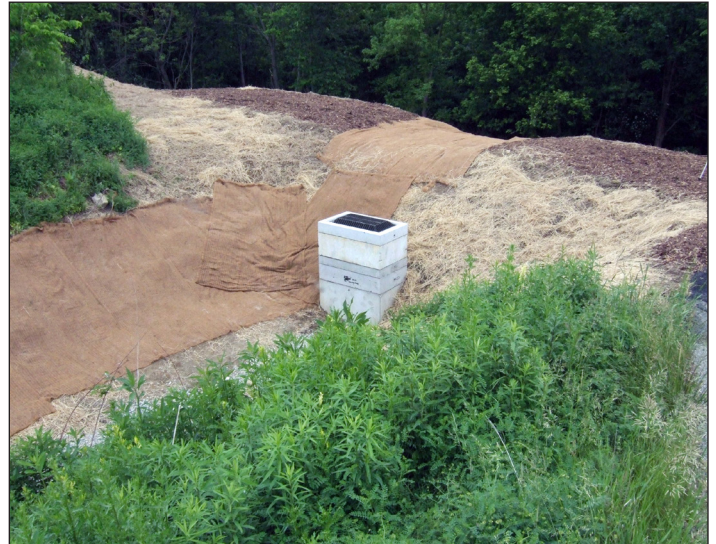
Completed construction of the basin

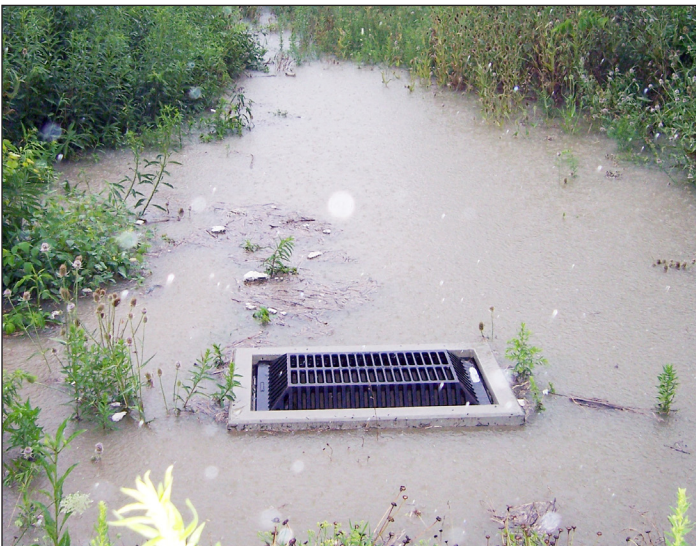
The retention basin managing stormwater during a rainfall two years after construction

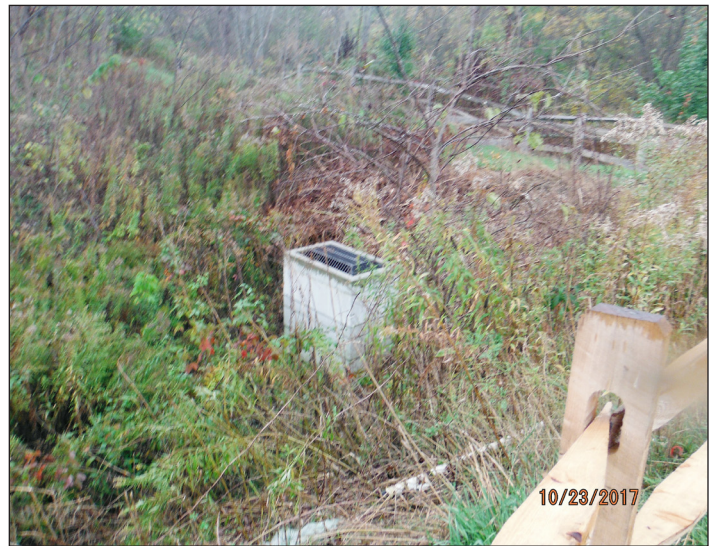
The Greenforge basin eight years after construction

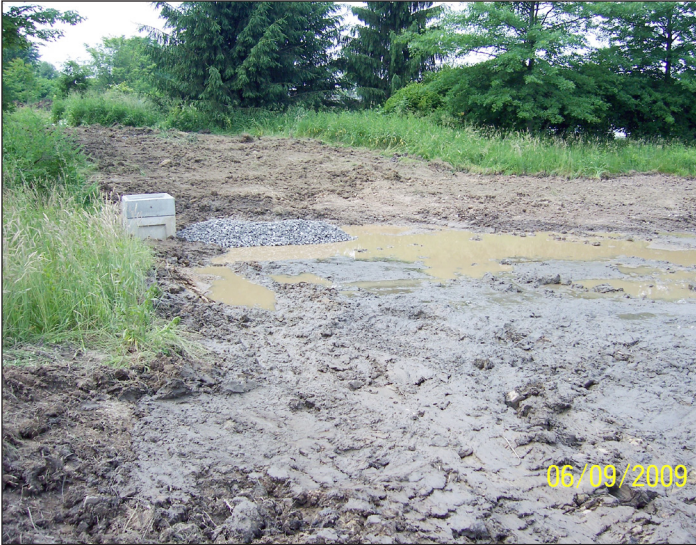
The Donohue basin with a new inlet riser installed

to flow directly into Donohue Creek. The Donohue Basin was retrofitted by installing a new inlet riser.

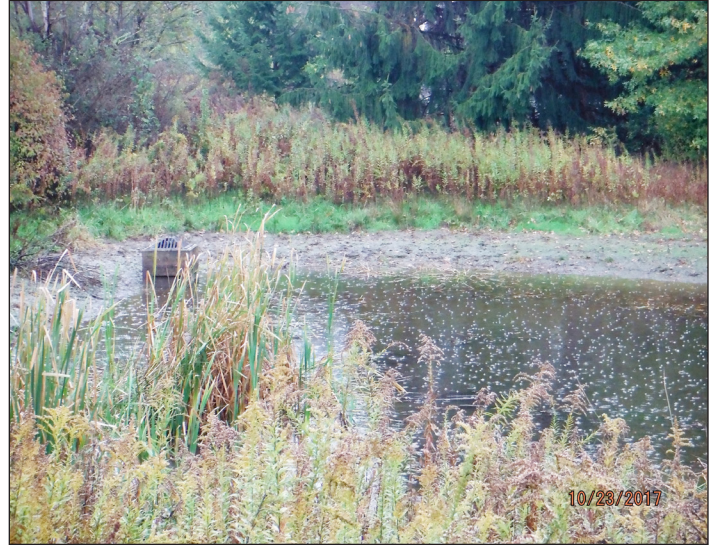
The Donohue basin eight years after retrofitting
