Sherrick Run Stream Mitigation

Design Features: rock cross vanes, j-hooks, riparian buffer, removal of concrete-lined channel, rock aprons, sediment baffles

Date of Installation: 2017

Location: along Old Rte. 119 in East Huntington Township, Westmoreland County

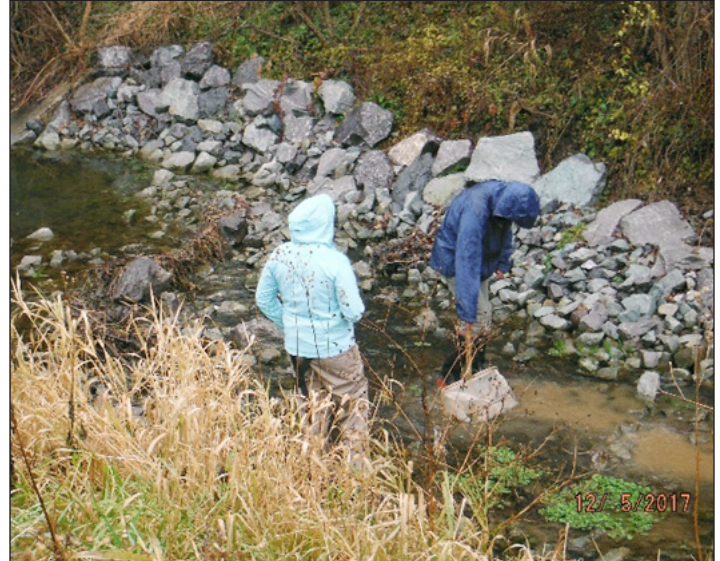
Stream monitoring in progress as benthic macro invertebrates are being collected

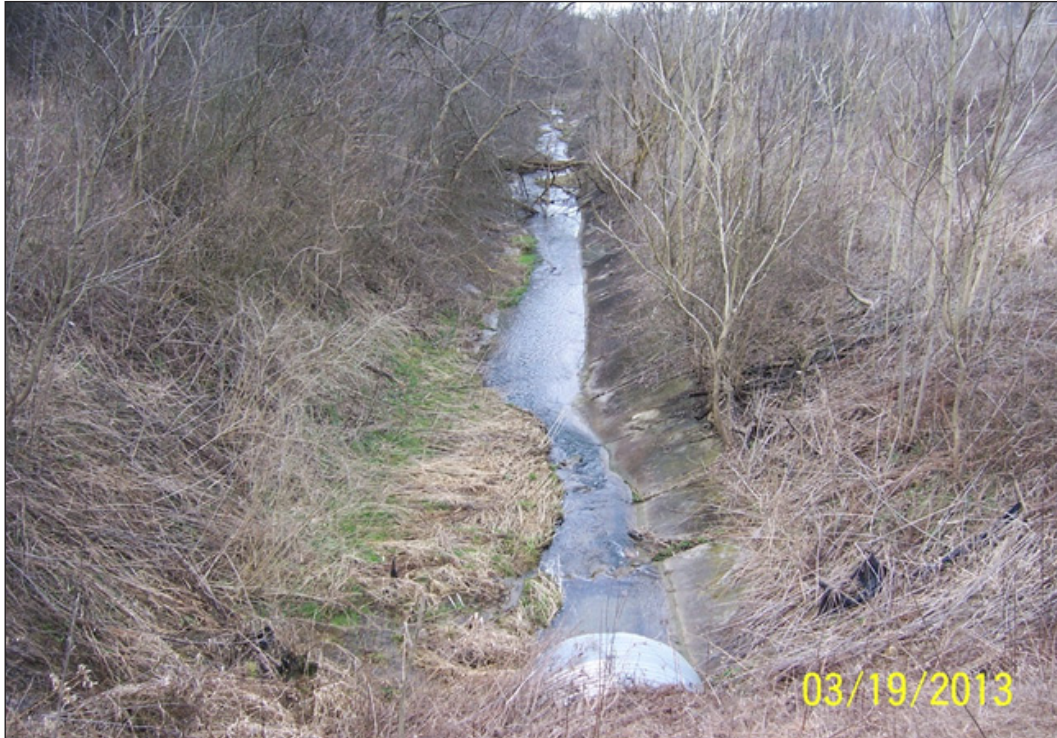
Sherrick Run before mitigation; note the concrete channel lining

Various Best Management Practices (BMPs) were implemented at the site after over 1,000 feet of existing concrete channel lining was removed. Rock aprons were installed at the outlets of the existing pipes along the channel. In addition, nine rock cross vanes and two j-hooks were installed along the stream bed, and 10 sediment retaining baffles were installed in the pipe that carries Sherrick Run under Route 119. Trees and shrubs were planted in a riparian buffer along the banks, and stream monitoring will

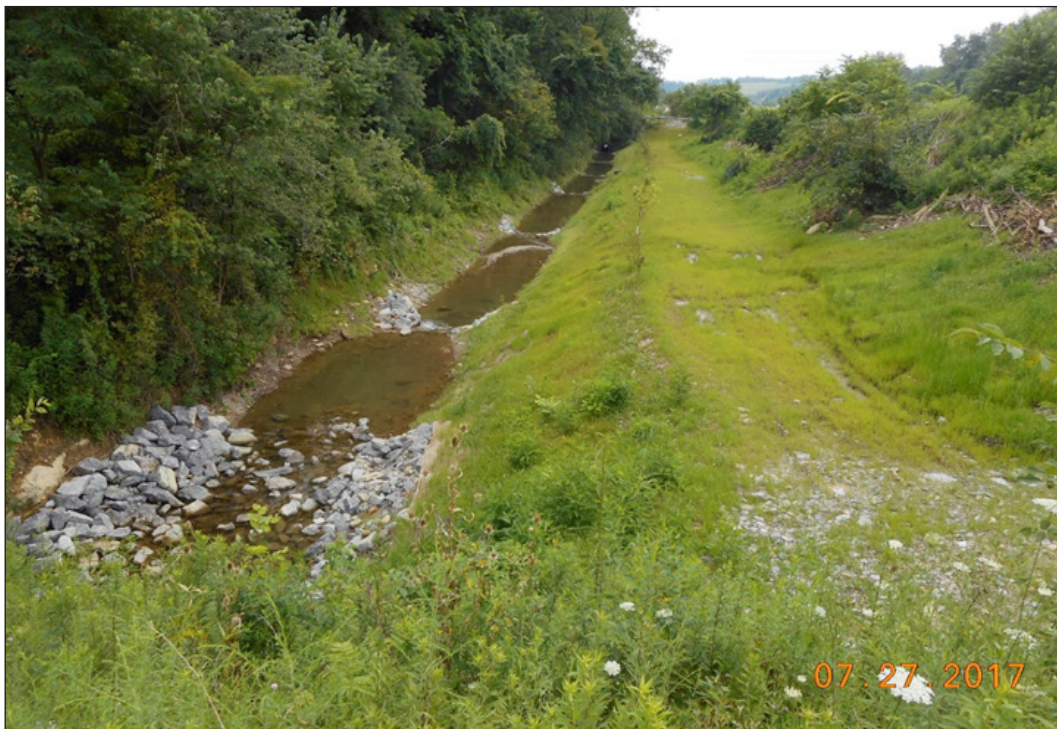
Sherrick Run after mitigation; there is now a natural stream bed and riparian buffer plantings along the banks

50 trees/shrubs and 200 live willow stakes were planted to stabilize the stream bank, and there is currently a 100% survival rate for the trees and shrubs and a 75% survival rate for the live stakes planted. The fourth water sampling site is upstream of the project location and shows a fair to good water quality rating based off of the benthic macro invertebrates collected. This shows the potential for these macro invertebrates to move downstream within the PennDOT mitigation project area in the future. Further monitoring of macro invertebrates, water chemistry, and physical habitat will hopefully lead to increasingly improved water quality ratings as the impacts of construction diminish. The riparian buffer plantings have decreased the water temperature and sedimentation into Sherrick Run, as well as stabilized the stream banks. Furthermore, the concrete removal, rock cross vanes, and j-hooks have improved the stream habitat by creating a natural stream corridor with a series of pools and in-stream cover for aquatic life.
