Watershed Restoration

Valley High School

Design Features: Stream improvements, debris basin, permeable parking surface,

Date of Installation: 2008-2012

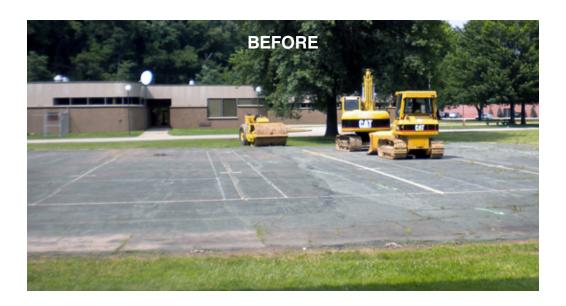
This Stormwater infiltration parking lot has reduced stormwater runoff and decreasing the volume of water to Little Pucketa Creek.

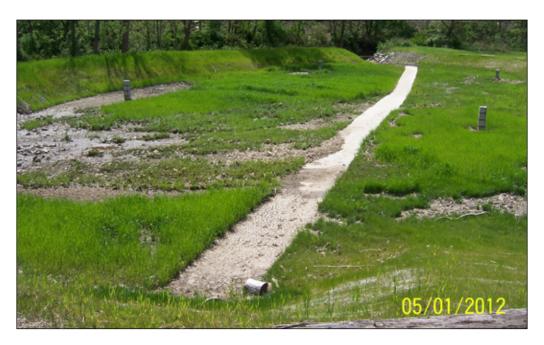
Constructed debris basin aids in the reduction of debris accumulating in the flood control channel in front of the school.

The debris basin was the last phase of the project to be completed to relieve flooding along Little Pucketa Creek. The bowl-shaped area of land, is about one acre in size and is located at the far end of the high school property, between the athletic fields and Route 56.

The basin acts like the strainer in your kitchen sink, catching pollution – anything from soil to litter – that the creek has picked up as it flows along. Catching pollution at this point in the stream's course prevents it from clogging up downstream near the high school, and contributing to flooding problems.

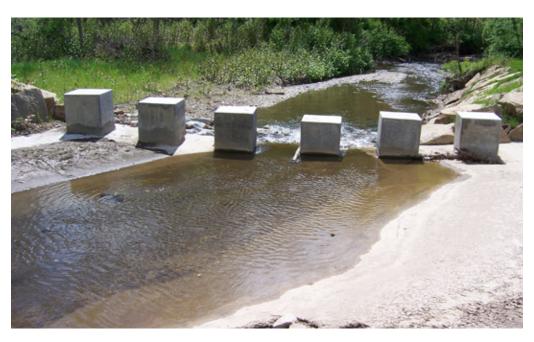
Debris Catcher is designed to trap large debris from continuing downstream and divert it into the debris basin.
