This 1880s era barn
has some amazing
NEW THINGS to show you

Westmoreland
Conservation
District

This building is a real barn that was built in the 1880s. For about 120 years, it housed grain and animals as part of a working farm in Penn Township, Westmoreland County.

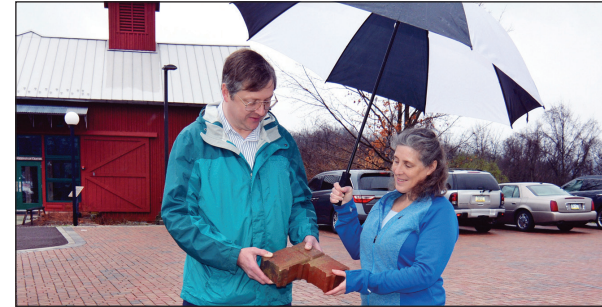
A sample of the permeable pavers used in the front parking lot.

Front and rear parking areas feature **permeable pavers** that allow stormwater to soak into the ground, rather than simply running off.

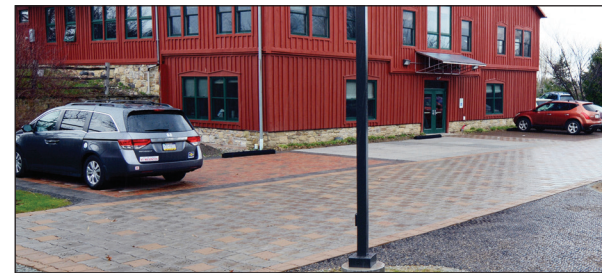
Several different kinds of permeable pavers were used in the barn's back parking lot for demonstration purposes.

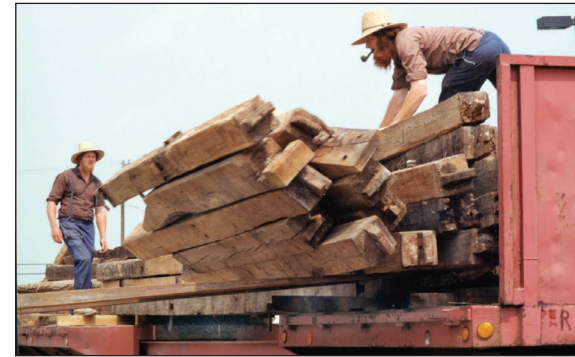
Top: Amish craftsmen unload original 1880s barn timbers for reconstruction at Donohoe Center.

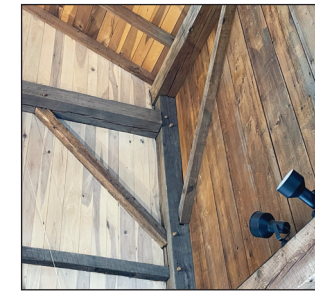
Right: The main hall of the completed District headquarters with original timbers and diverse wood wall paneling.

- 80% of the barn's **original structural timbers have been reused**, and the limited number of new timbers needed came from Westmoreland County forests.
- Inside walls are finished with a variety of wood types**, representing the natural diversity found in area forests.
