Stormwater Management

Hempfield Park Stormwater Retrofits

Design Features: Two new rain gardens totaling 900 ft², 400 feet of streambank stabilization, 40,000 ft² of native pollinator mix, 23 tree plantings, a concrete ramp for stream access, and an educational sign

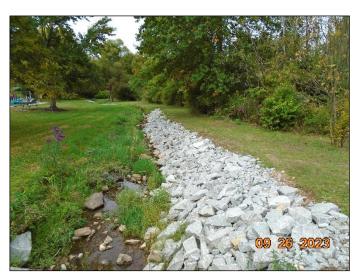
Stabilized streambank by means of bank and dumped rock protection

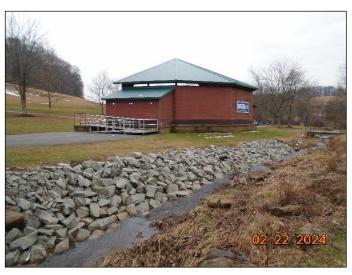
After Construction

Streambank stabilization by means of bank grading and dumped rock protection

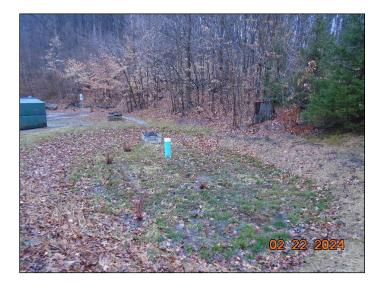
New rain garden with shrub plantings

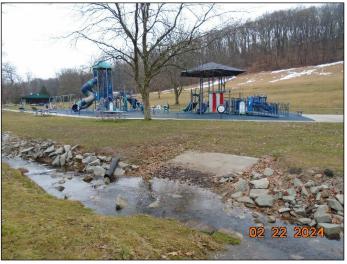
New concrete ramp to allow for educational stream access
