Ligonier Valley School District Basin Retrofits

Design Features: Retrofitted storm water basins, vegetated channel, rock lined channel, and new outlet structures allowing for additional storage capacity

Location: R.K. Mellon Elementary School, Ligonier, Westmoreland County

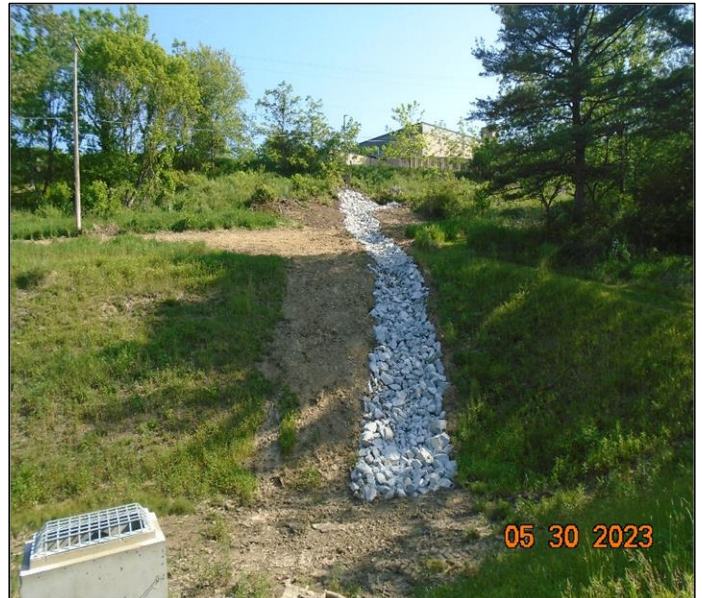
Finished rock-lined channel for stormwater conveyance leading into the stormwater basin

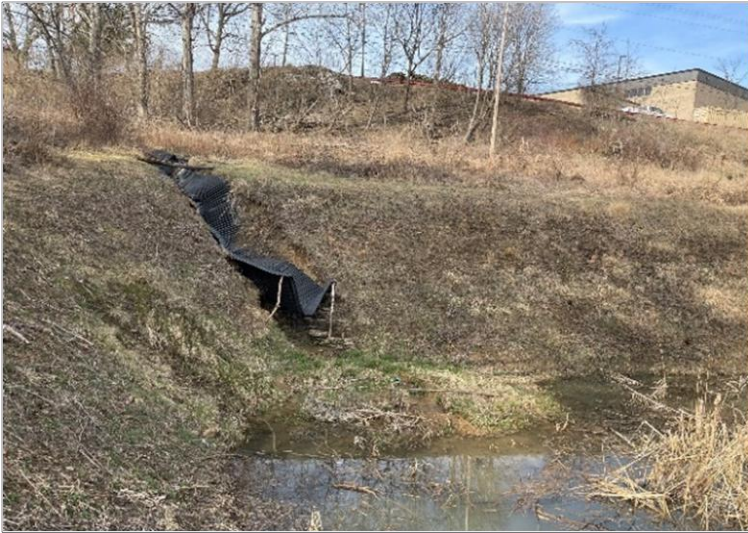
Before the project, a declining plastic conveyance channel disrupted the efficiency of stormwater drainage into a detention pond. This caused one of the stormwater basins to fill with excess sediment. In response to this issue, new outlet structures were added to two of the existing basins which allowed stormwater to be temporarily stored instead of exiting immediately. The plastic lined channel was replaced with approximately 210 feet of rock lined channel. The project also removed sediment from one of the basins to increase storage capacity, water quality, and protection of habitat.

(Before) Existing plastic channel as outlet to basin with accumulated sediment.

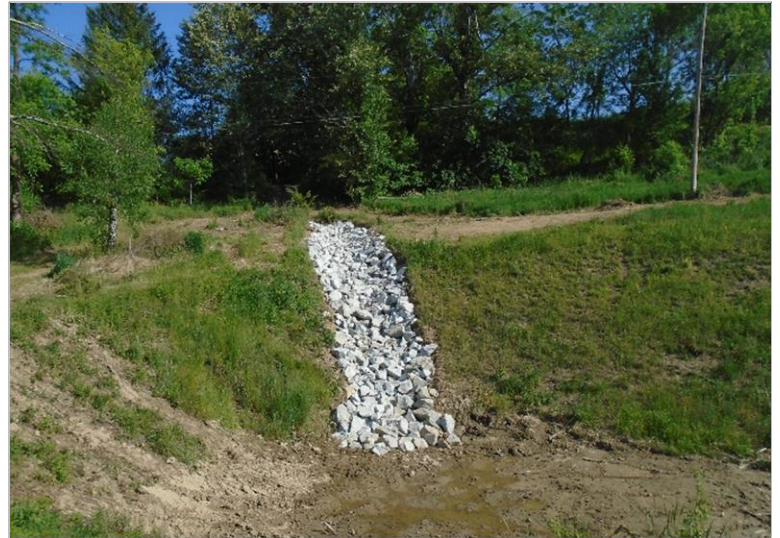
(After) Plastic channel replaced with rock lined channel. Basin restored to original conditions.

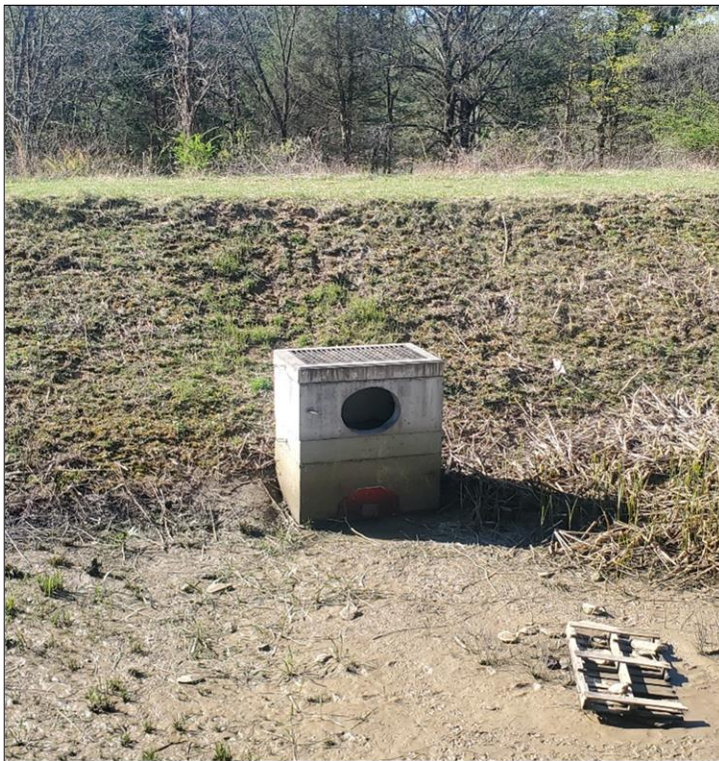
(Before) Stormwater basin outlet structure

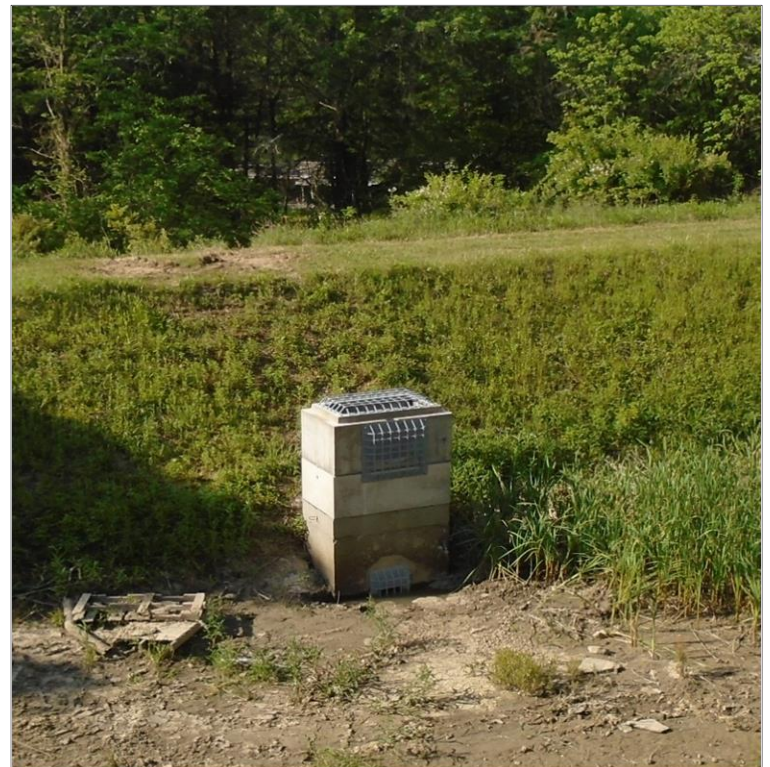
(After) Retrofitted outlet structure with risers and trash racks
