Watershed Restoration

Fox's Stormwater Detention Improvements

Design Features: Stormwater detention basin, vegetated swale, Redi-Rock block

Date of Installation: Fall 2023

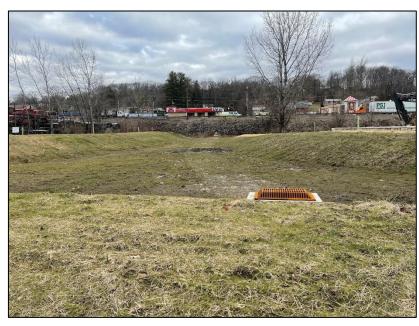
View of newly constructed basin looking towards Route 22

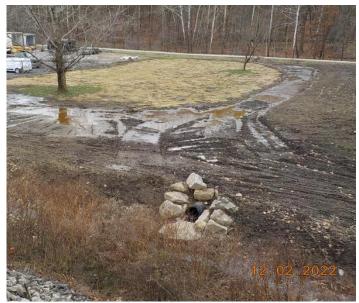
Before Construction

Before Construction: Flooding of parking lot facility at Fox's Pizza.

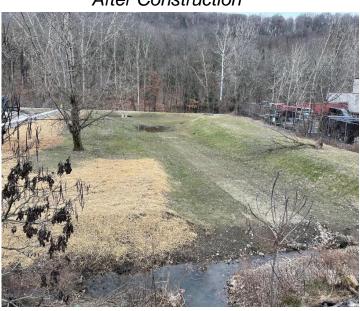
After Construction

View looking towards the Westmoreland Heritage trail.

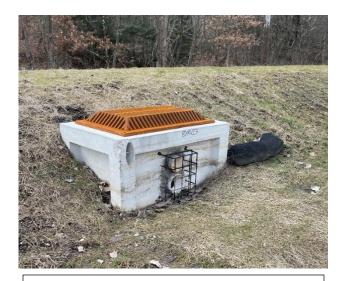
New riser structure with trash rack will ensure that debris does not block the inlet pipe, to allow for stormwater to flow out of the basin.

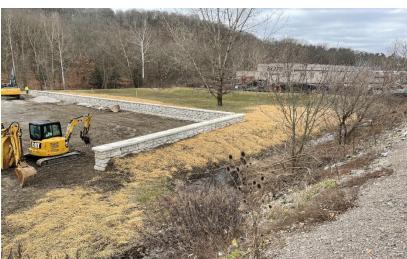
Site after Redi-Rock wall was installed
