Haymaker Run Stream Habitat Improvement Project

Design Features: Log framed cross vane, modified mudsill, log framed stone deflector, single log vane deflector, graded stream banks, armor toe of slope with rip-rap

Date of Installation: Summer 2023

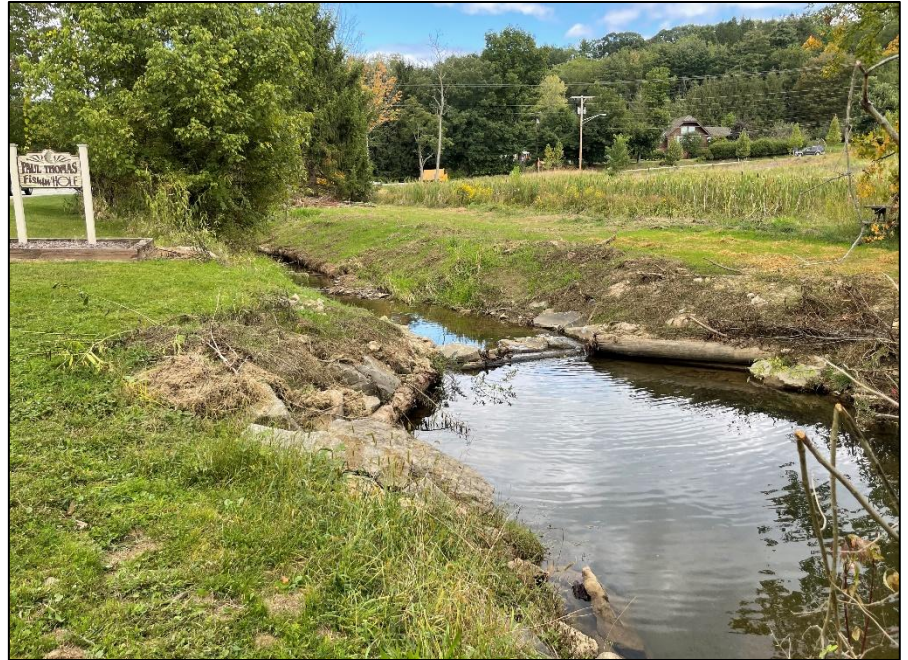
In-stream jack dam structure was retrofitted to meet current PFBC design standards to create better fish habitat and more stable streambanks.

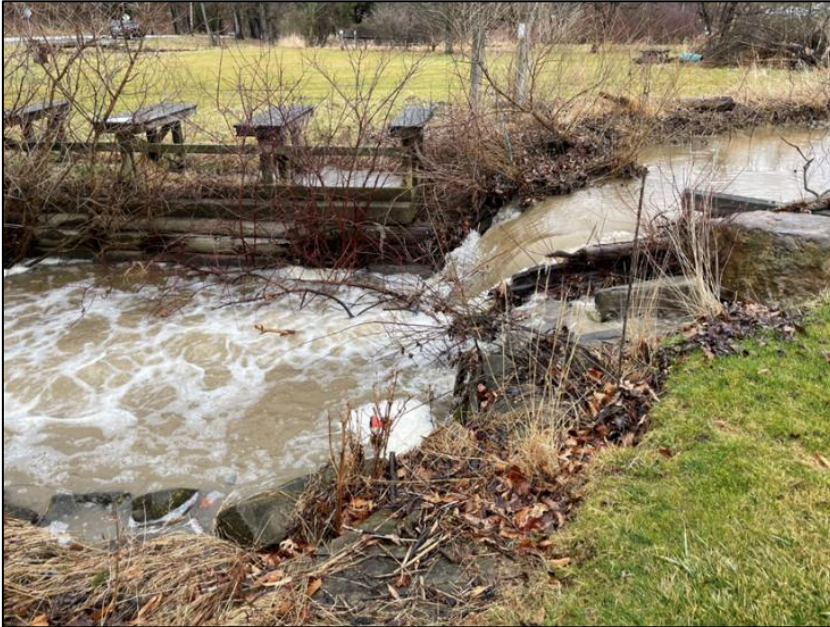
Site of collapsed bridge on top of in-stream structure. Debris is blocking stream flow and creating severe erosion along streambanks.

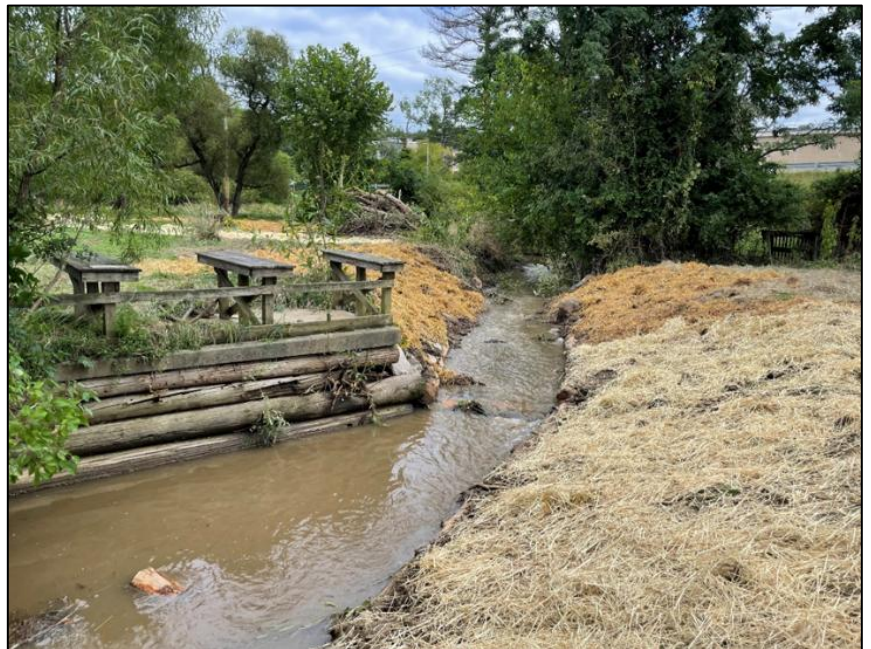
Site after debris was removed and structure was repaired and retrofitted. Banks were also graded and stabilized.
