Manor Borough Stormwater Retrofit

Design Features: 2 rain gardens, permeable parking spots, concrete curbs and curb cuts, native trees and shrubs, lawn expansion

Location: Manor Borough, Westmoreland County PA

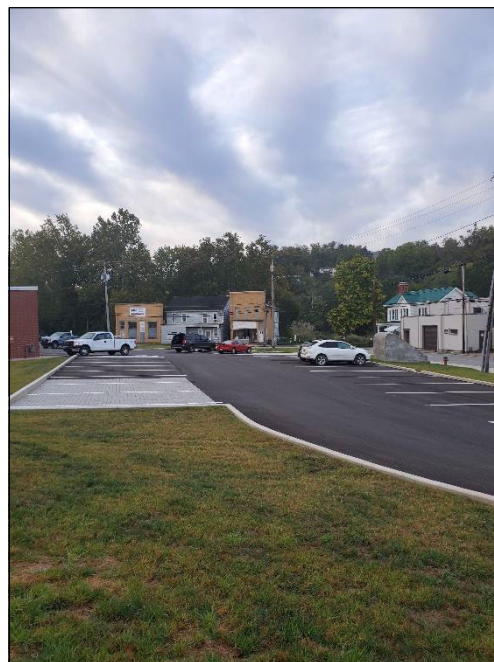
Completed parking lot with permeable parking spots

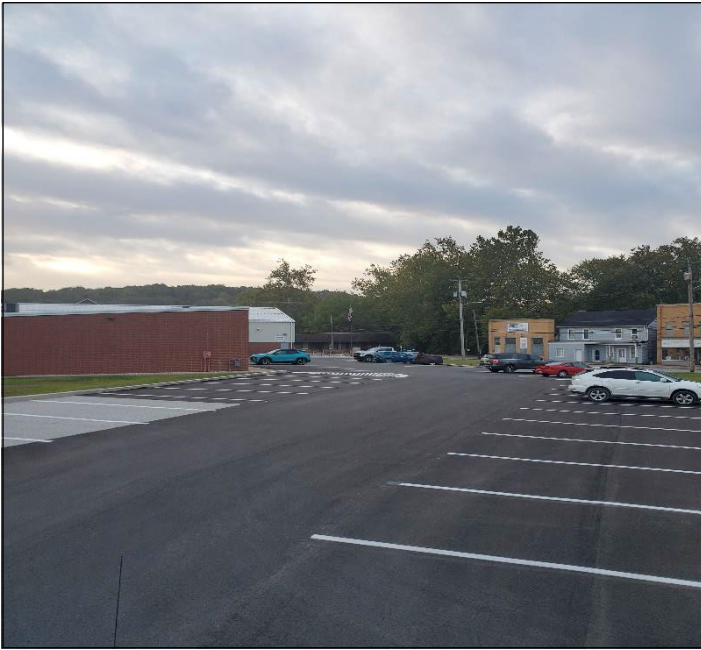
Re-defined parking lot

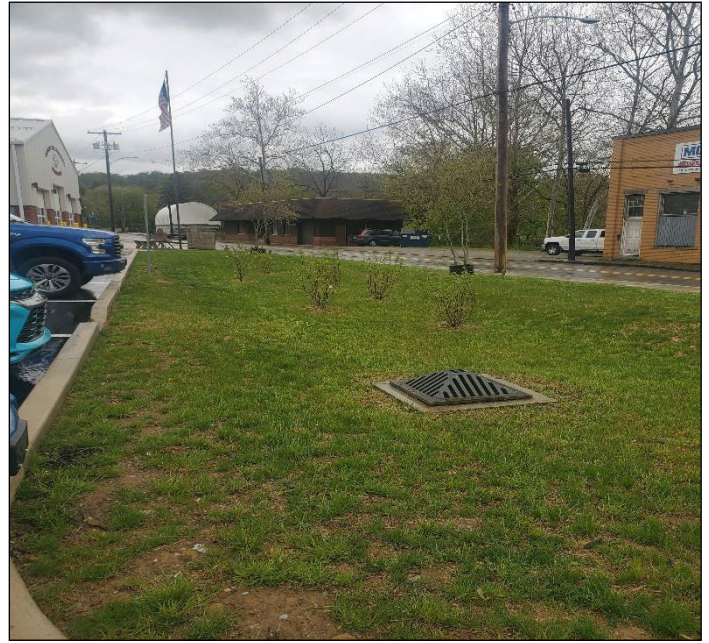
Rain garden and native shrubs

In order to combat stormwater runoff from flooding and depositing sediment in Brush Creek, this project investigated and applied stormwater best management practices to the 1 acre Borough building and parking lot. Two rain gardens were installed to help control runoff and filter out pollutants that may create runoff. Approximately 1,120 square feet of permeable pavers were added to allow the stormwater to infiltrate through cracks between the pavers into the soil layer below. Concrete curbs and cuts directed stormwater from the parking lot into the rain garden. Additionally, 12 native trees and 17 shrubs were planted to promote water infiltration.

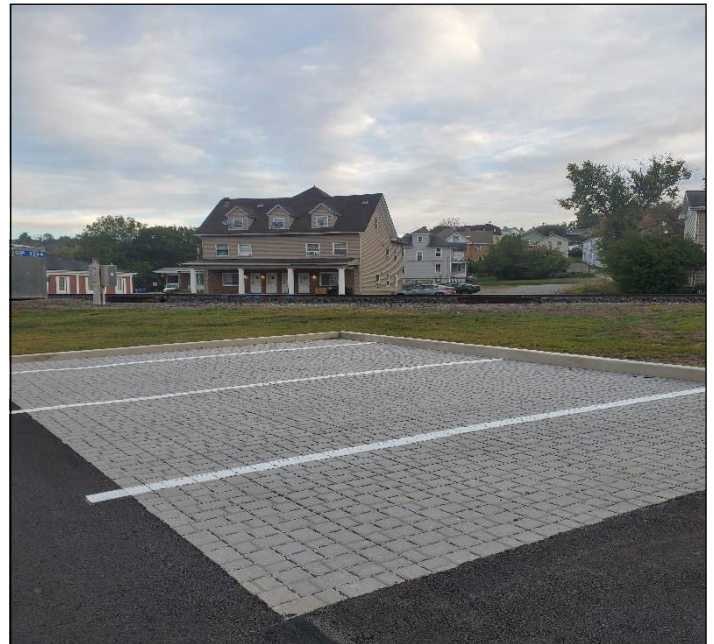
Eco-optiloc permeable pavers

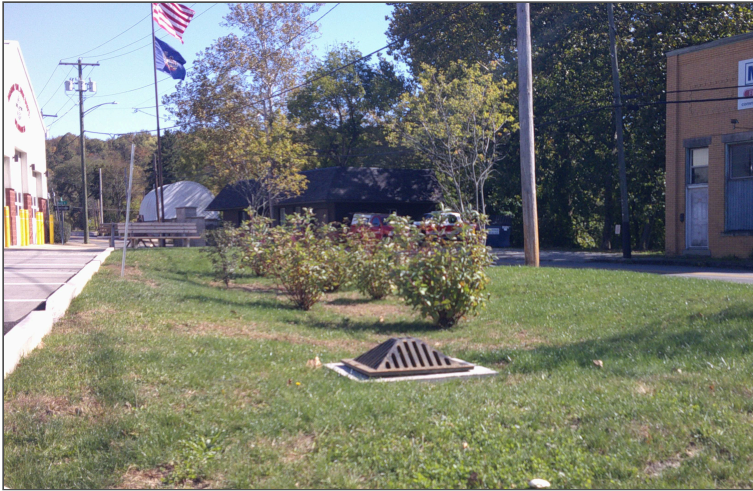
Rain garden two years after construction

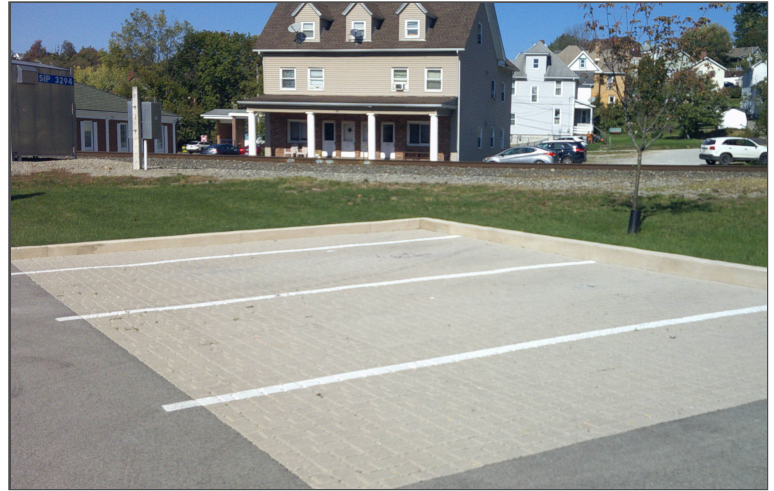
Premeable pavers two years after construction

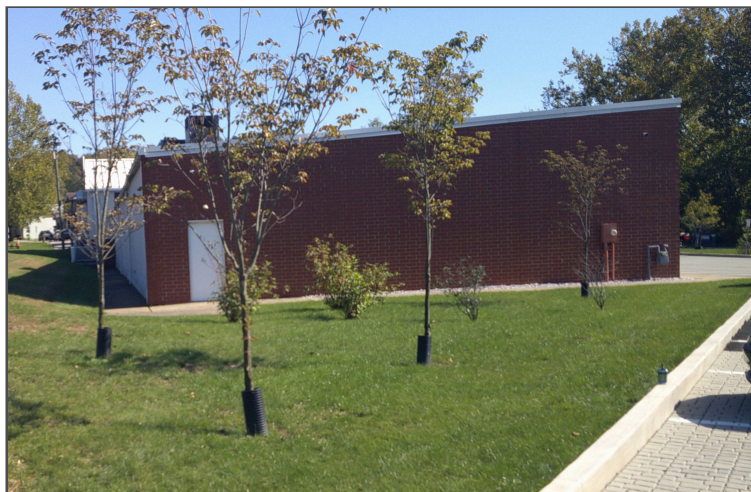
Planted trees two years after construction
